**ICON ENVIRONMENTAL CONSULTANTS  
 526 WEST RIVER ROAD SUITE 2  
 AUGUSTA, MAINE 04330  
 AIR SAMPLE ANALYSIS REPORT  
 207-458-7143  
 Iconenviro@aol.com**

1104 Forest Avenue  
 Portland, Maine

Re: 1104 Forest Avenue Portland, Maine Project #15-171

Re: 1104 Forest Avenue Portland, Maine Project #15-171, Phase 2

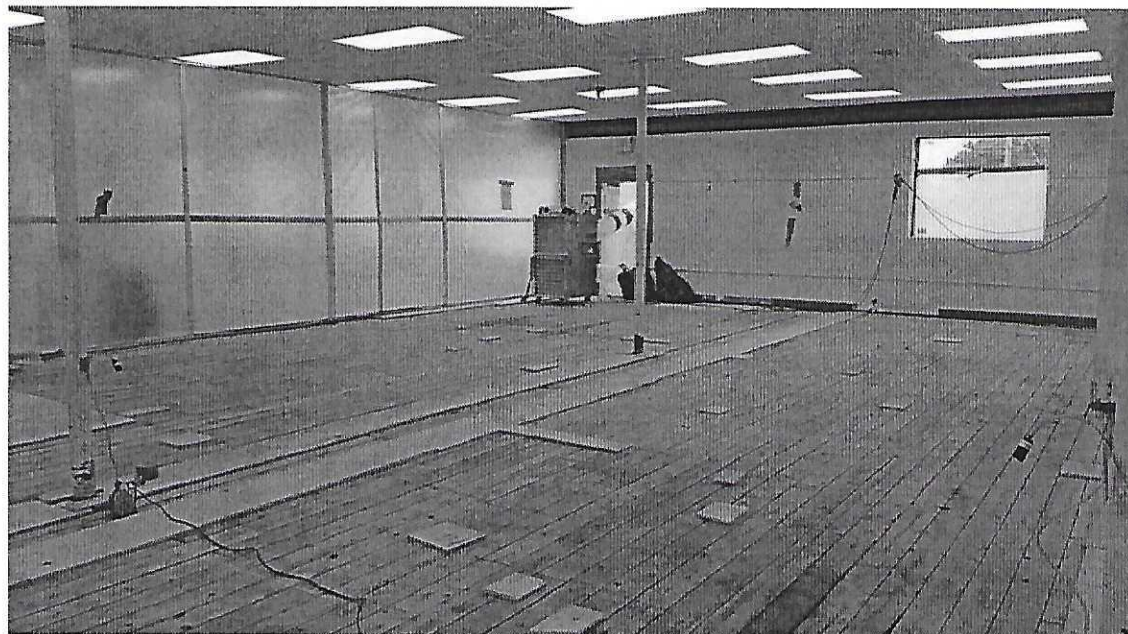
Icon Environmental performed a Final Visual Evaluation and Clearance Air Sample Analysis at 1104 Forest Avenue Portland, Maine. The main floor right side abatement work was completed on June 23, 2015. Abatement Professionals removed 4,000 square feet of flooring. The work was performed using Maine DEP standard containment procedures under negative air. The abatement activity was performed by Maine DEP licensed personnel.
