PROJECT: New Portland Service Building
Five (5) Foot East Truck Bay Building Addition
Punch List
Portland, Maine
DATE: Thursday, December 29, 2011

PUNCH LIST ITEMS

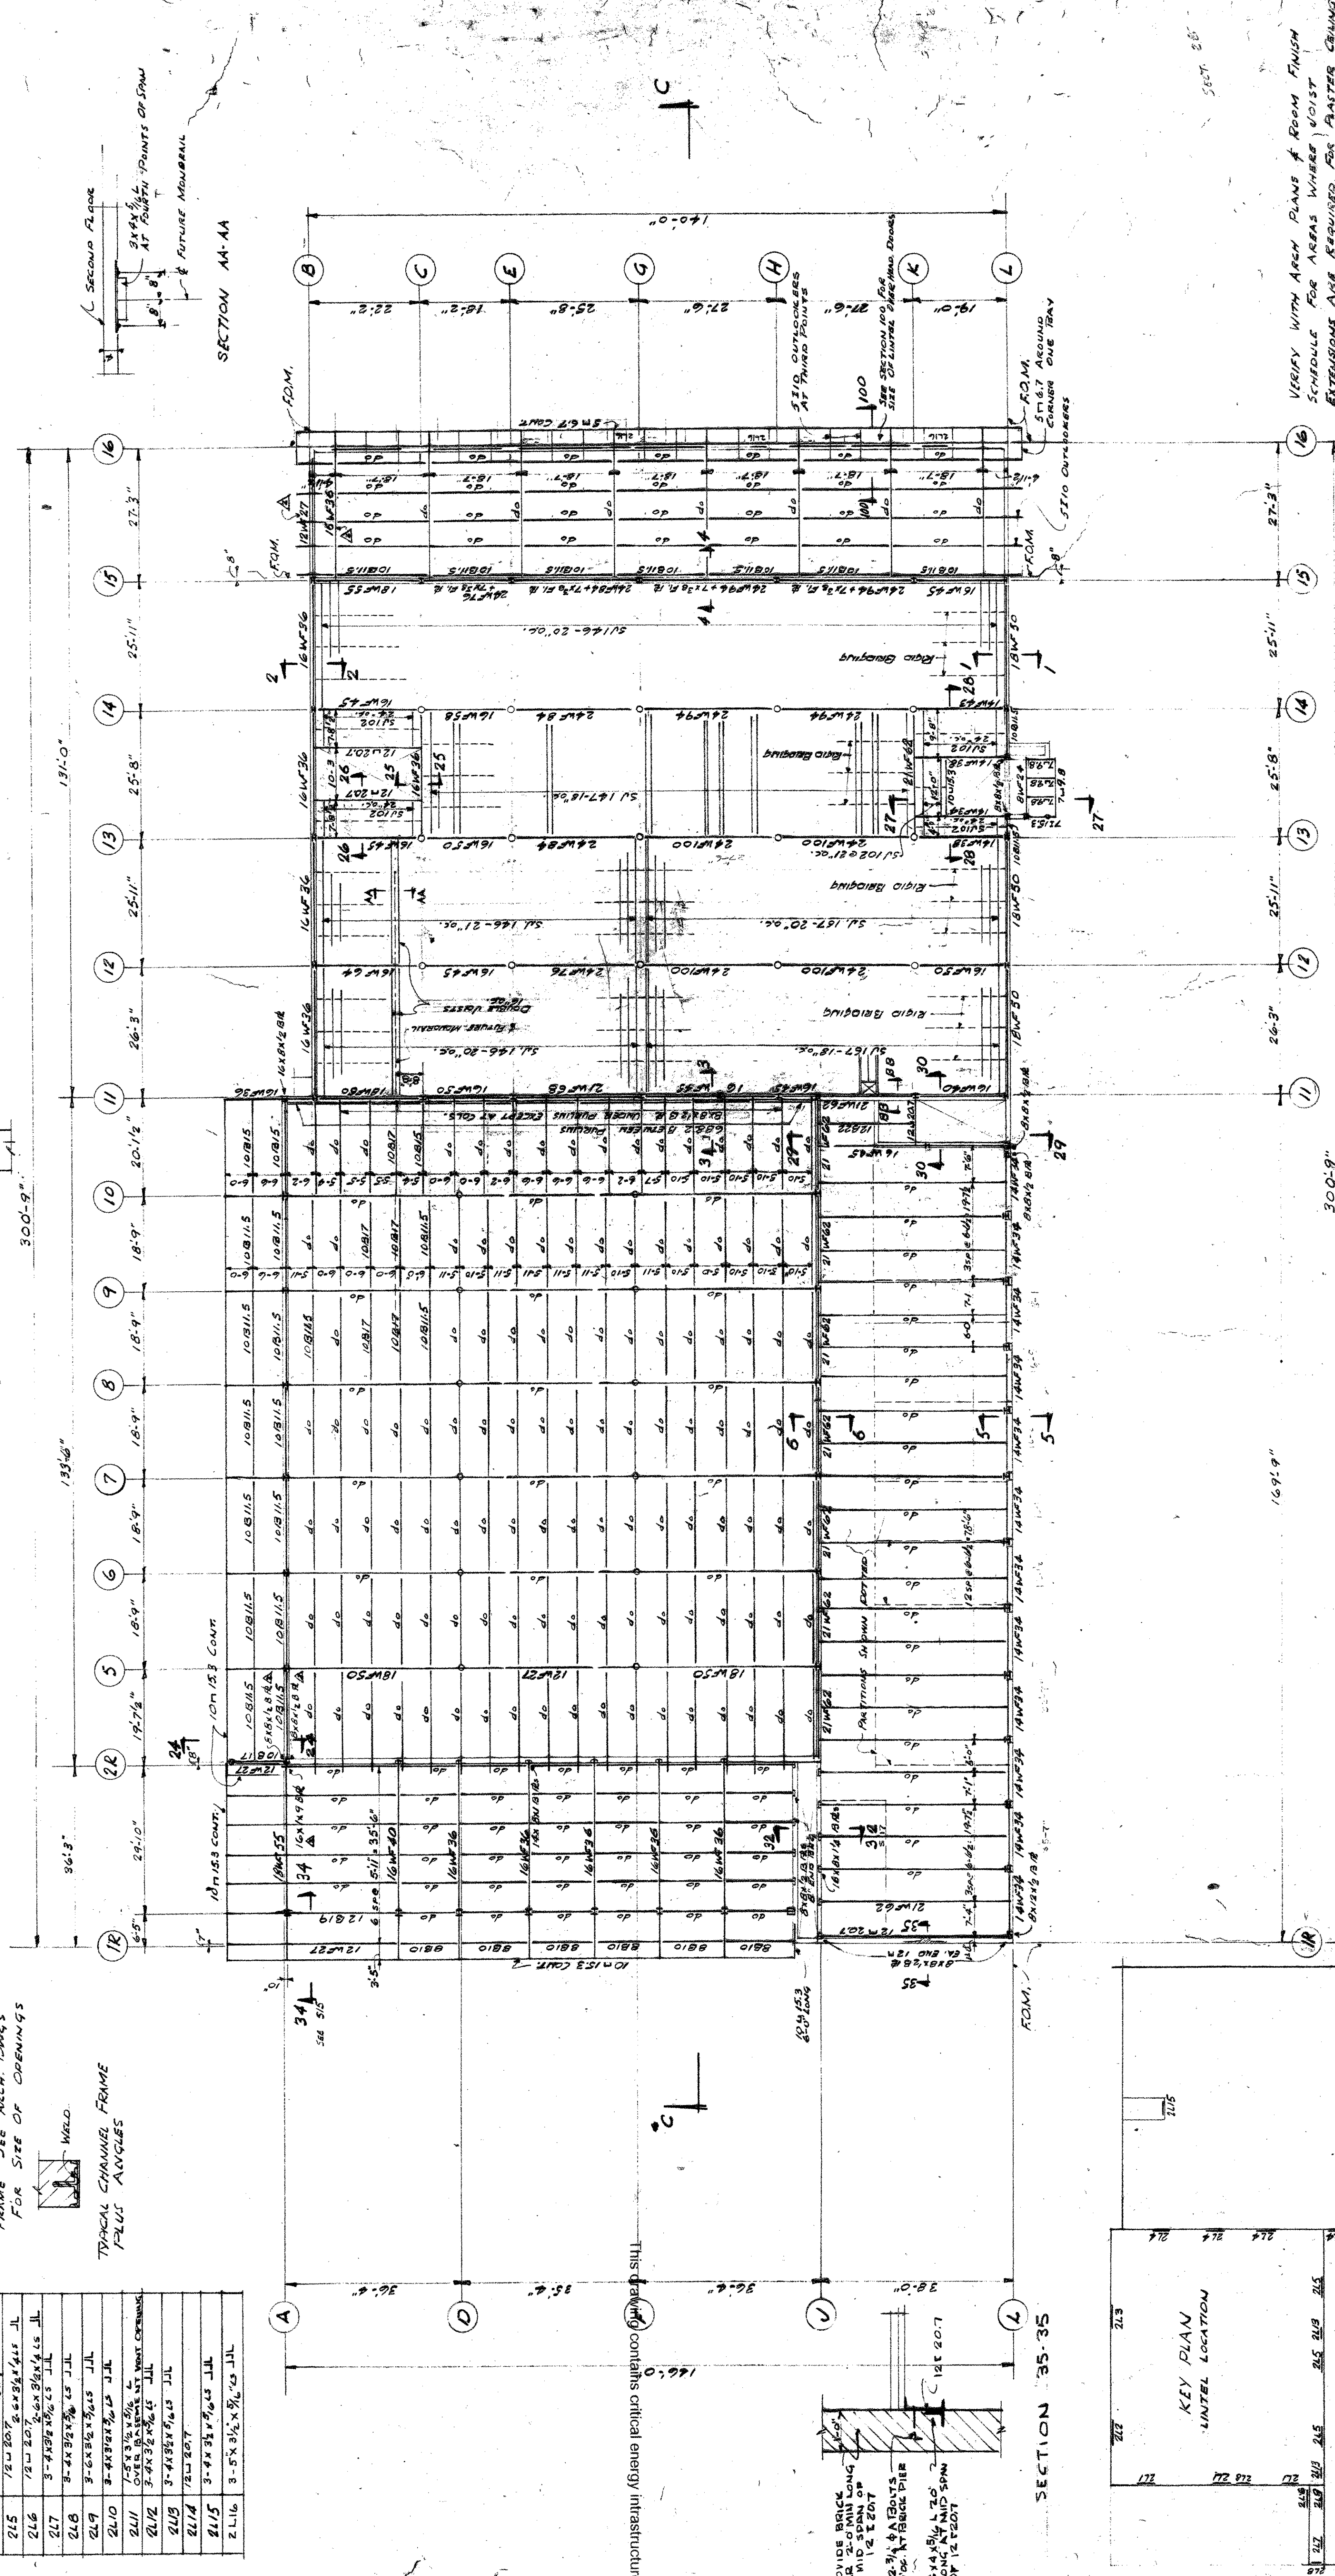
DRAWING: SECOND FLOOR & LOW ROOF FRAMING PLANS

1. H.E. Callahan and Overhead Door Company have supported the door motors by extending partial angles from the door header beam back to the original door motor support that is fastened up to the second floor roof beams. There were no details on how to attach the new motors. Placing new motor supports 5 feet closer since the door moved 5 feet would have required tearing large holes in the ceilings to weld on brackets to the upper beams. This can still be done but would require that the holes be patched back in. Overhead Door felt the motor support extensions to the existing motor supports steel would adequately support the motor. It can safely support the weight of the motor; however, when the motor stops or is interrupted by the electric eyes and changes direction there is a high torque on the motor that creates the motor to significantly bounce and is not acceptable to CMP. H.E. Callahan will review the situation with Overhead Door and advisee CMOP and SECS. A copy of the second floor support steel drawing is attached in the event that the motor support needs to be extended to the floor beams.

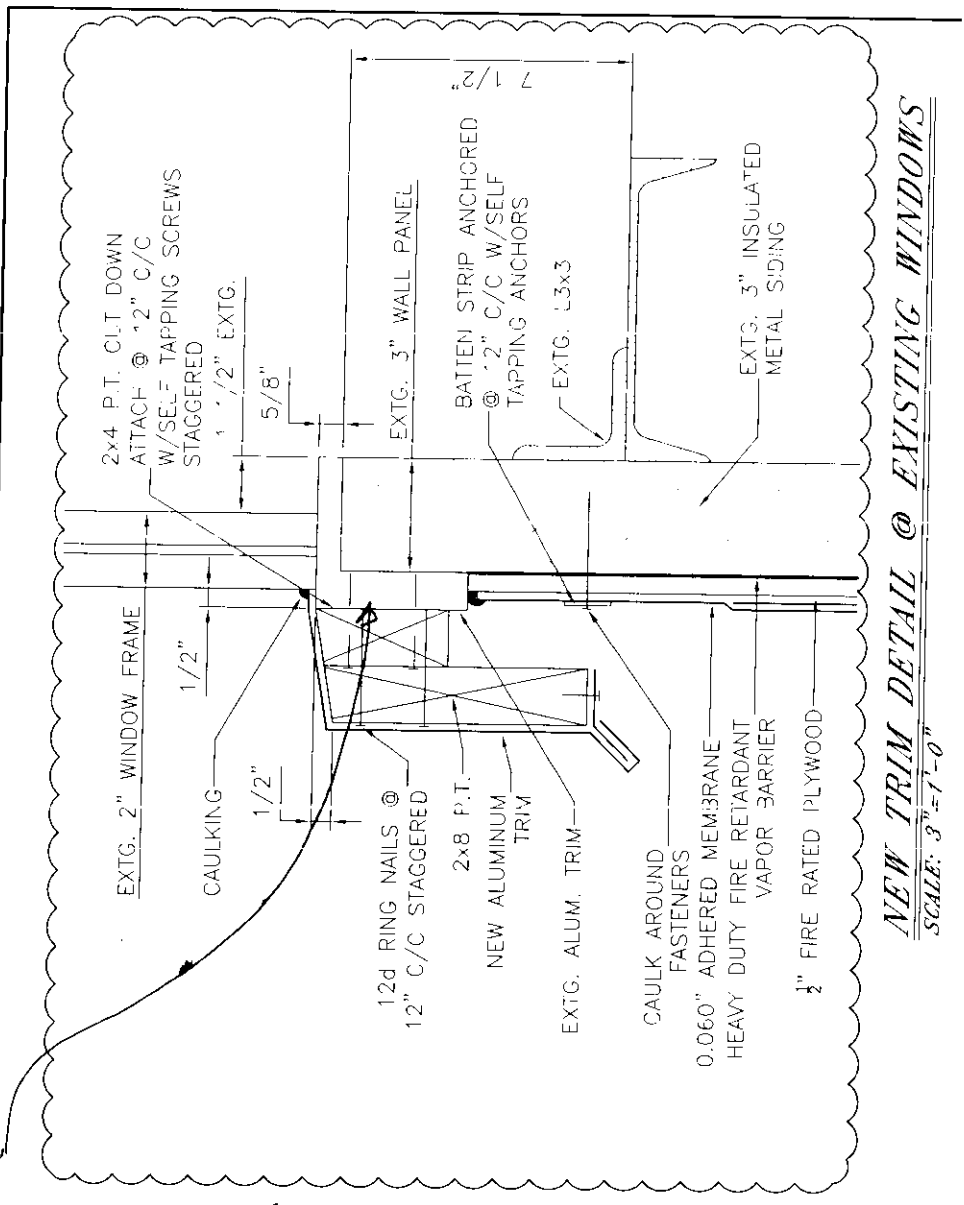
NEW TRIM DETAIL @ EXISTING WINDOWS
SCALE: 3/8" = 1'-0"

3. A leak was reported in the middle of overhead door #6. SECS's original design detail was changed by SMR roofers. The SMR detail is a good detail; however, it did not address the vertical seams that extend up onto the horizontal portion of the existing window sills. Also the existing window sills did not get recaulked as shown on the original detail. H.E. Callahan will need to get a detail to seal the open vertical/horizontal seams and recaulk the horizontal window seam. With the cold weather it may not be possible to do a permanent fix. SECS recommends as a minimum filling the open voids with RV sealant to get through the winter and prevent any damage to the new sheetrock. A copy of the original detail sketch is attached and photos showing the open vertical joints in the existing window trim.

THE EXISTING WINDOW TRIM WHICH WAS EXTENDED HAS A VERTICAL GAP BETWEEN SECTIONS WHICH IS NOT SEALED

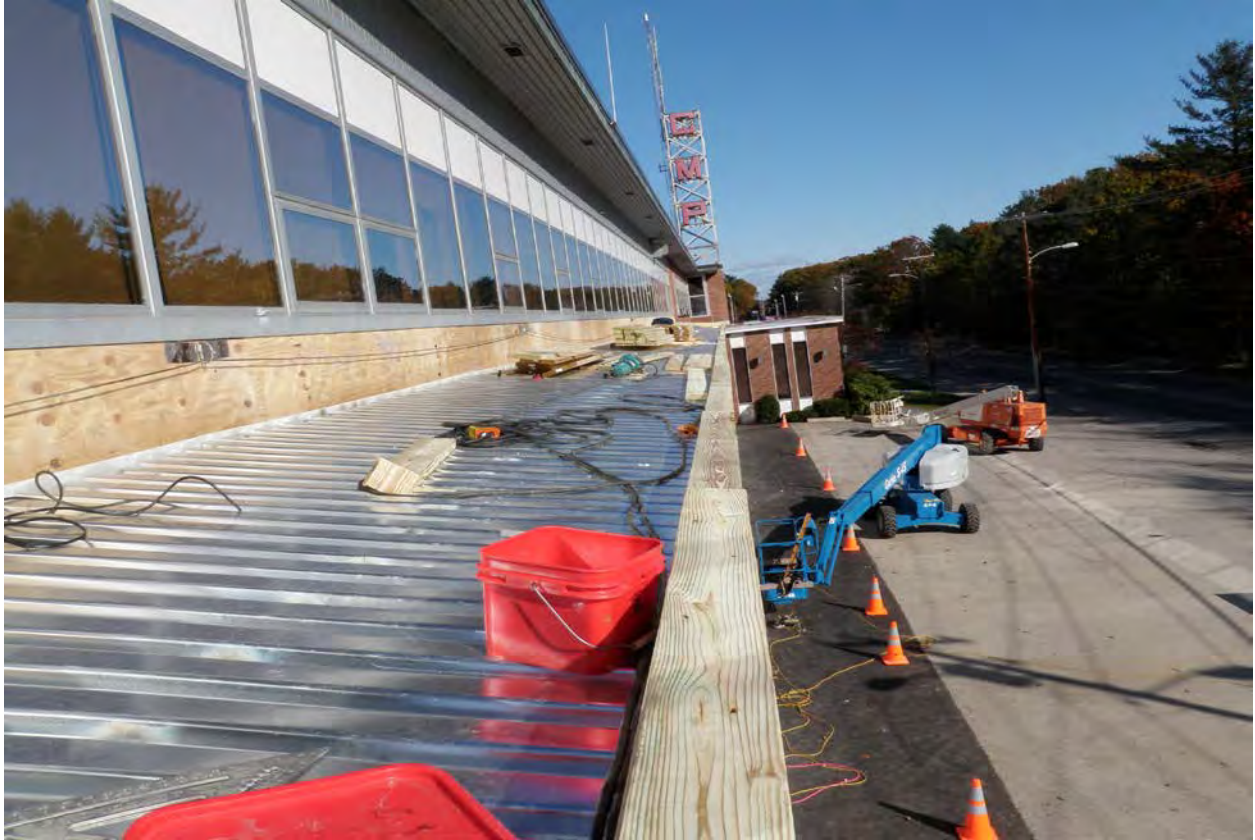
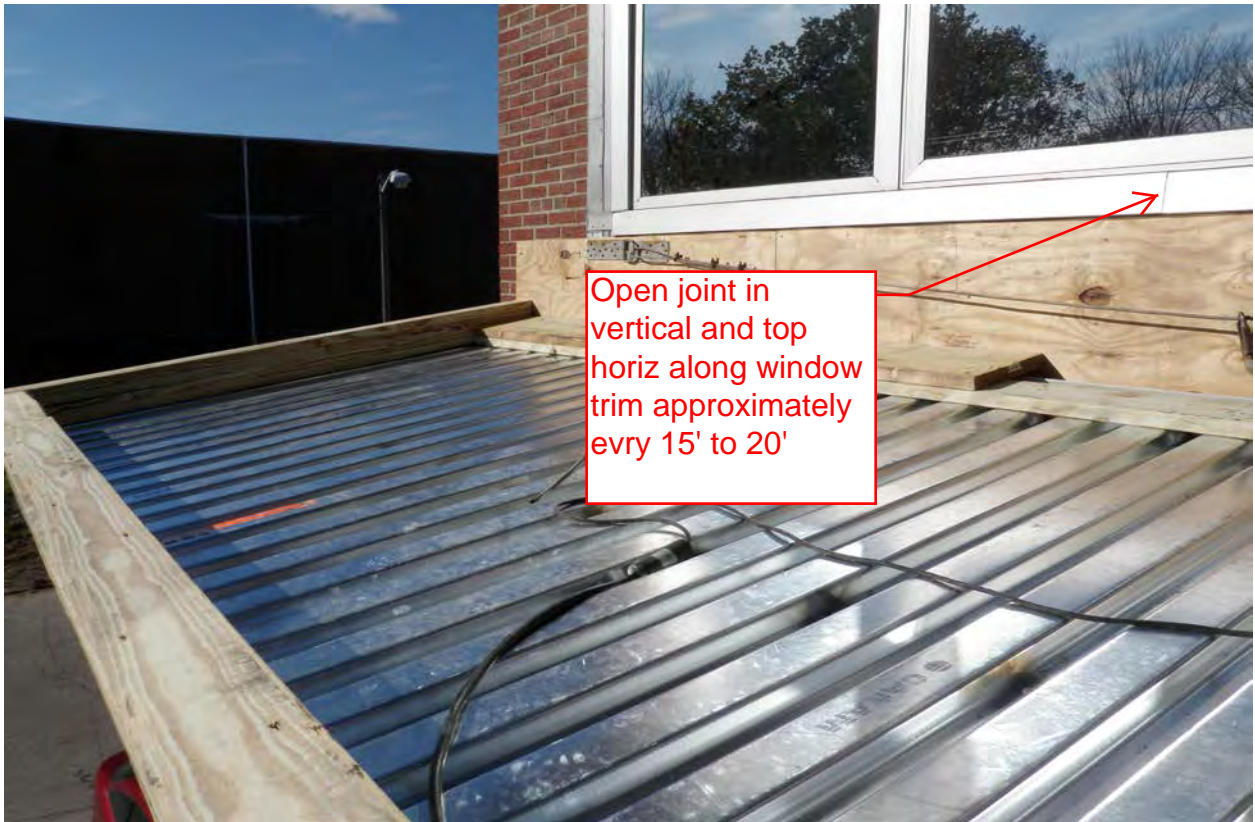
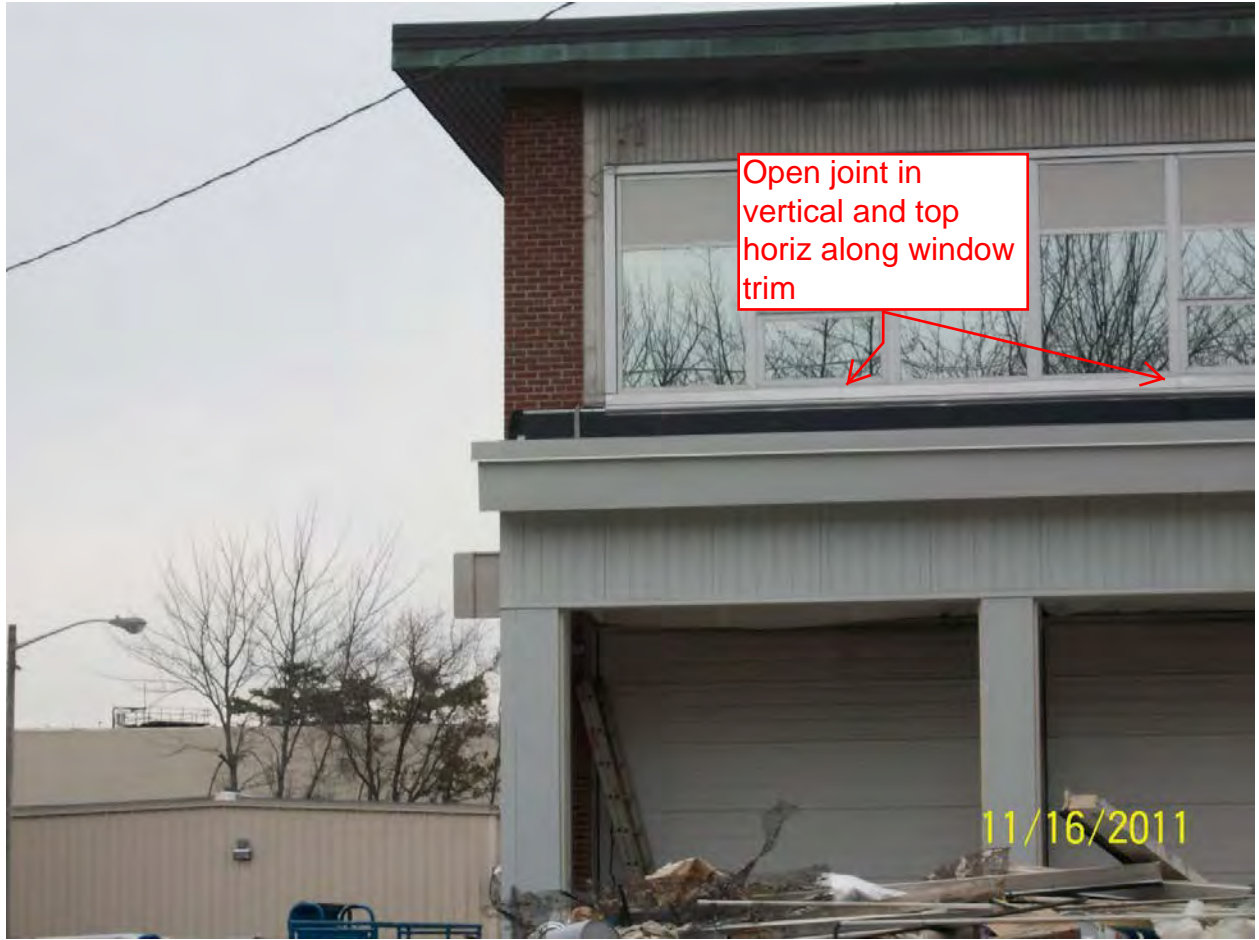
Open joint in
vertical and top
horiz along window
trim
