Slope Reconstruction

Back Cove Estates

2013-097

Subject: Geotechnical Consultation Services  
Back Cove Estates Condominiums  
East Road Slope Repair  
Portland, Maine

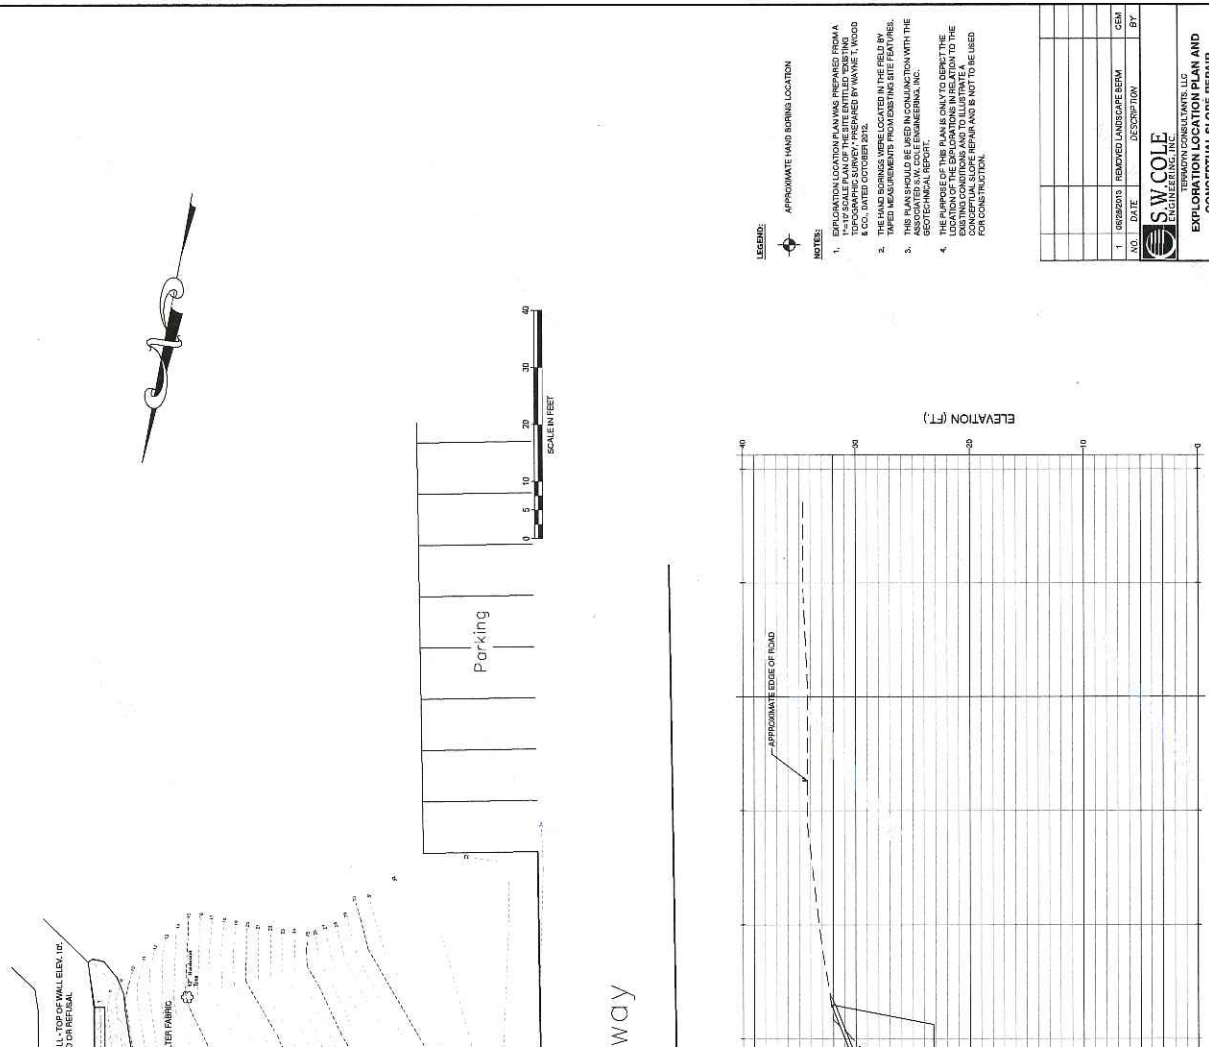
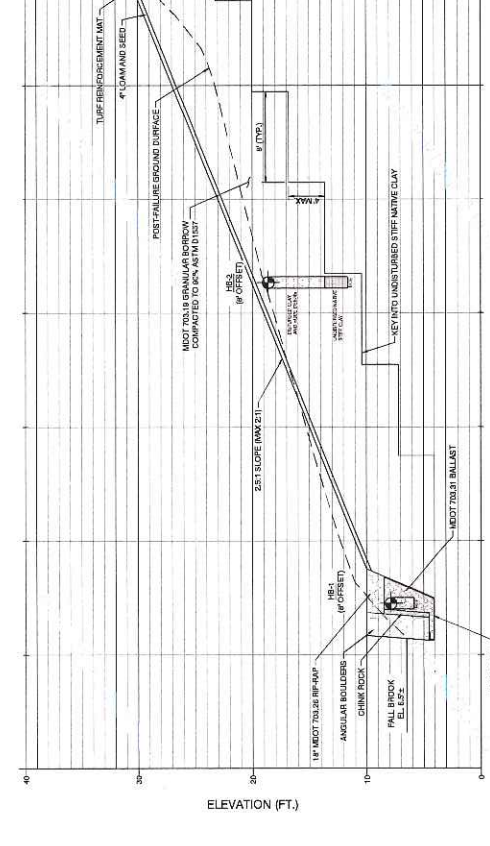
**EXPLORATION LOCATION PLAN AND CONCEPTUAL SLOPE REPAIR**

Based upon visual observations and subsurface findings at the hand boring locations, the slide plane of the failure area appeared to be relatively shallow and on the order of 5 feet below the surface of the slide debris. The stream bank upstream and downstream of the failure area consists of erodible native clay and the stream bed consists of relatively stable sand and gravel or bedrock. Considering the visible surface conditions and subsurface findings, it is our opinion the slope failure was likely due to toe erosion that undermined the stream bank and caused a shallow surface failure.

We recommend the slide area be repaired by armoring the stream bank with a boulder wall, removing the slide debris to expose undisturbed native clay and keying in a compacted granular borrow fill to re-establish the slope. The surface of the slope should be covered with a loam and seed that is protected by a turf reinforcement mat until a root mass of vegetation is established. We also recommend grading the slope and incorporating plantings to prevent future soil erosion. Conceptual Slope Repair details are illustrated on Sheet 1.

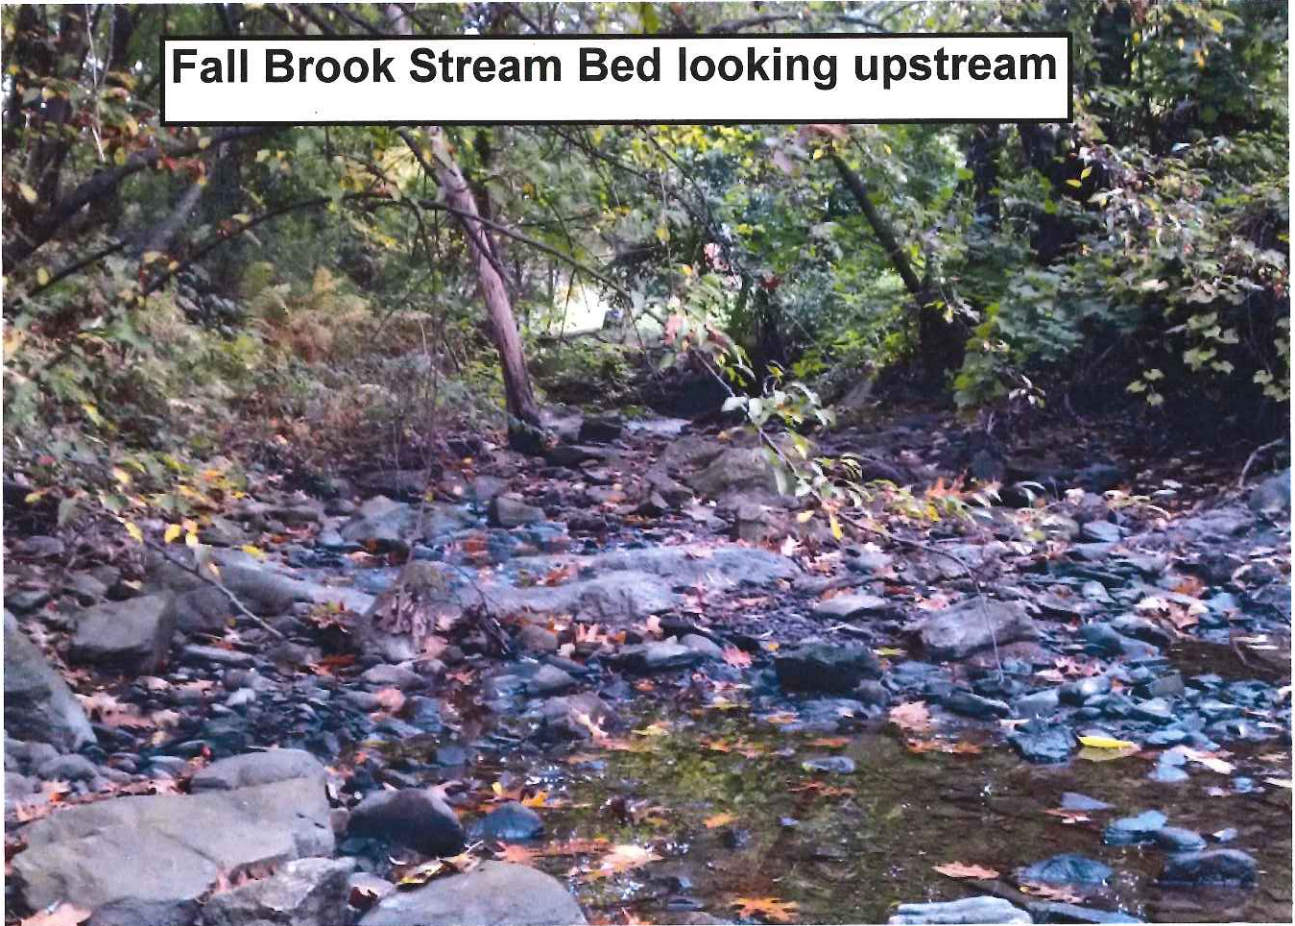
**Fall Brook Stream Bed looking upstream**

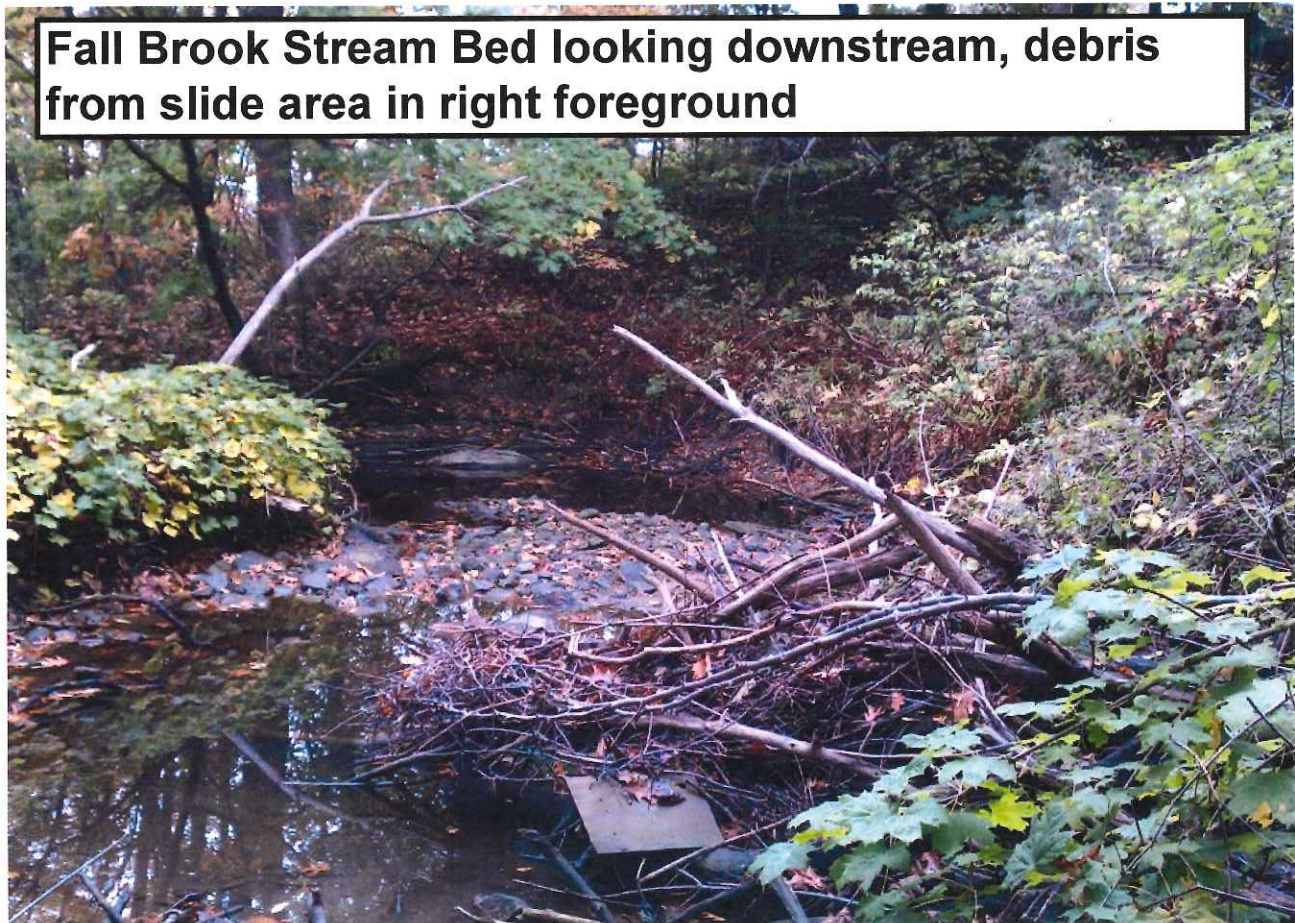
**Fall Brook Stream Bed looking downstream, debris from slide area in right foreground**

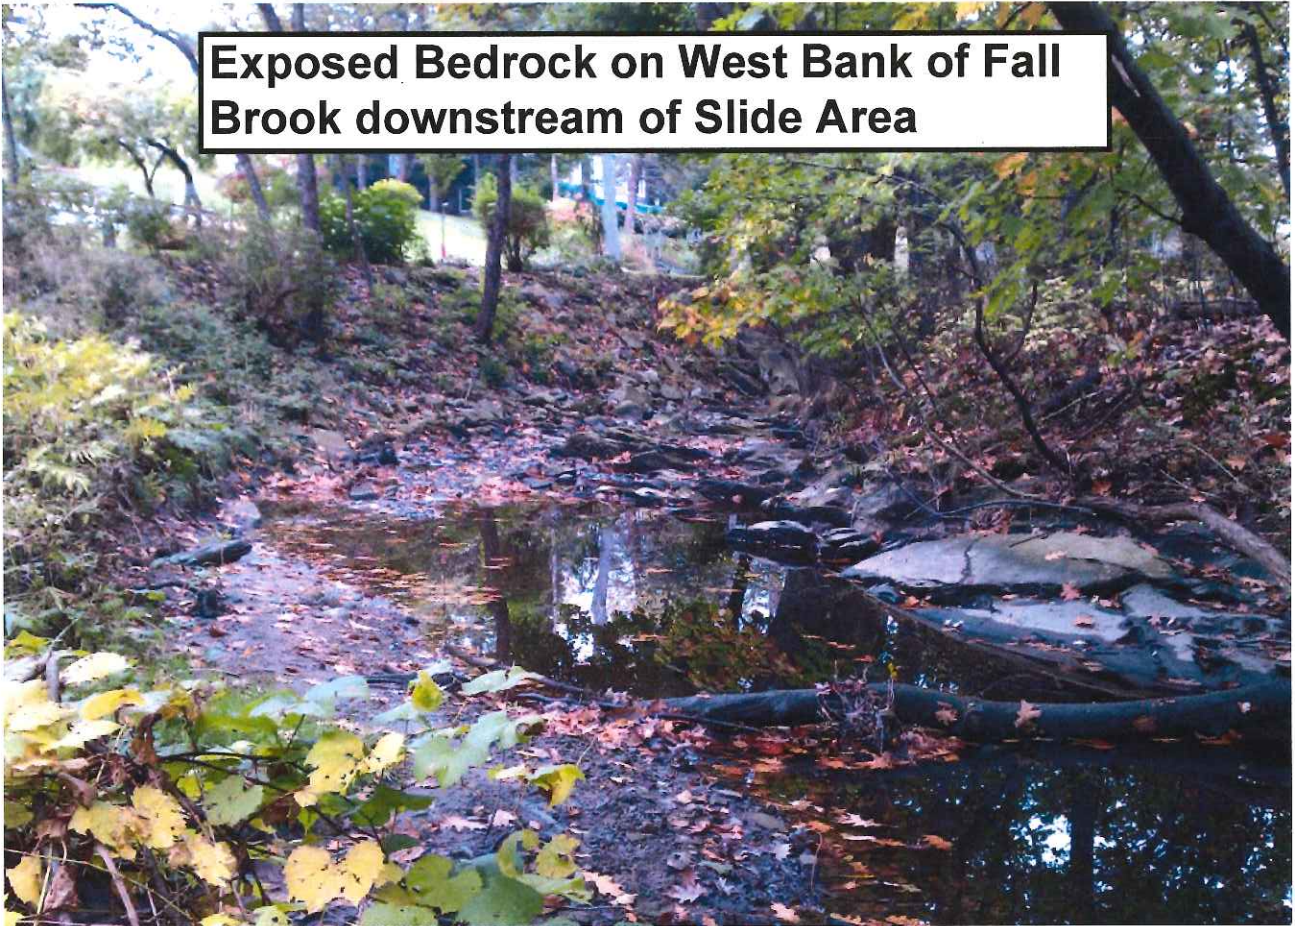
**Exposed Bedrock on West Bank of Fall Brook downstream of Slide Area**

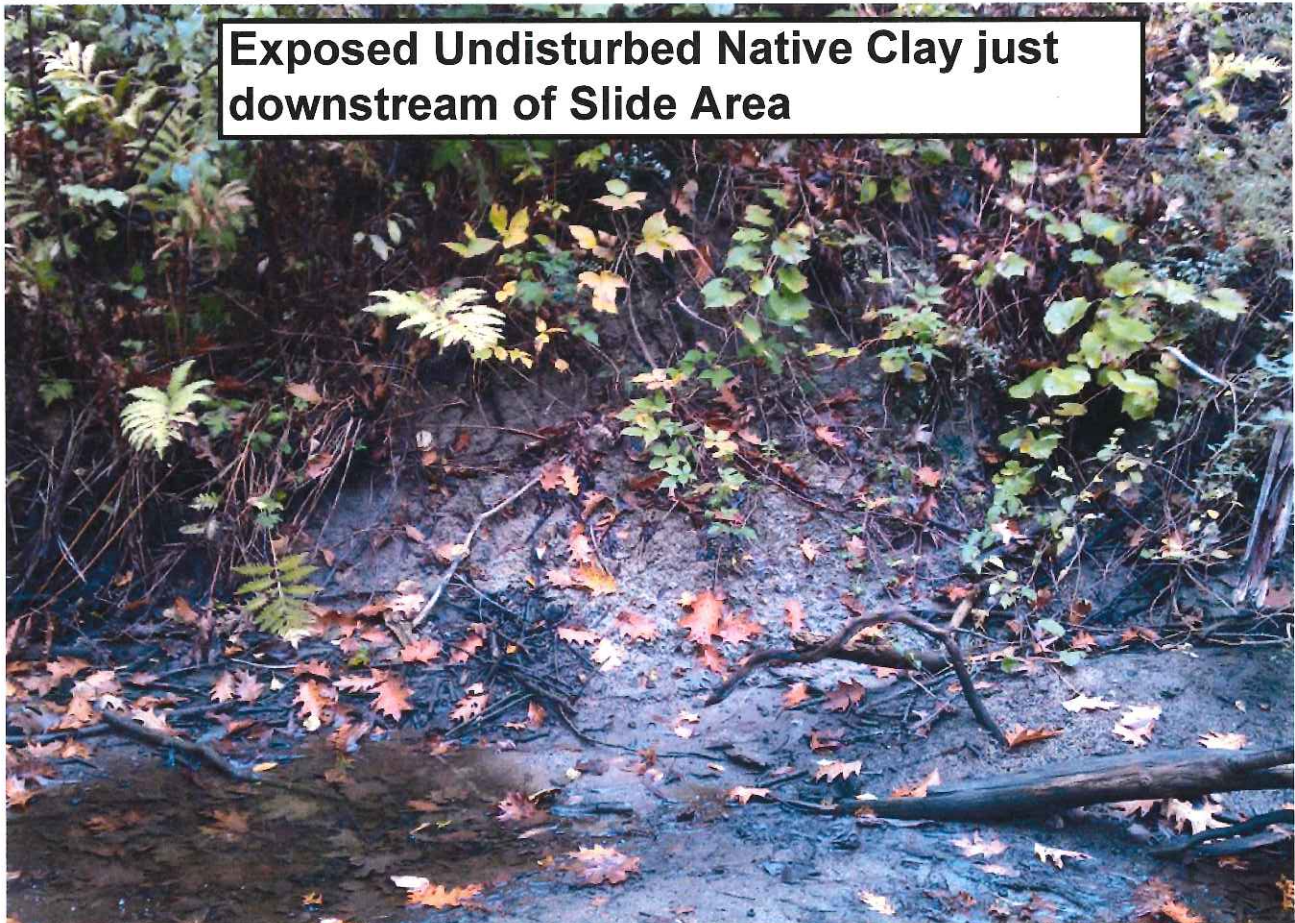
**Exposed Undisturbed Native Clay just downstream of Slide Area**

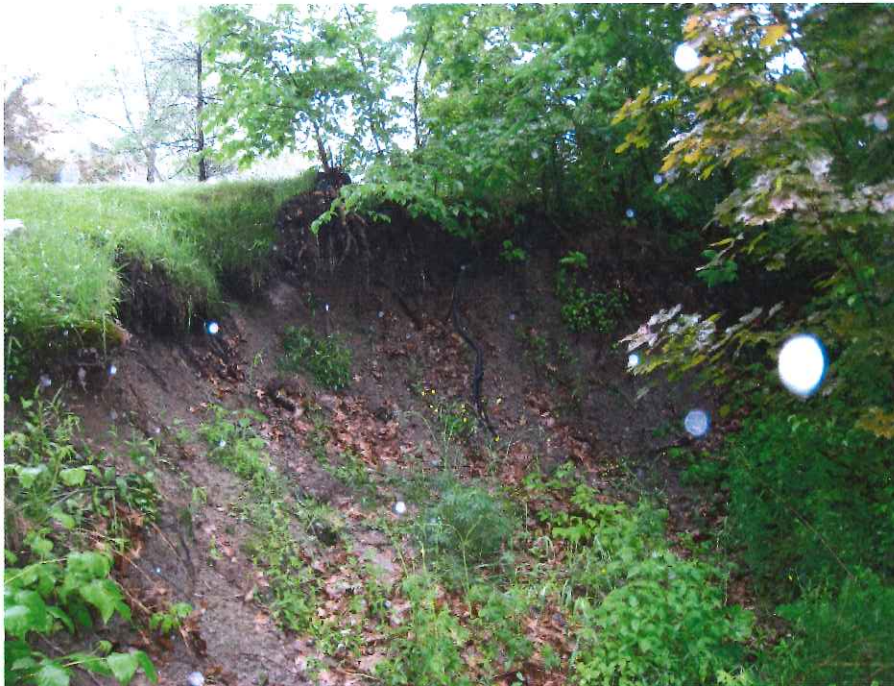
*A 6'-8' high vertical face is located along the upper rim of the slide.*

The slide plane formed at the interface of the soft & hard clay. They recommended that the area be repaired by armoring the stream bank with a boulder wall, removing the slide debris to expose undisturbed native clay and keying in a compacted granular borrow fill to re-establish the slope. A copy of their report is attached to this section.

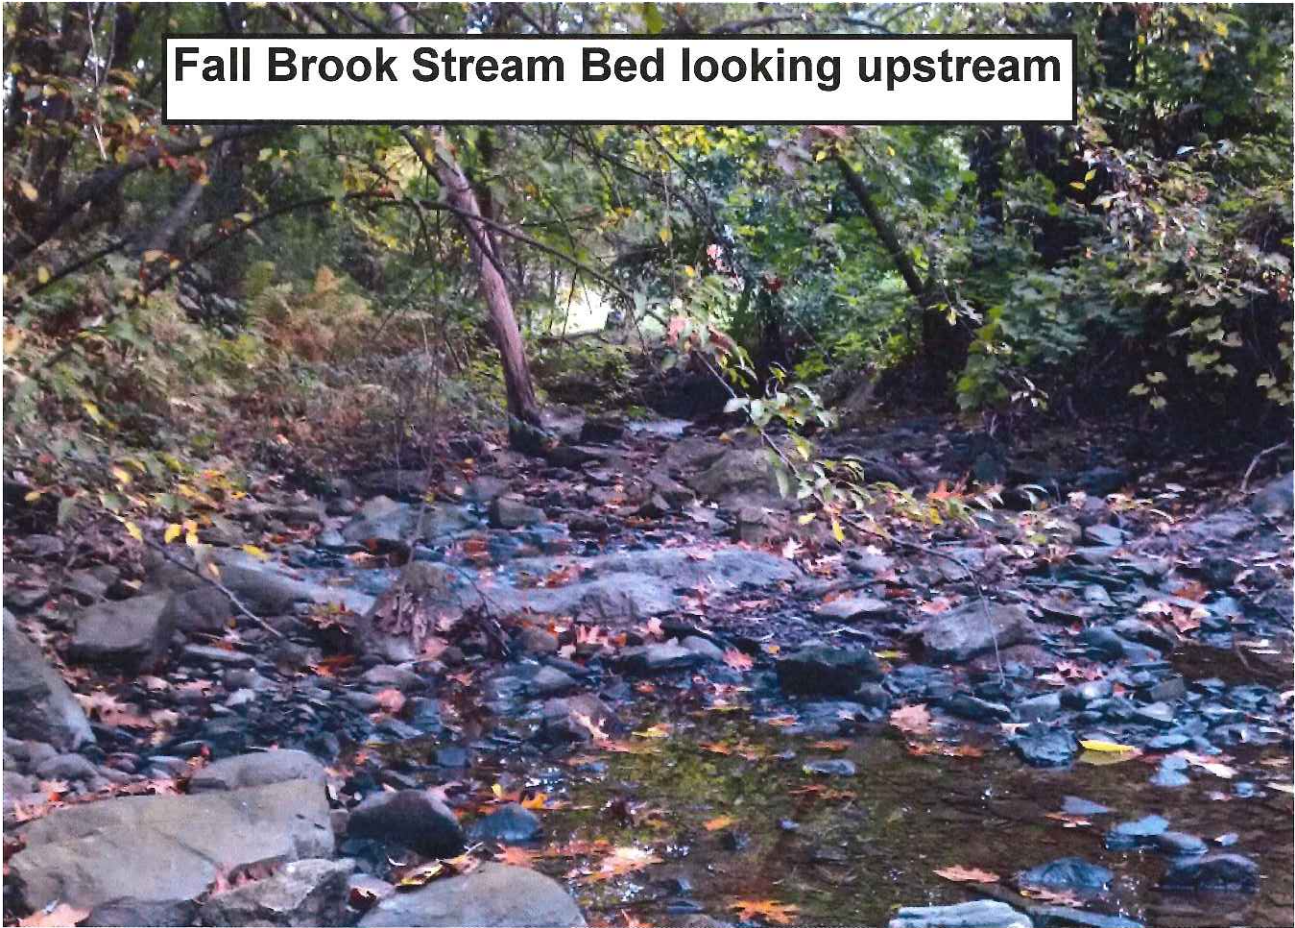
**Fall Brook Stream Bed looking upstream**

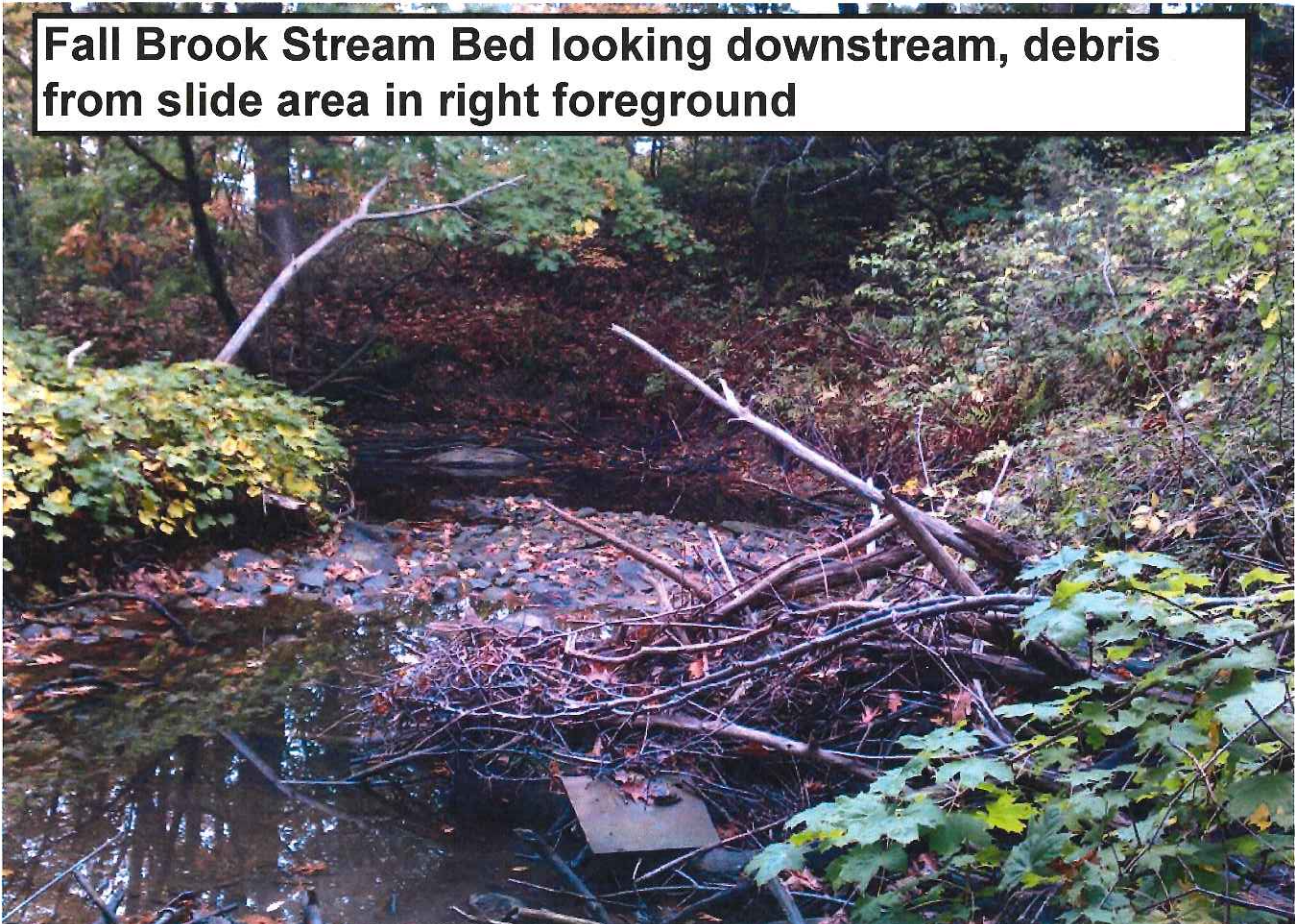
**Fall Brook Stream Bed looking downstream, debris from slide area in right foreground**

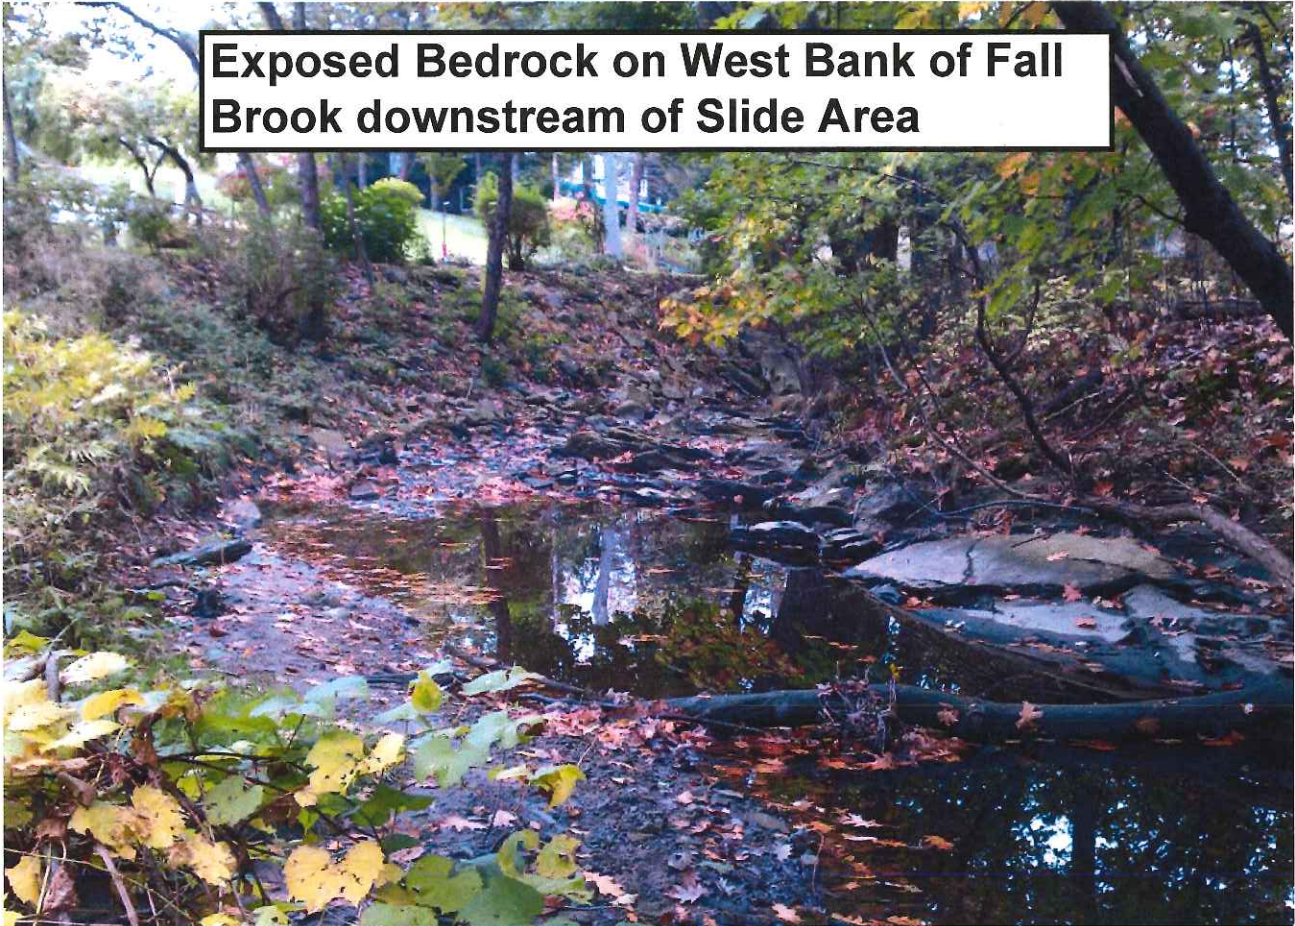
**Exposed Bedrock on West Bank of Fall Brook downstream of Slide Area**

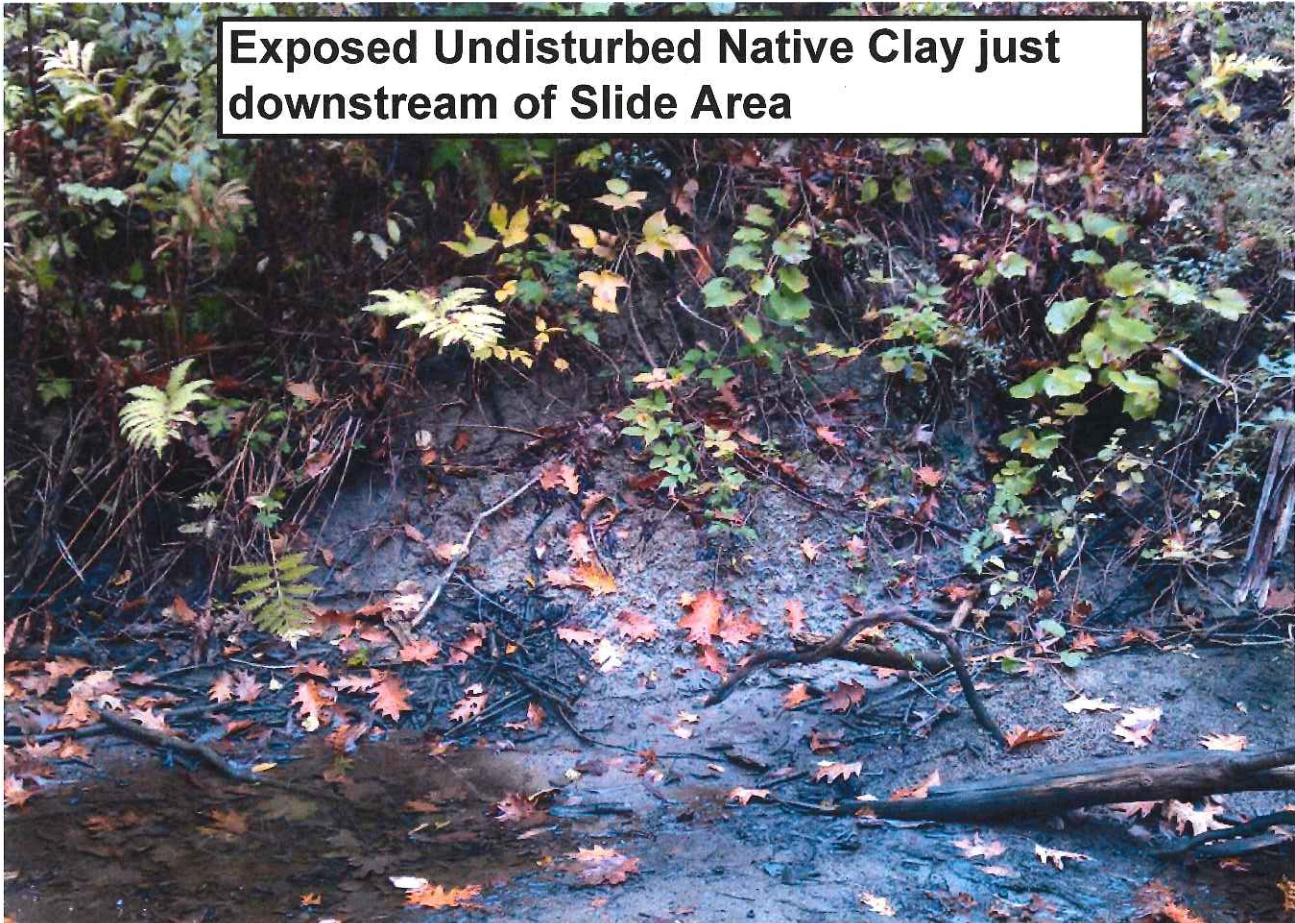
**Exposed Undisturbed Native Clay just downstream of Slide Area**

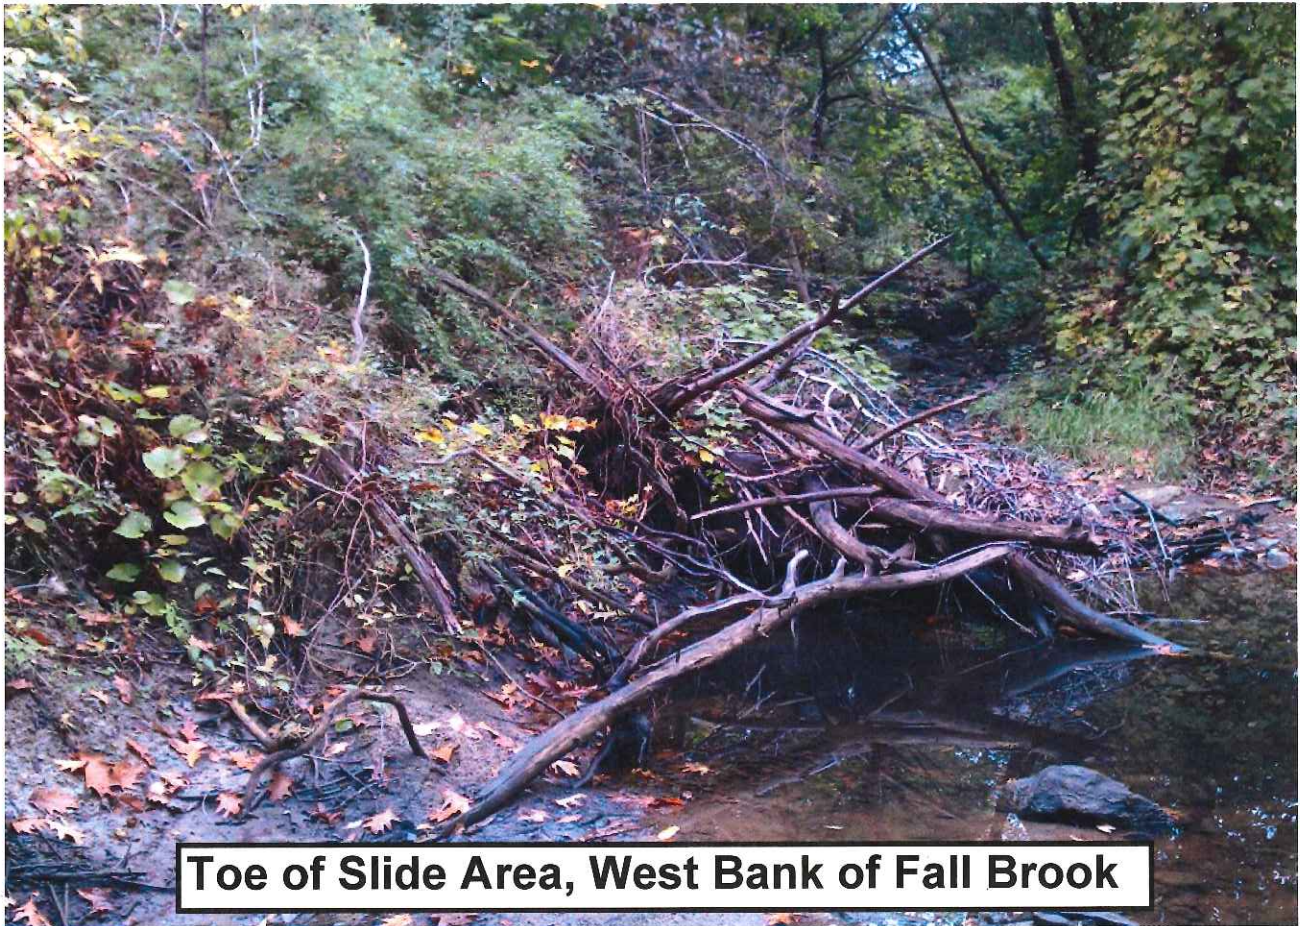
slope failure area (slide area) consist of disturbed clay with organics (slide debris) overlying a relatively stiff undisturbed native clay exposed at the head of the slide area, see photos attached as Sheet 4. We did not observe tension cracking or faulting upslope of the head scarp of the slide area.

**Head of Slide Area, East Road Above**

We recommend the slide area be repaired by armoring the stream bank with a boulder wall, removing the slide debris to expose undisturbed native clay and keying in a

compacted granular borrow fill to re-establish the slope. The surface of the slope should be covered with a loam and seed that is protected by a turf reinforcement mat until a root mass of vegetation is established. We also recommend creating a landscape berm at the head of the slope to divert runoff around the repaired slope area. Conceptual Slope Repair details are illustrated on Sheet 1.
