Development Review Application  
Planning Division Transmittal Form

Project Name: Slope Re-Construction - Back Cove Estates

Project Description: Reconstruction of a failed embankment. Original embankment slid down the hill and came to rest in and adjacent to Fallbrook.

## Activity Description

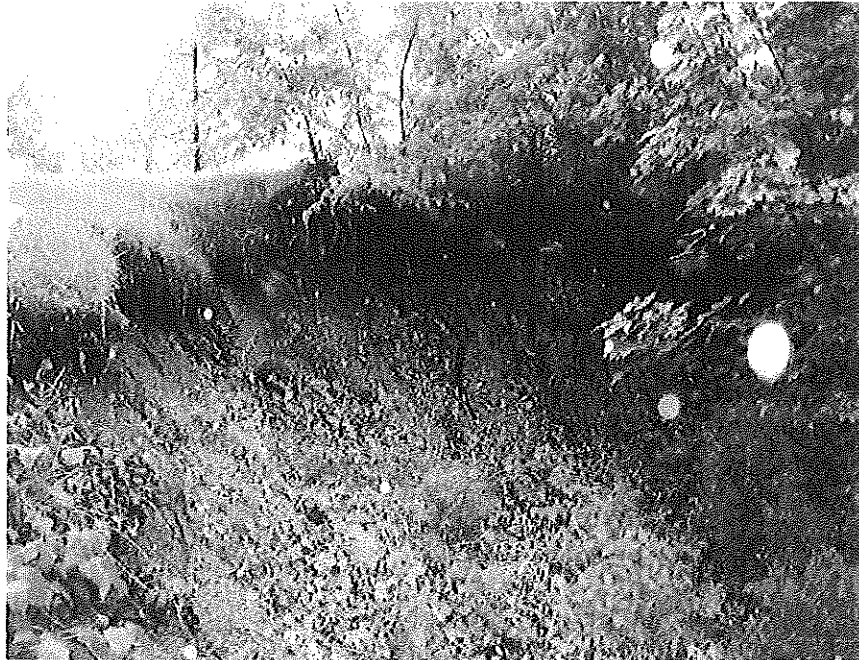
S.W.Cole performed a geotechnical reconnaissance to determine the likely cause of the embankment failure. They examined the embankment and performed a series of hand borings. They determined that the original embankment had a small layer of organics on top of a 5' deep layer of soft clay that was resting on top of a layer of hard clay. They concluded that the slope failure was likely due to toe erosion that undermined the stream bank and caused a shallow surface failure.

*A 6'-8' high vertical face is located along the upper rim of the slide.*

The slide plane formed at the interface of the soft & hard clay. They recommended that the area be repaired by armoring the stream bank with a boulder wall, removing the slide debris to expose undisturbed native clay and keying in a compacted granular borrow fill to re-establish the slope. A copy of their report is attached to this section.

We propose to reconstruct the slope to its approximate original grade. The soft clay and organic slide material will be removed. The underlying stiff clay will be terraced to allow for the stable installation of granular fill material. The granular fill will allow for proper compaction of the reconstructed slope.

Riprap will be placed along the edge of Fall Brook and will extend up to the 100 year flood elevation. The riprap directly adjacent to the brook will have a large diameter, typically 2'-3'. We propose large boulders in this area for two reasons. First, the large stones will help to support the newly constructed embankment. Secondly, the shore of Fall Brook has an approximately 2' high vertical face in the area adjacent to the project area. The large rocks -being the same height as the existing vertical face- will allow for an easy transition back into the natural stream bed at the edge of the riprap.
