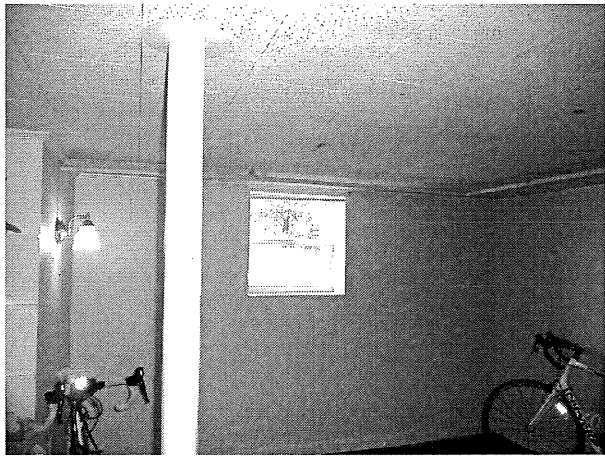
**Photo #4 – Basement window near north end of west endwall**

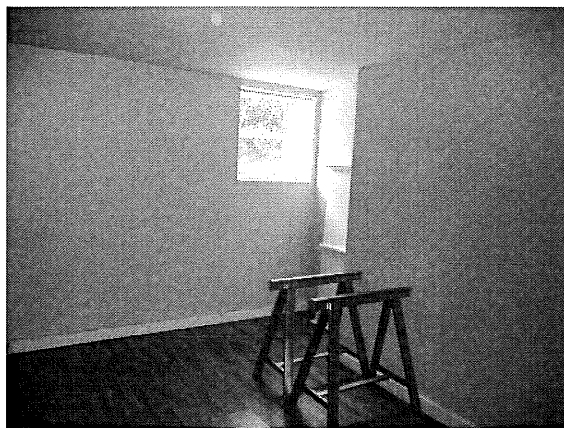
**Photo # 5 – Basement window at middle of west endwall**

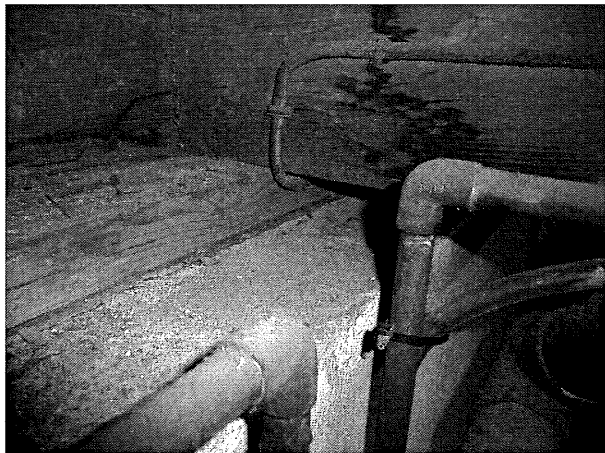
**Photo #6– Existing 1<sup>st</sup> floor joist bearing on foundation sill**
