Re: Garage at 9 Ray Street
Building Survey Findings
RPF File No. 135532

DAVID INGRAHAM
9 Ray Street, Portland, ME

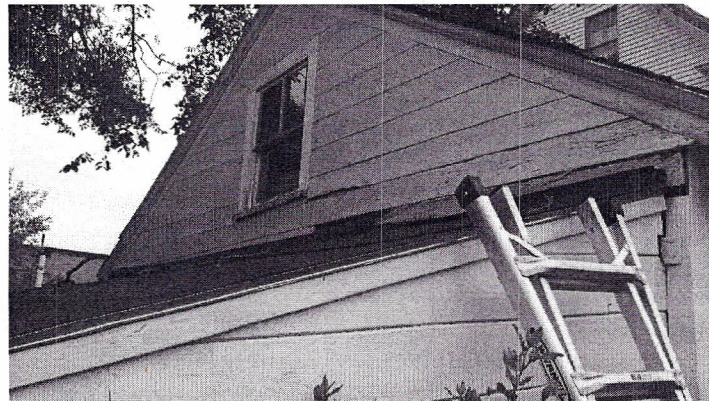
Rear side of garage and storage addition. Roofing, window glaze and siding felt paper all found to be non-detect for asbestos.

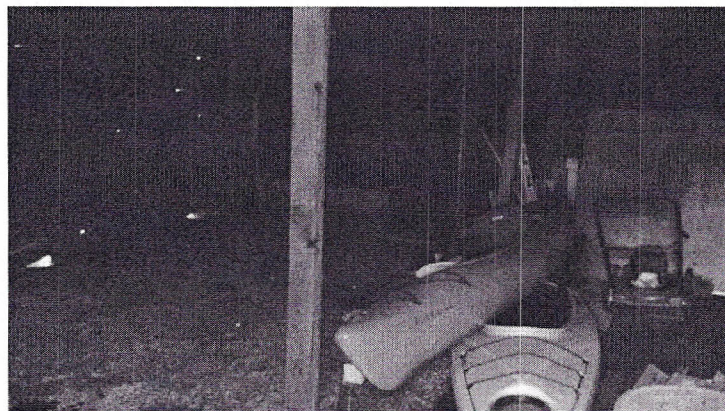
Stored items in garage.
