Re: 118 Colonial Road Portland, Maine

At your request I recently met with you at the above residence in Portland, Maine to inspect the structural repair and remodeling work performed on the first and second floor framing. The construction work included re-framing of a portion of the first floor area, adding supplemental joists to the second floor framing to reinforce the existing joists, the addition of a steel beam at the center of the second floor and posting of the beam to the foundation.

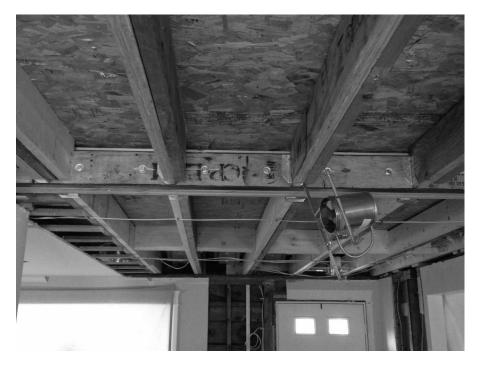
photo #1 showing new steel channel beam at center of second floor.

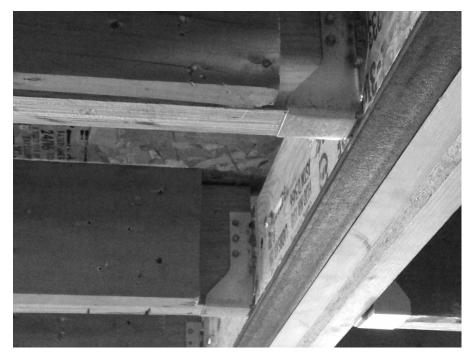
Photo #2 Showing reinforced floor joists and connection to new steel channel beam

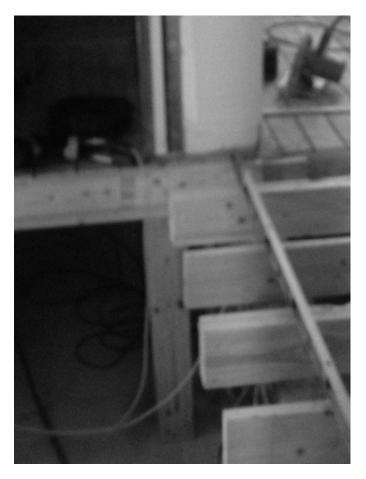
Photo #3 Showing New posting and first floor framing

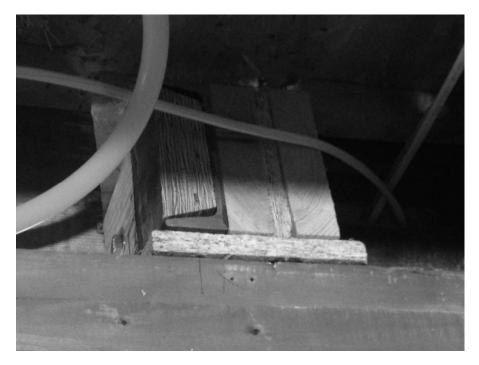
Photo #4 showing end bearing of steel beam
