DANIEL O'WRIL, P.E.

RE: 93 Westland Avenue Renovation project

EXIST ROOF FRAMING N.T.S.
 THOMPSON RESIDENCE
 93 WESTLAND AVE
 PORTLAND, ME 04103

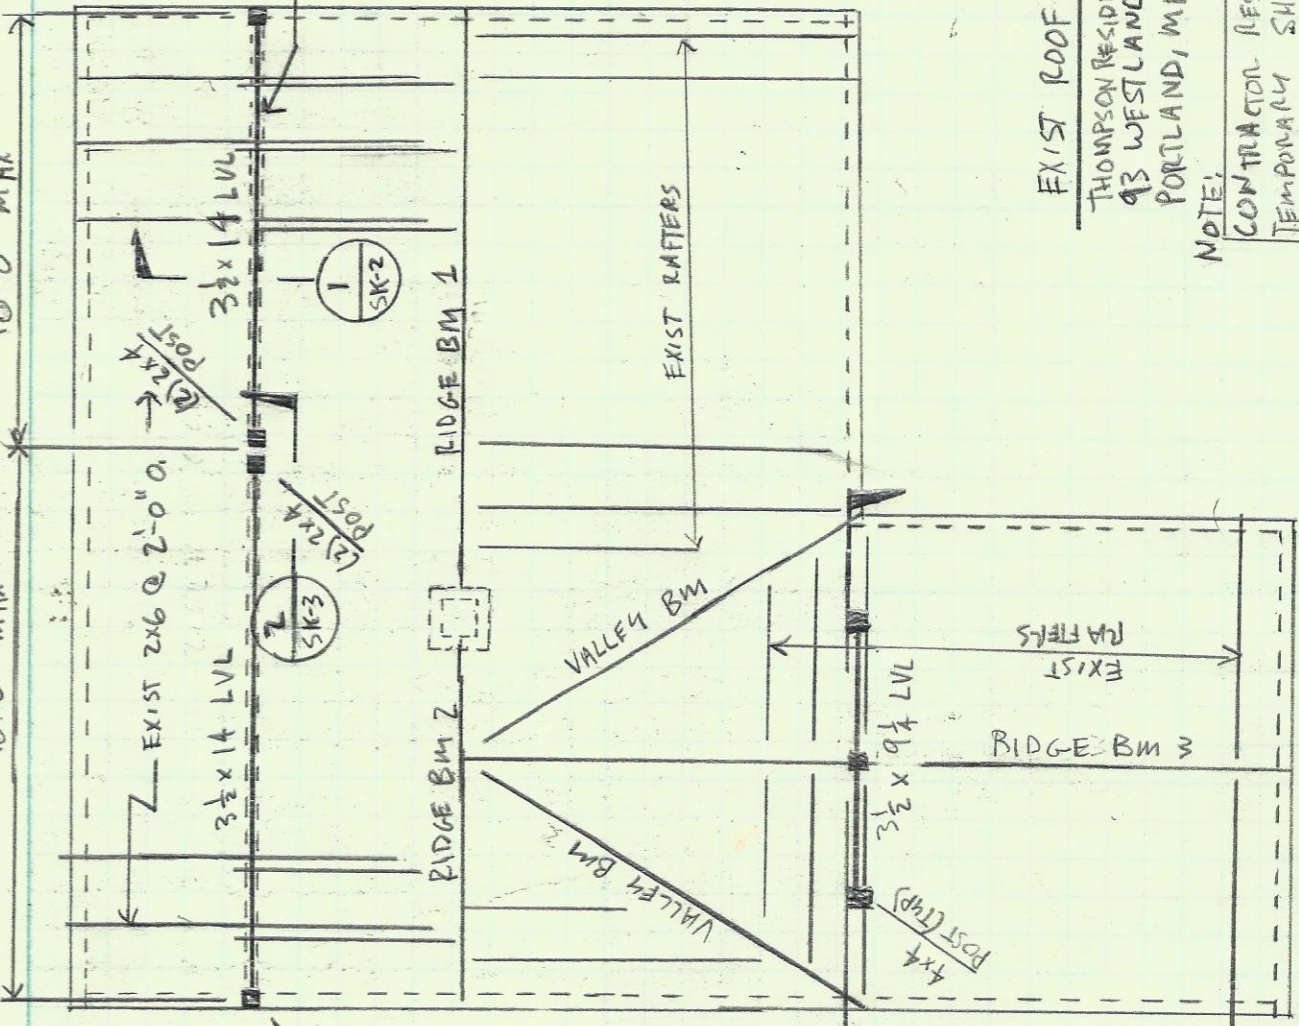
SK-1
1 OF 5

The first item I reviewed was a ridge beam running from the southwest side of the house (labeled Ridge Beam 3 on Sketch SK-1). The ridge beam is a 1 3/4"x 11 7/8"LVL, and spans approximately 23'-0". This existing ridge beam was found to be overstressed according to current building code requirements. It is recommended that the contractor install a vertical support to reduce the span of the ridge beam to meet current building code requirements. The installation of this support is detailed on the attached sketches.

The second issue I reviewed was the roof rafters on the North side of the building. The original roof was reportedly lifted at the ridgeline to allow for more living space on the second floor. The rafters currently bear on the exterior wall at one end, a new knee wall at center span, and a new ridge beam at the other end. The new knee wall at center span is supported by the second floor framing. New rafters were sistered alongside the existing rafters to span from the knee wall to the center ridgeline. Upon review of this framing for code compliance, I found that the floor below the knee wall lacked the structural capacity to carry the roof loads from above. I recommend removing the existing knee wall and installing two LVL beams to remove the roof load from the existing floor framing. Details of this recommended repair are shown on the attached sketches.
