**MEMORANDUM**

Subject: Water Penetration and Spray Nozzle Test  
Terminal Enhancement, Portland International Jetport  
Portland, Maine  
RWG&A Project No. 0557-014

**FIELD TEST REPORT**

**Project Identification:** Portland International Jetport  
Portland, Maine

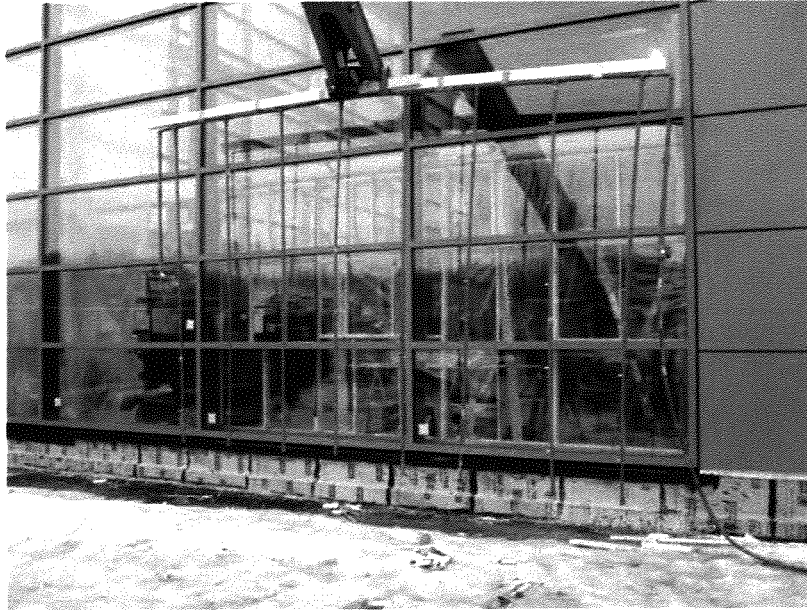
**Photo No. 1**  
**Test Specimen #1**  
**Exterior View of Specimen with Spray Rack in Place**

<u>Title of Test</u>	<u>Test Results</u>	<u>Allowable</u>
Water Penetration @ 8.00 psf	No water leakage	No water leakage

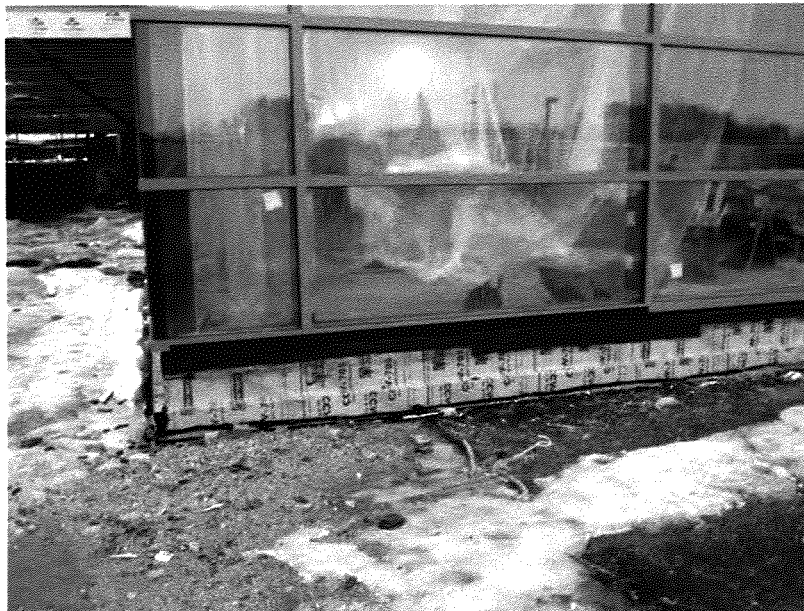
**Photo No 2**  
**Test Specimen #2**  
**Exterior View of Specimen with Test Area Highlighted**

<u>Title of Test</u>	<u>Test Results</u>	<u>Allowable</u>
Water Penetration @ 32.5 psi	No water leakage	No water leakage
