Hazardous Building Materials Inventory **0 and 3 Thompson's Point** **Portland, Maine**

Prepared for and funded by:
Maine Department of Environmental Protection
17 State House Station
Augusta, Maine 04333

May 19, 2016

In Reference to:
Credere Project No. 13001211

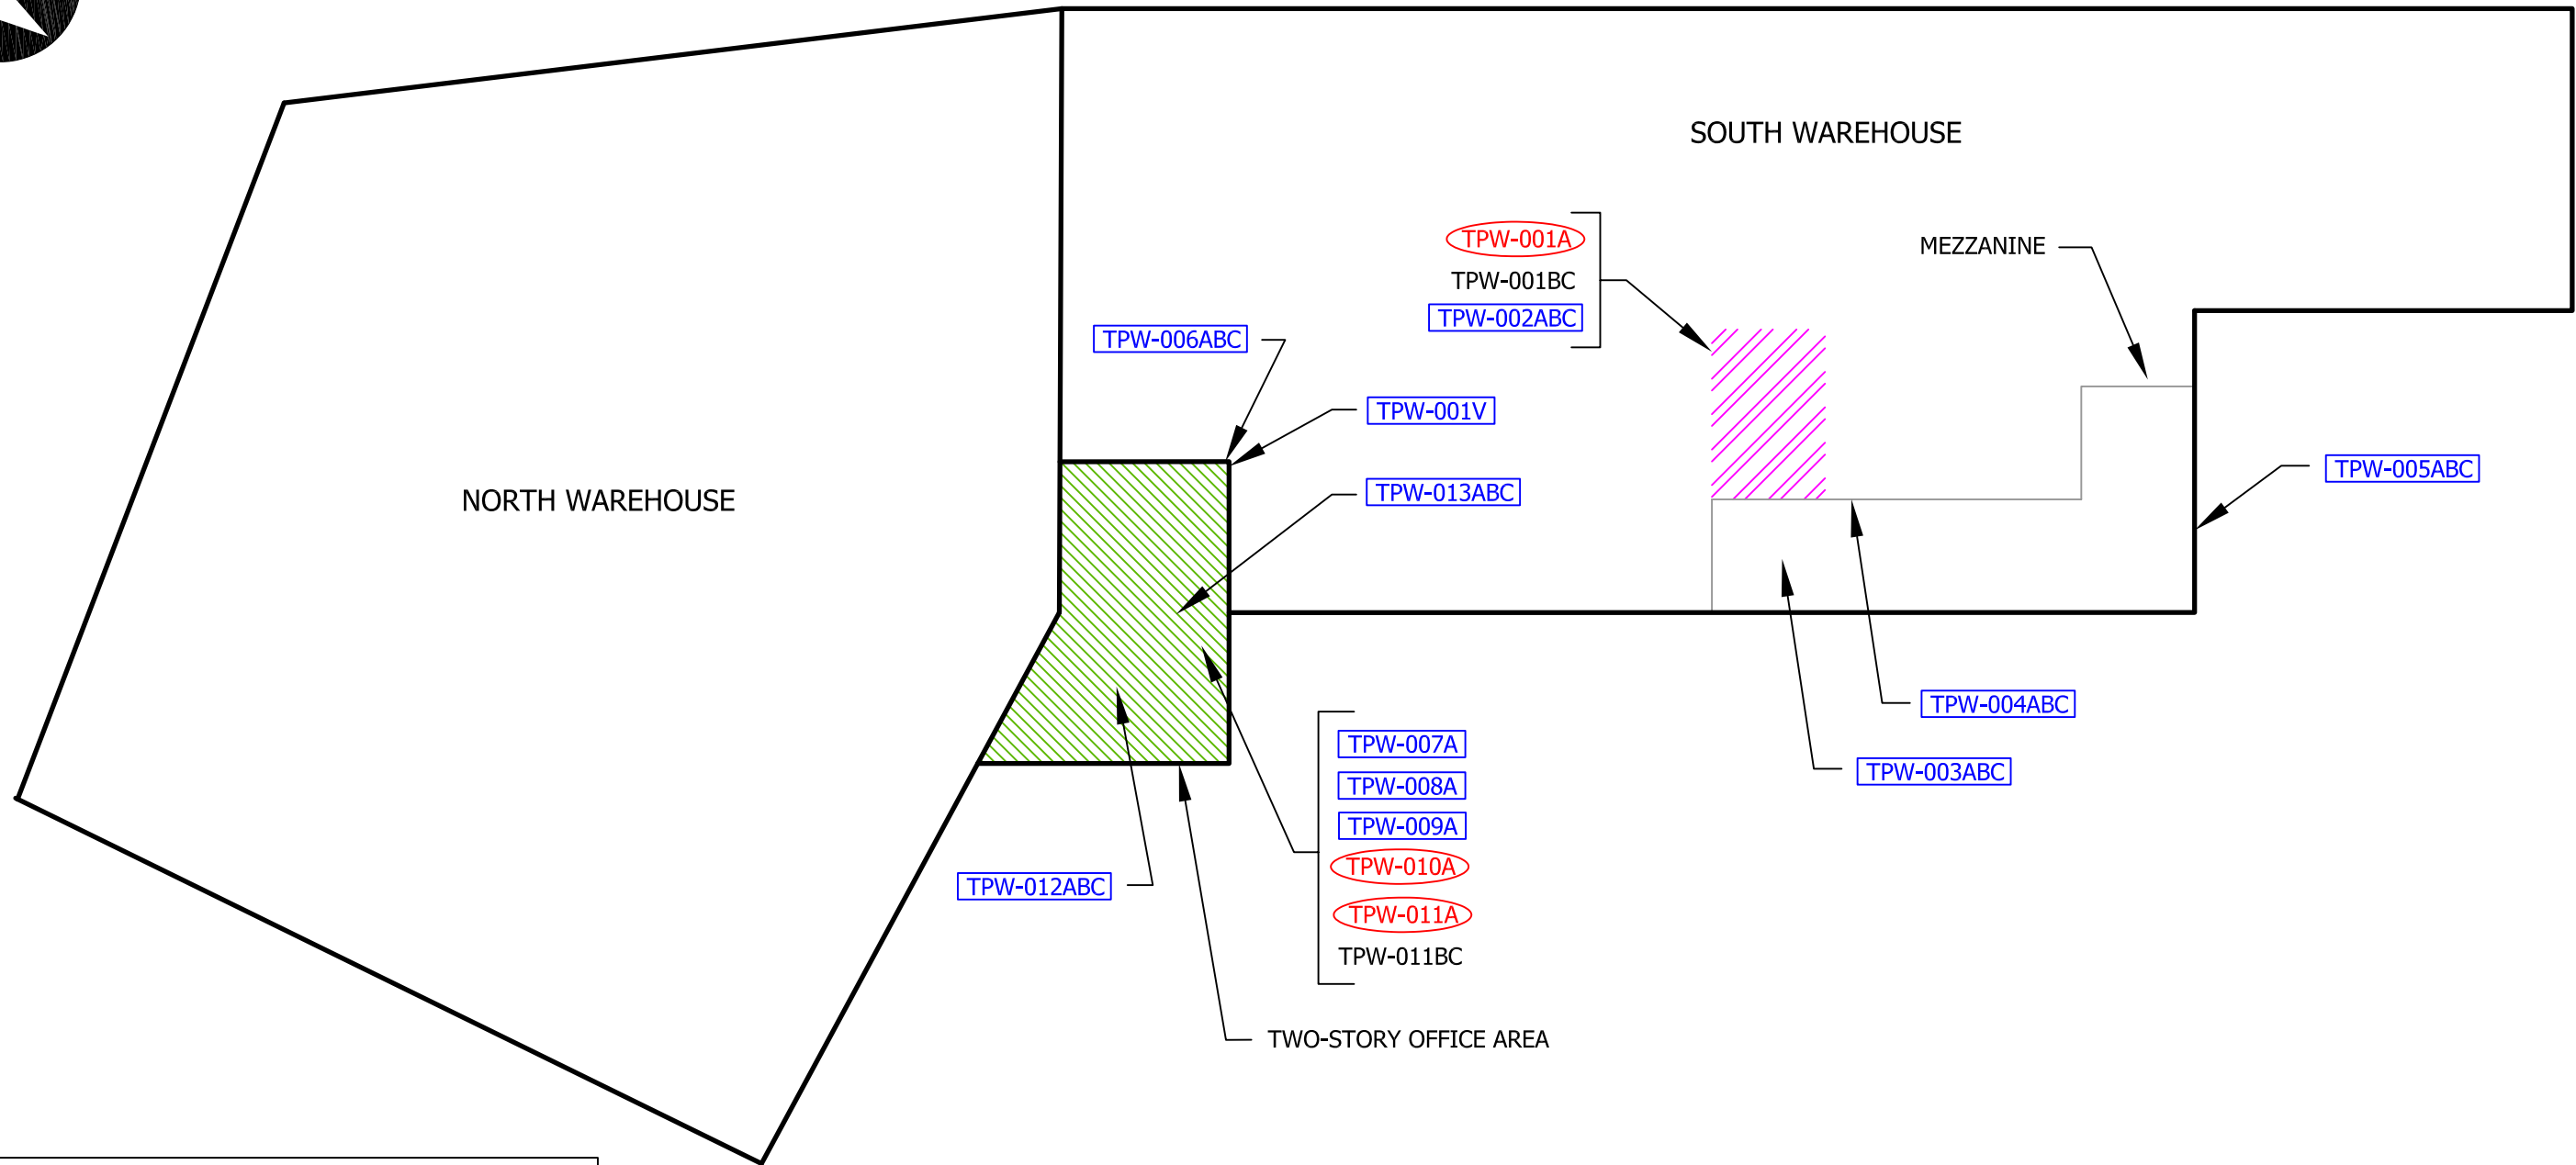
FIGURE 1

- 9-inch by 9-inch green floor tile in the south warehouse;
- 12-inch by 12-inch brown floor tile in the office building; and
- Subflooring material in the office building.

Current regulations require ACM to be removed prior to disturbance by renovation, demolition or other building maintenance activities. The ACM floor tile identified within the south warehouse and the ACM floor tile and associated subflooring on the first floor of the office building must be abated (i.e., be removed) prior to demolition or renovation of the building. ACM abatement must be performed using a Maine licensed Asbestos Abatement Contractor, using approved methods in accordance with applicable regulations established by the MEDEP, the USEPA, and the Occupational Safety and Health Administration (OSHA). Should the membrane roof present over the north warehouse and office be impacted by future renovations or demolition, the roof should be evaluated for the presence of suspect ACM at that time.

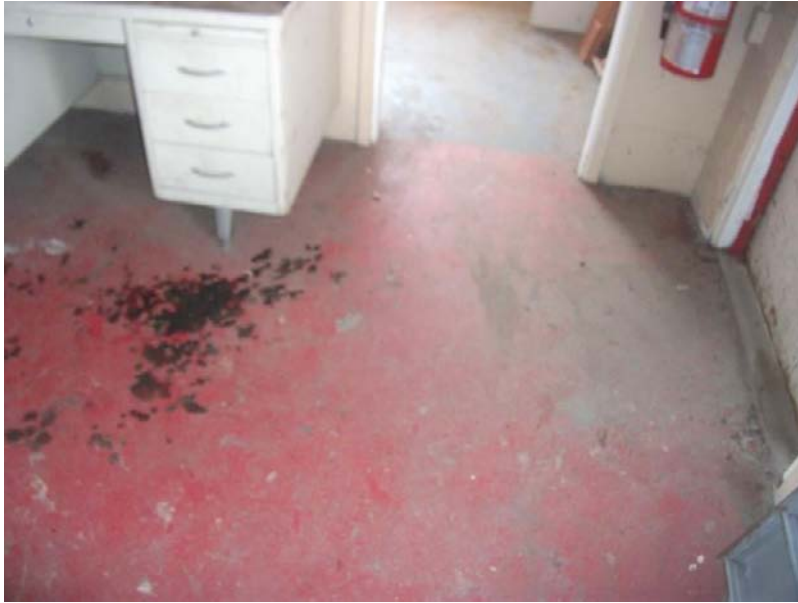
1. Potential lead and PCB paint on floors in Building #3.

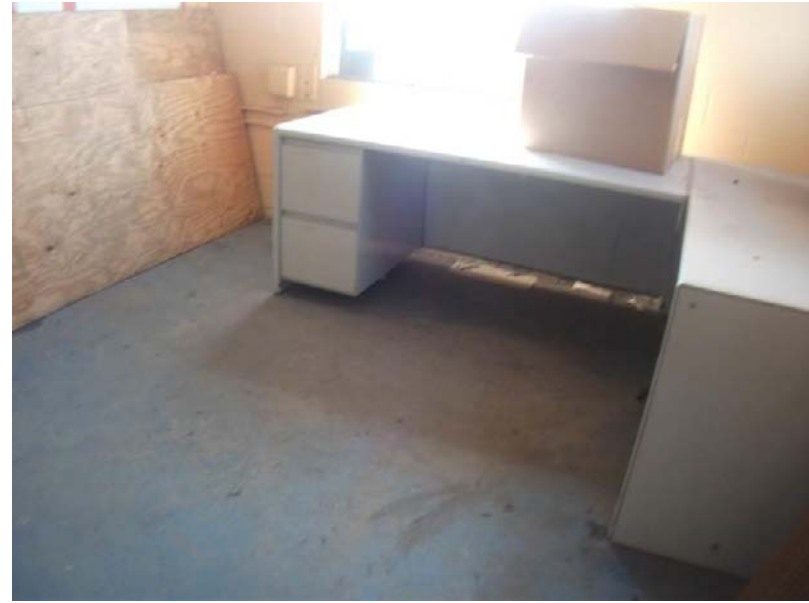
2. Potential lead and PCB paint on floors in Building #3.

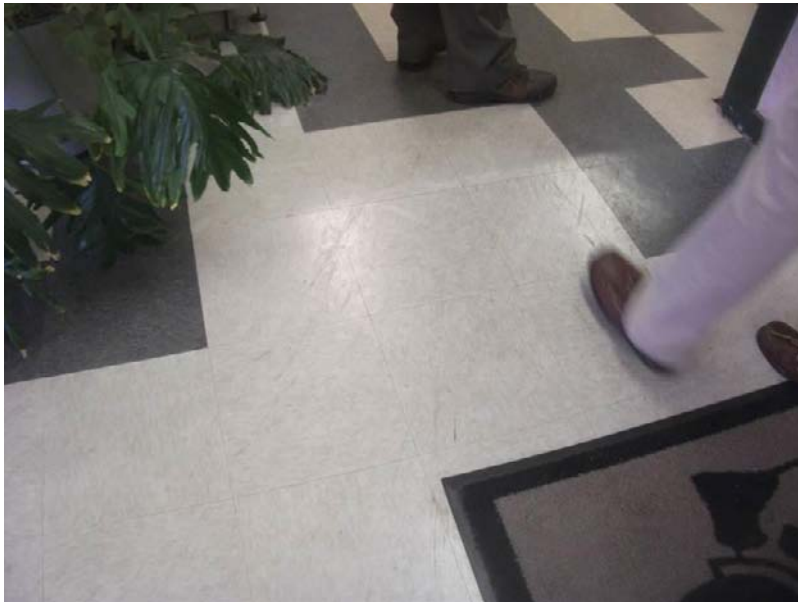
3. Potential ACM floor tile in Building #1, room 1.

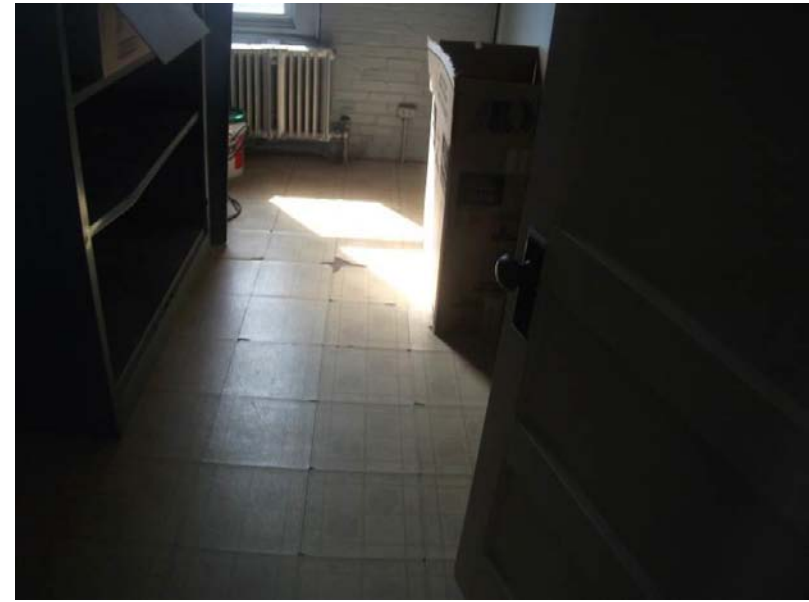
4. Potential ACM floor tile in Building #1, room 9.

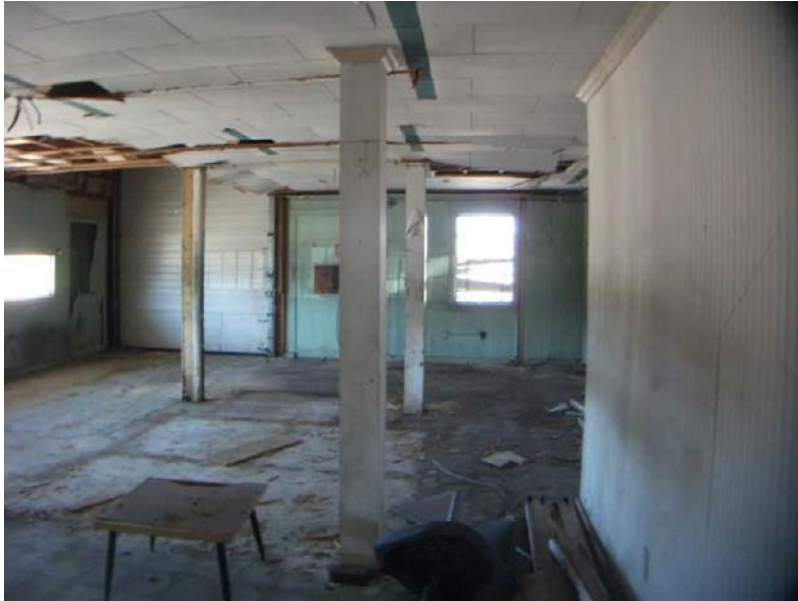
5. Potential lead and PCB paint on walls and floors, potential ACM floor tile, and waste fluorescent lighting in Building #2, room 1.

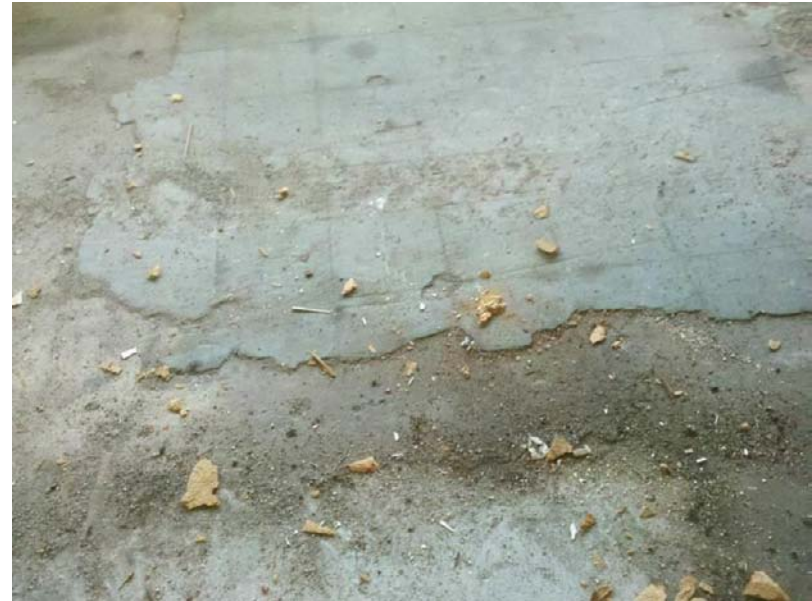
6. Potential ACM floor tile in Building #2, room 1.

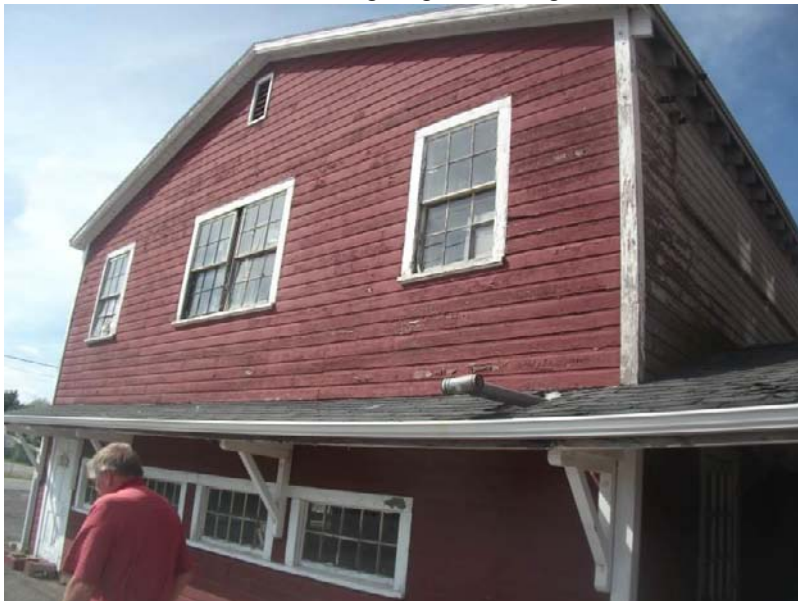
7. Potential lead and PCB paint on walls and trim, potential ACM window glazing, on exterior of Building #2.

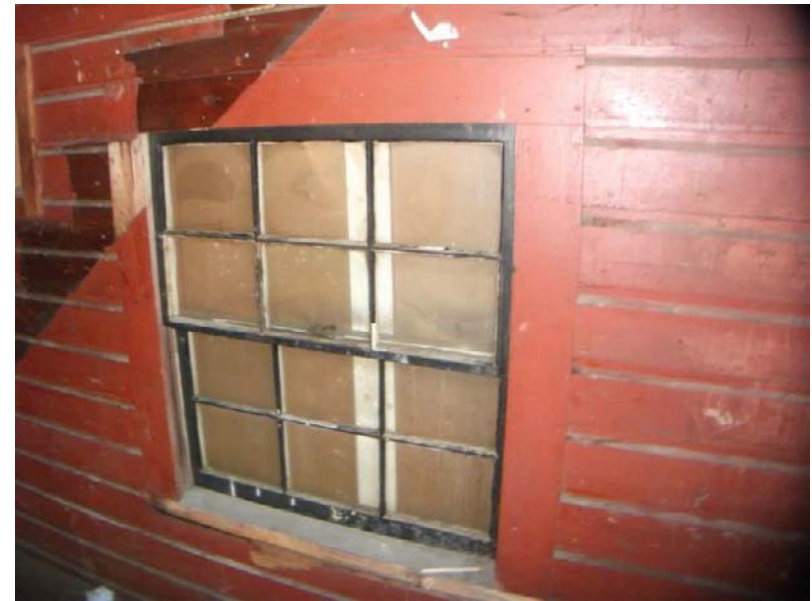
8. Potential lead and PCB paint on walls and potential ACM window glazing in Building #2, room 2.

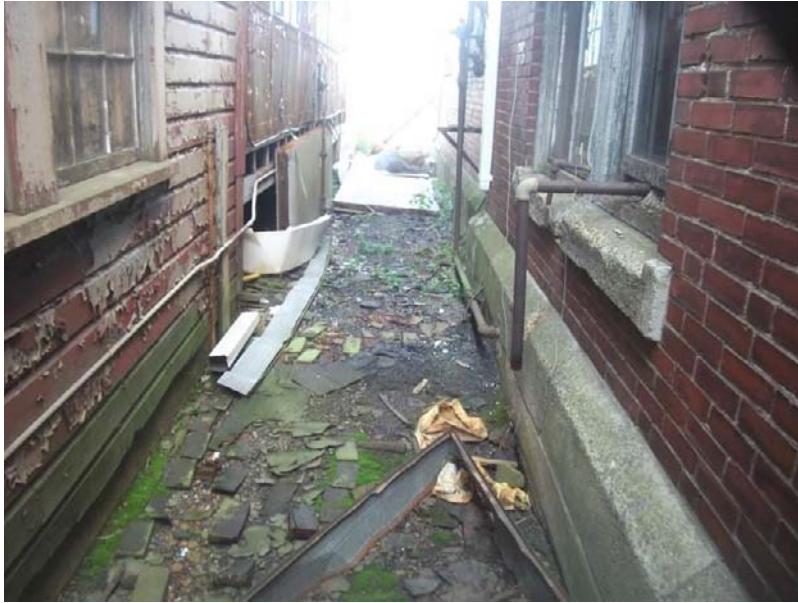
9. Waste potential ACM roof shingles in between Buildings #1 and #2

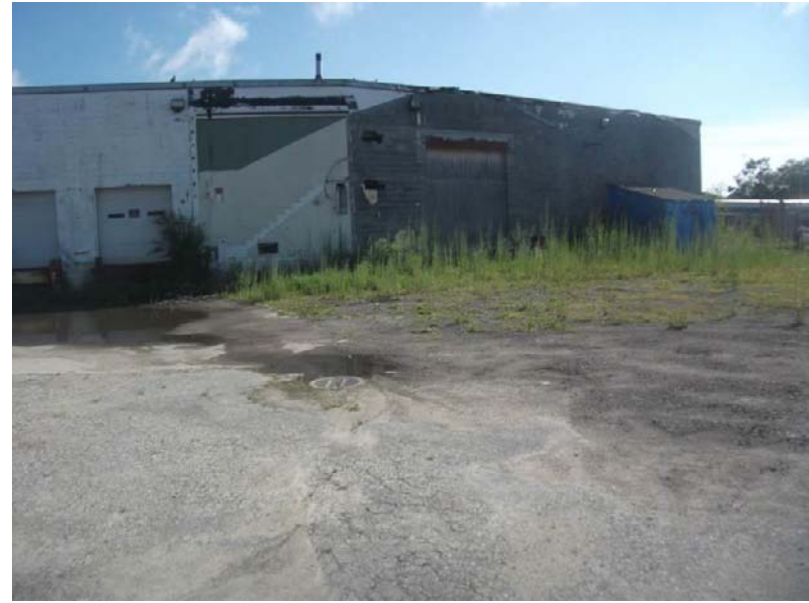
10. Potential lead and PCB paint on walls on exterior of Building #5.

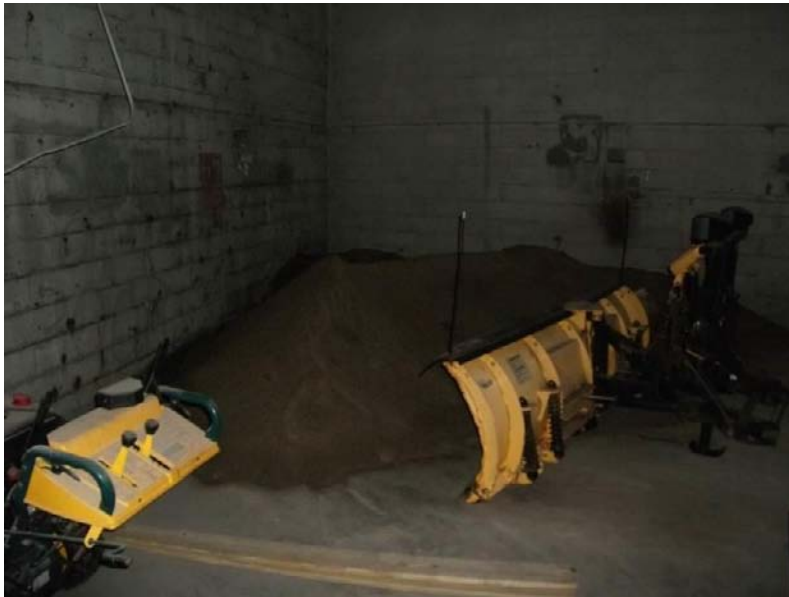
11. Potential lead and PCB paint on walls on interior of Building #5.
