Project: **Brick North**
Thompson's Point Portland, ME

S103

Existing Roof Framing Plan

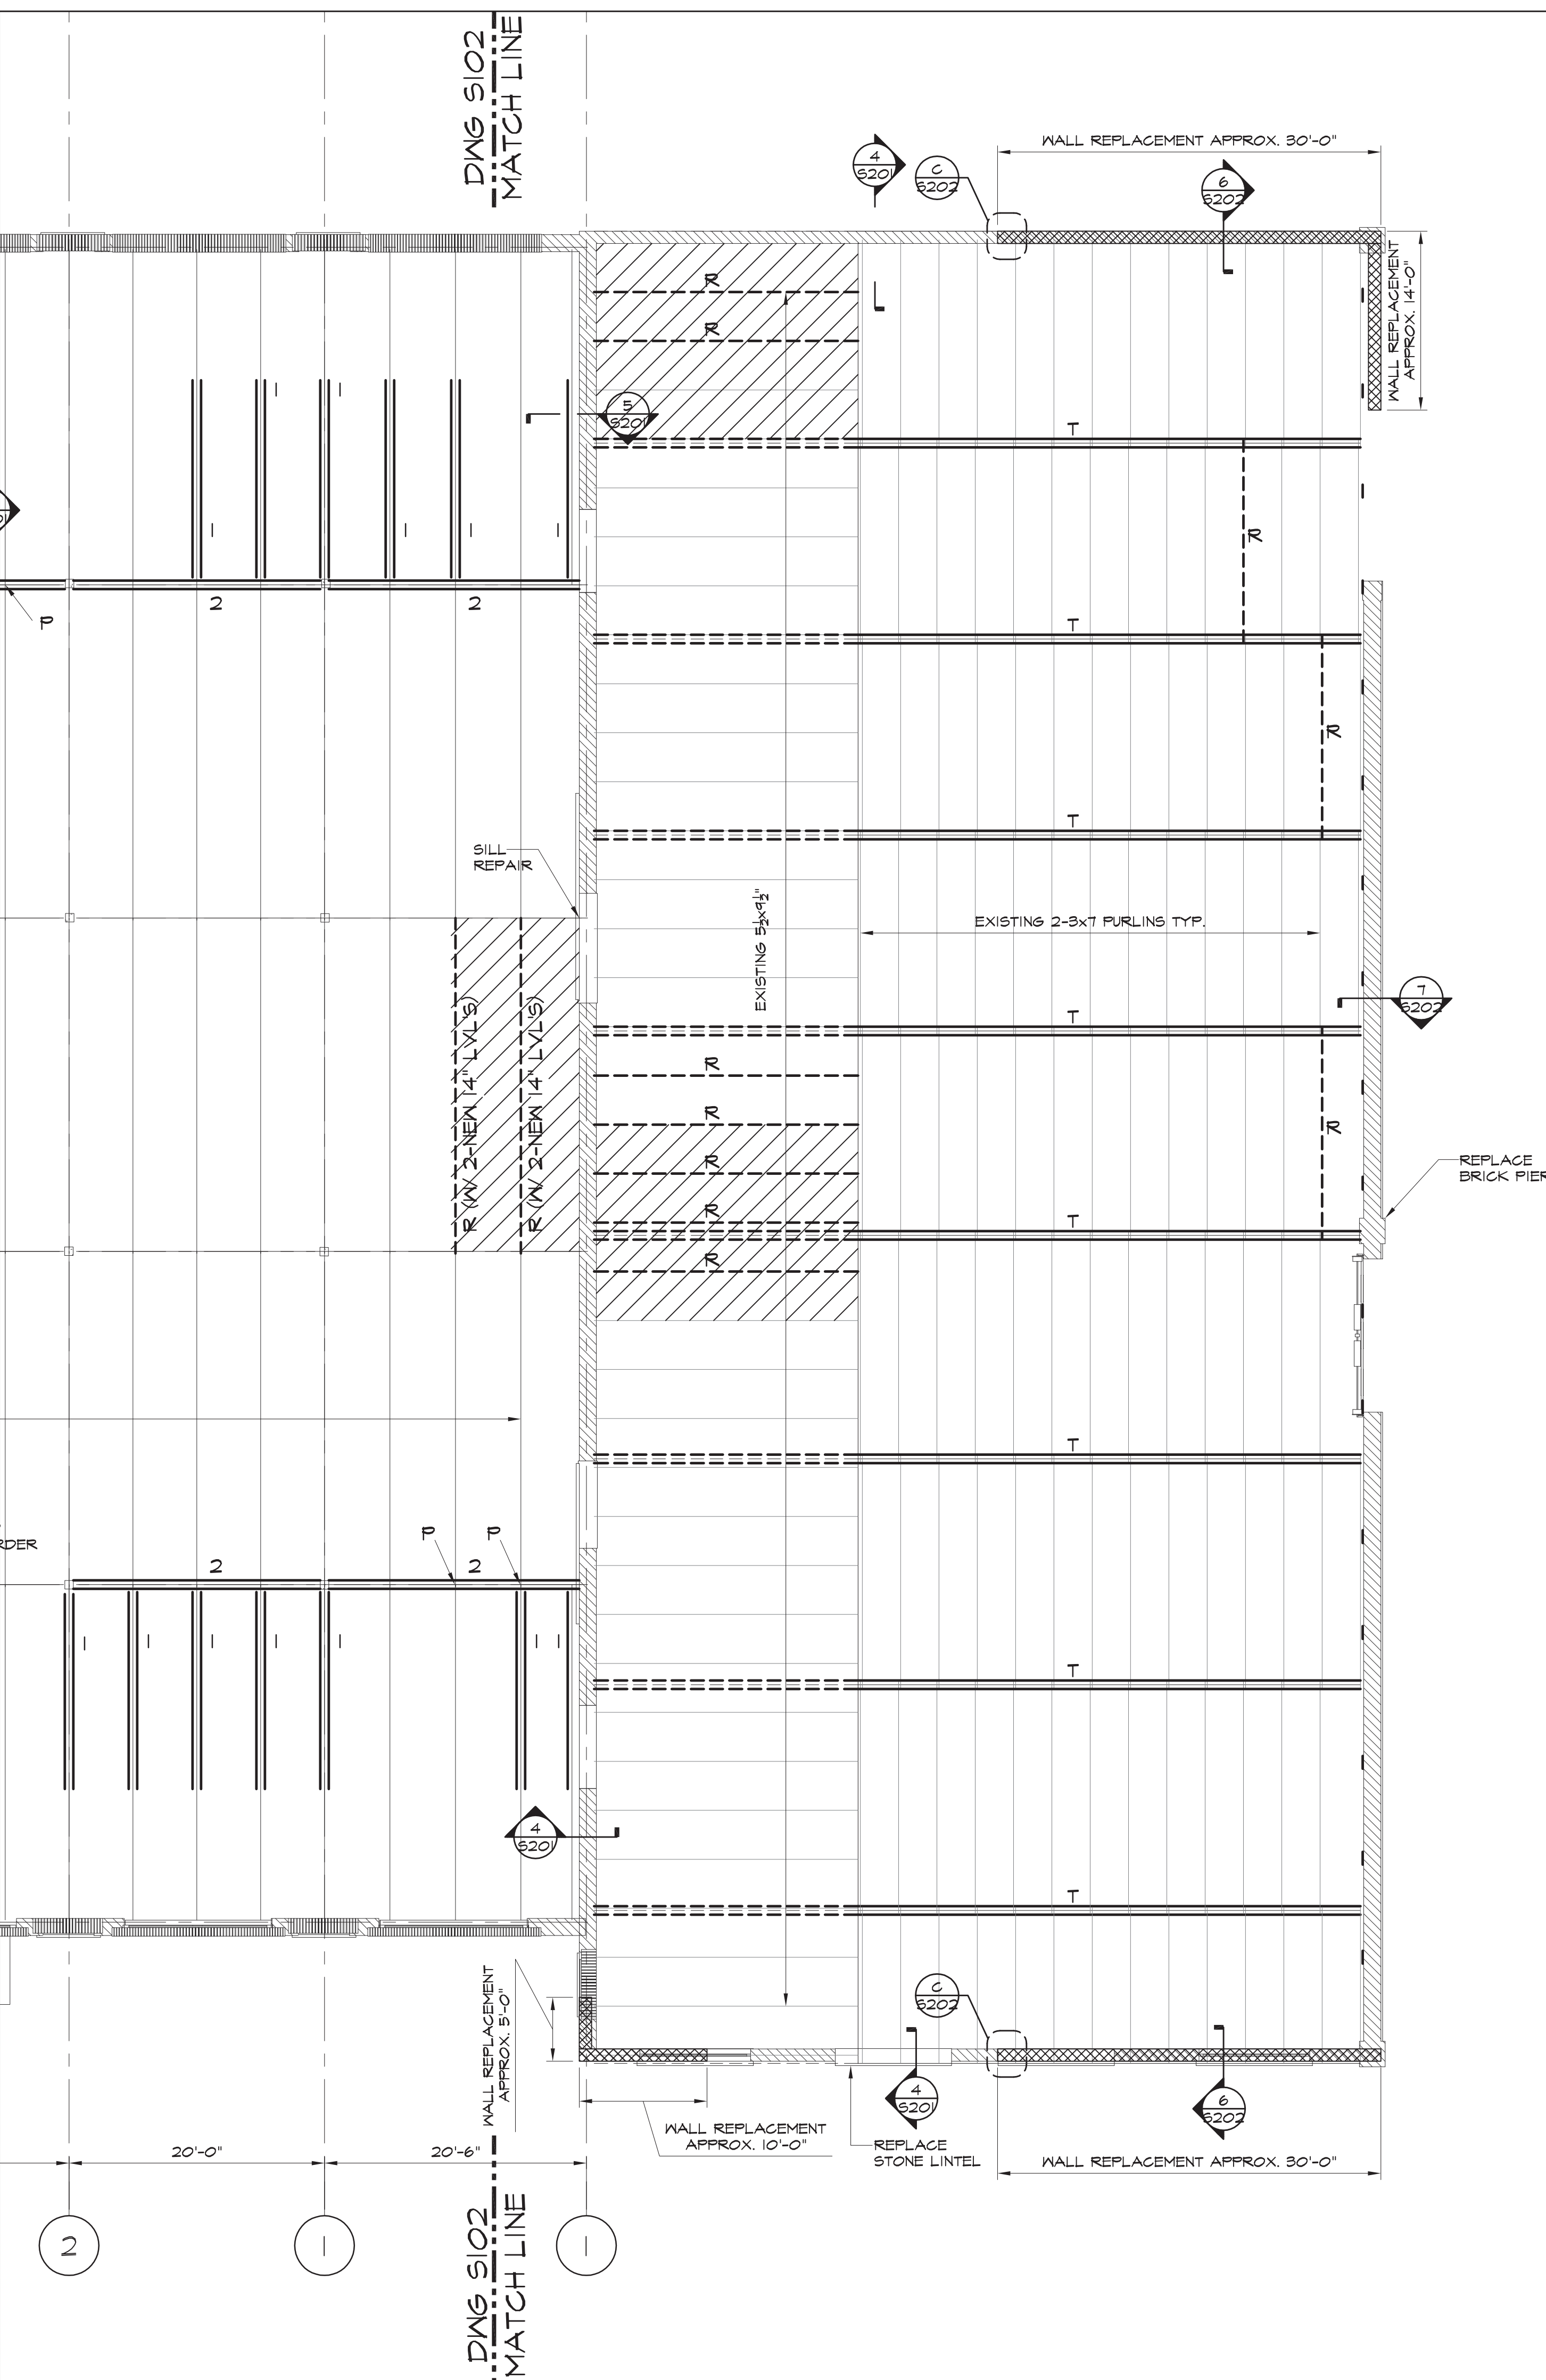
INDICATES DECK TO BE REPLACED WITH NEW TO MATCH EXISTING.

INDICATES WALL REPLACEMENT. SEE DWG S202.

REPAIR NOTATION	
DESIGNATION	SEE DWG. S201 & S202 FOR REPAIR DETAILS
1	INDICATES TYPE 1 BEAM REPAIR. SEE DWG S201.
2	INDICATES TYPE 2 GIRDER REPAIR. SEE DWG S201.
T	TRUSS REINFORCEMENT. SEE DWG S202.
P	INDICATES POST REPAIR. SEE DWG S201.
R	INDICATES BEAM TO BE REPLACED WITH NEW TO MATCH EXISTING U.N.O.
