LOCATED AT: 145 JETPORT BLVD
CBL: 209A A016002
RE: PD CASE # 14-33-26_VEHICLE INTO PORTE COCHERE

To:	Eric Smith	From:	Bryan Beaulieu
Company:	EJ Drywall	Date:	11/15/14
Re:	Hilton Garden Inn - Portland, ME - Porte Cochere Assessment

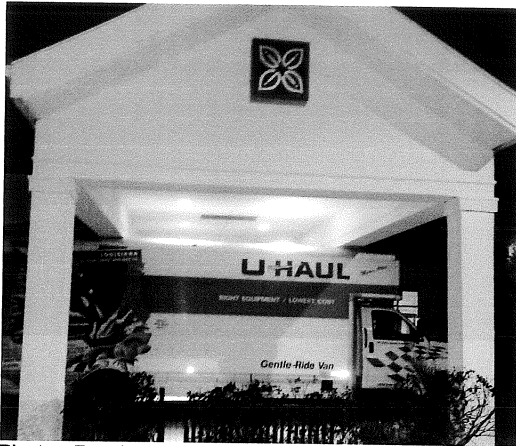
Photos Provided By Eric Smith

On the morning of Friday, November 14th, I visited the site and met with Al Delaney of the Hilton Garden Inn to go over the damage. The extent of the damage is the sheathing material and minor crushing damage to the light gage soffit framing in an isolated area. The framing may have temporarily shifted a small amount during the incident to cause the cracking where the soffit meets the wall. Considering the brittle nature of the material used to face the soffit, this is not surprising. The frame was checked to see if the porte cochere remained shifted but was found to be perfectly upright. The hole on the vertical face of the soffit was done with a hammer and not the vehicle.

Based on the damage observed, the structural steel system (the WF beams and tube steel columns) were not impacted by the accident. Only the non-structural cladding system in an isolated area sustained some damage and can likely just be patched over or removed and replaced. It is our opinion that the porte cochere does not pose any danger after this accident.
