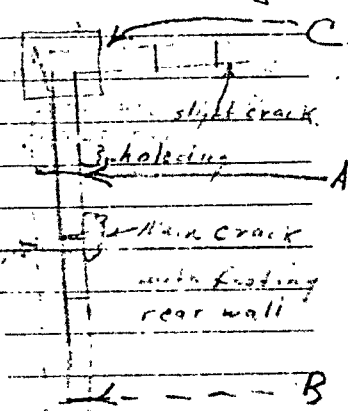
5-13-54 Found vertical crack  
about 1/2" wide in rear wall near  
right hand window. Crack slightly  
wider at top than bottom.

Rough concrete footing has been  
poured directly under cracked wall.  
Slight crack has developed on right  
hand wall. Collar has inches of  
sandy clay. Drain open. *DE*  
5/17/54 - Better - *mm*

5-25-54 Muddy water  
floor. Still draining.  
A pile of gravel has  
been dumped in one corner.  
It has moved back  
little to wash in again.  
Now well causing a  
2 1/2" concavity at wall.  
The wall is 2 1/2" off top  
of concrete wall at  
the larger crack. No  
particular change in  
the cracks can be  
noted from foot of  
collar stairs.

Found a concrete footing  
had been placed under  
corner of wall between  
cracks. See sketch *DE*.

8/26/54 - Better - *mm*  
11/17/54 - *mm* - large wave  
in, and is to take  
out and rebuild a  
section of rear  
wall - limits to  
be suggested by  
him and approved  
by N. R. C. *mm*

11-24-54 Cracked wall  
removed between A + B  
see Day above. New  
footing to go under wall  
from A to C. Old wall  
& new wall dovetailed together *DE*
