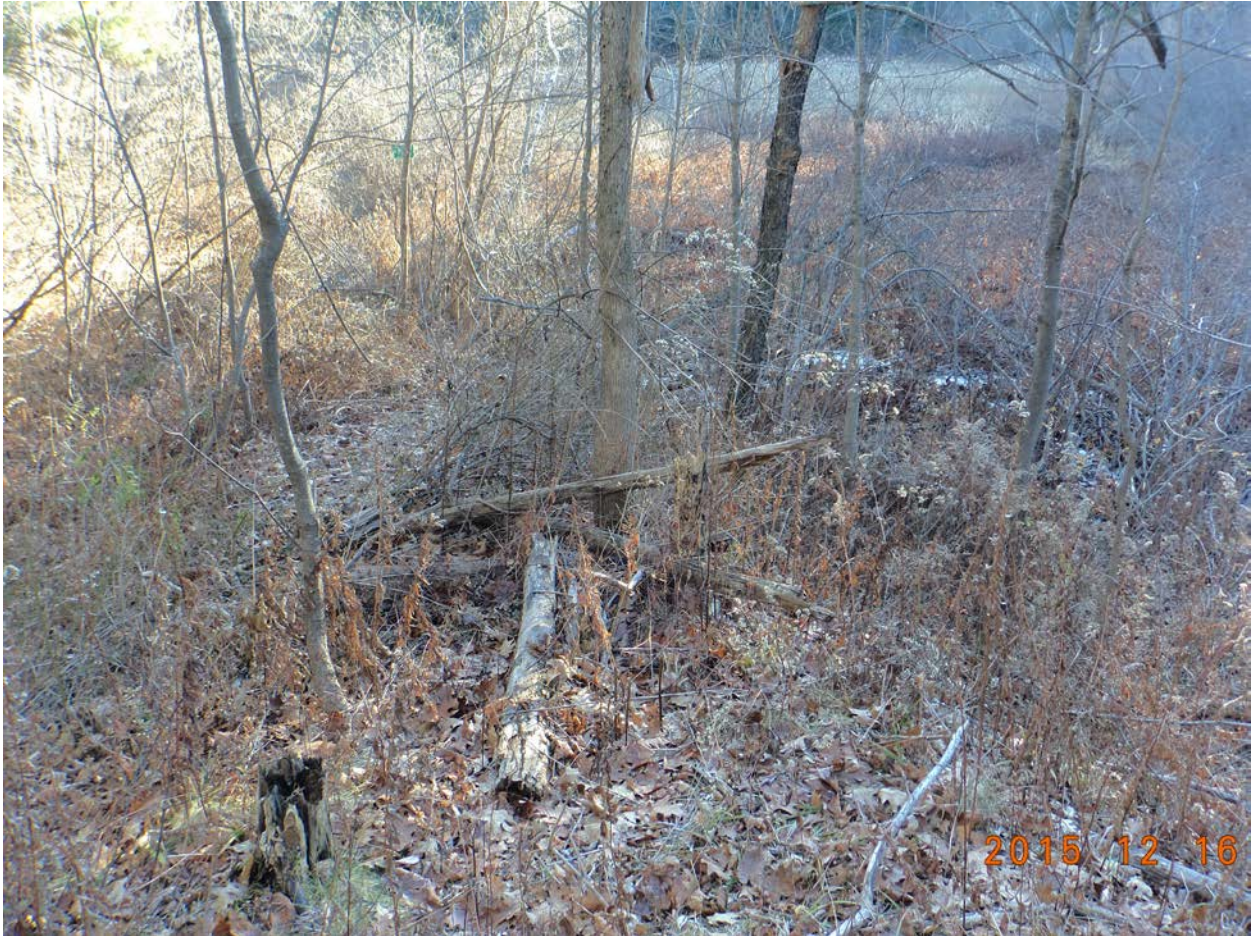
Photo 1: Area where proposed outfall will daylight.

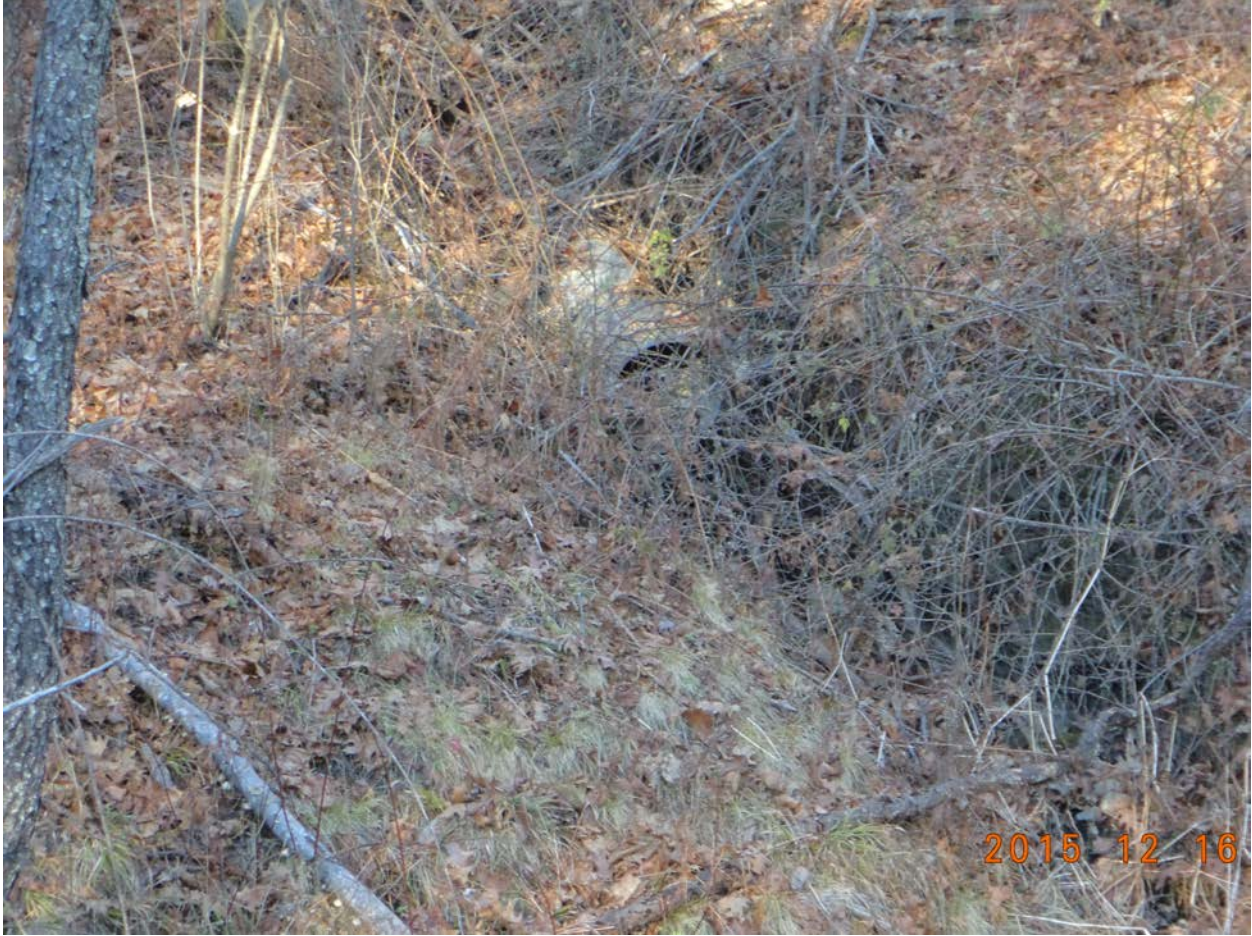
Photo 2: Existing Culvert to be replaced by proposed 24" SD outfall.

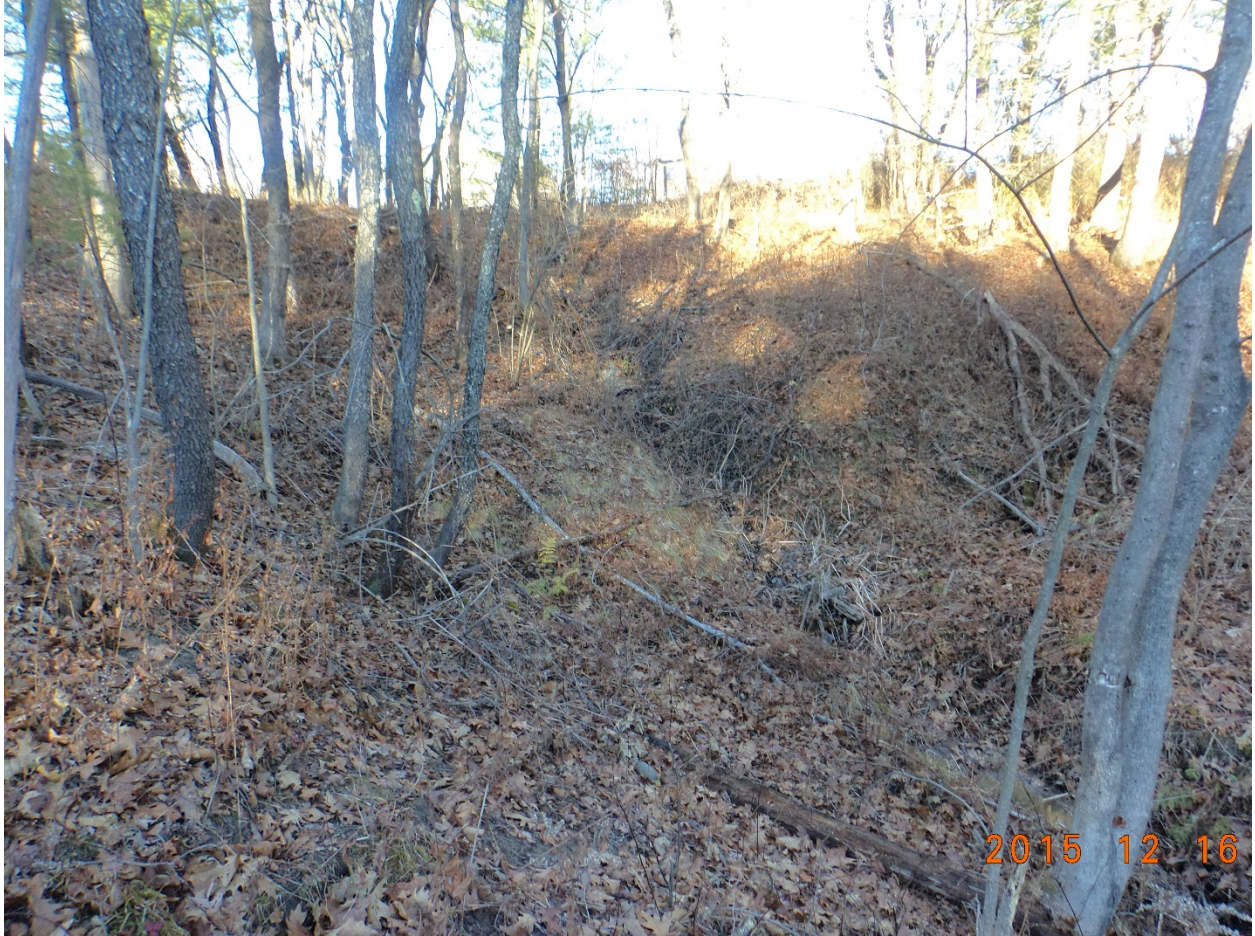
Photo 3: View of existing bank where outfall pipe will extend down. Note slope erosion occurring in the existing condition. New outfall will extend down and outlet at the toe of the slope with velocity reducing rip rap outlet.

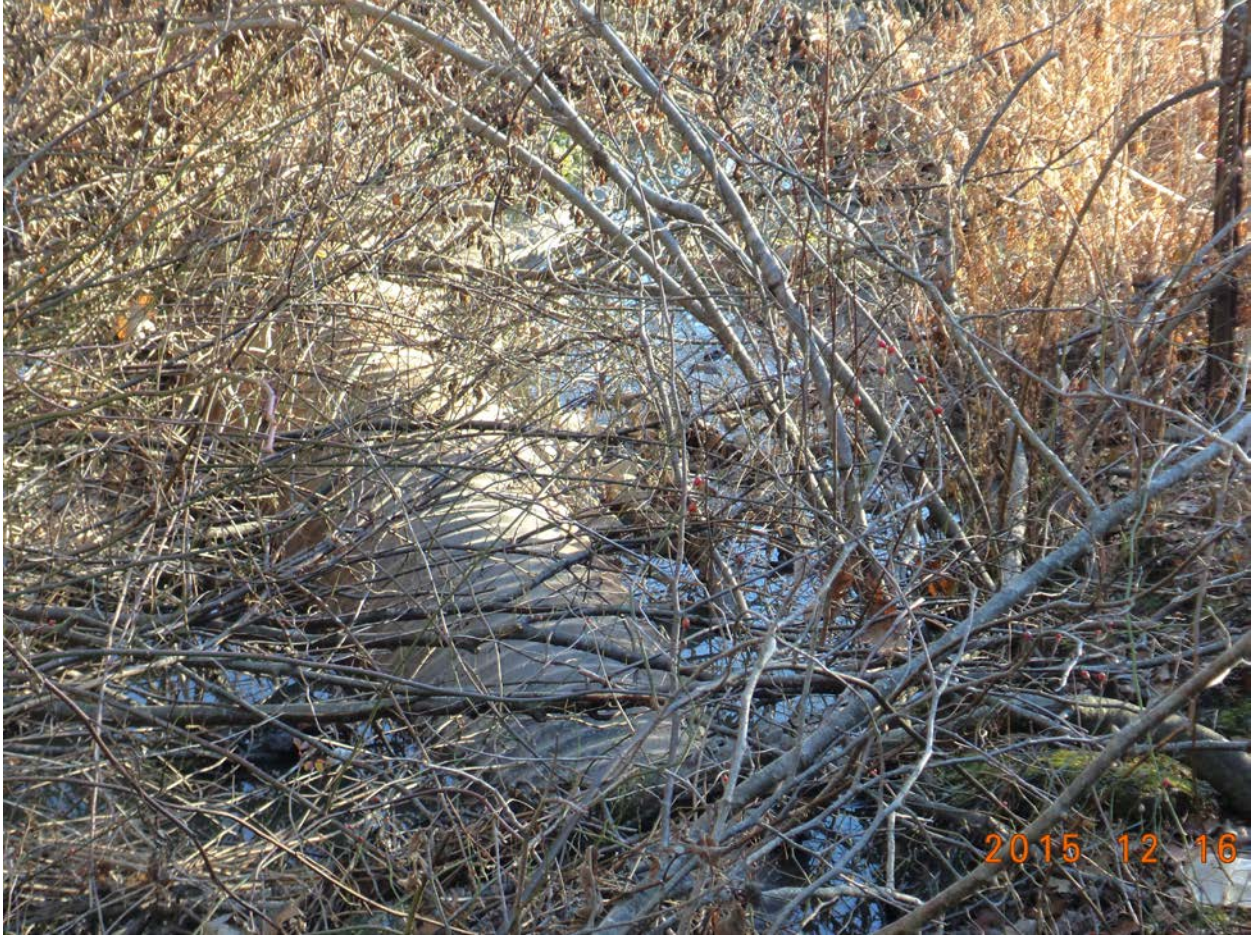
Photo 4: Section of existing CMP culvert that has washed away from the rest of the culvert, highlighting the need for replacement.

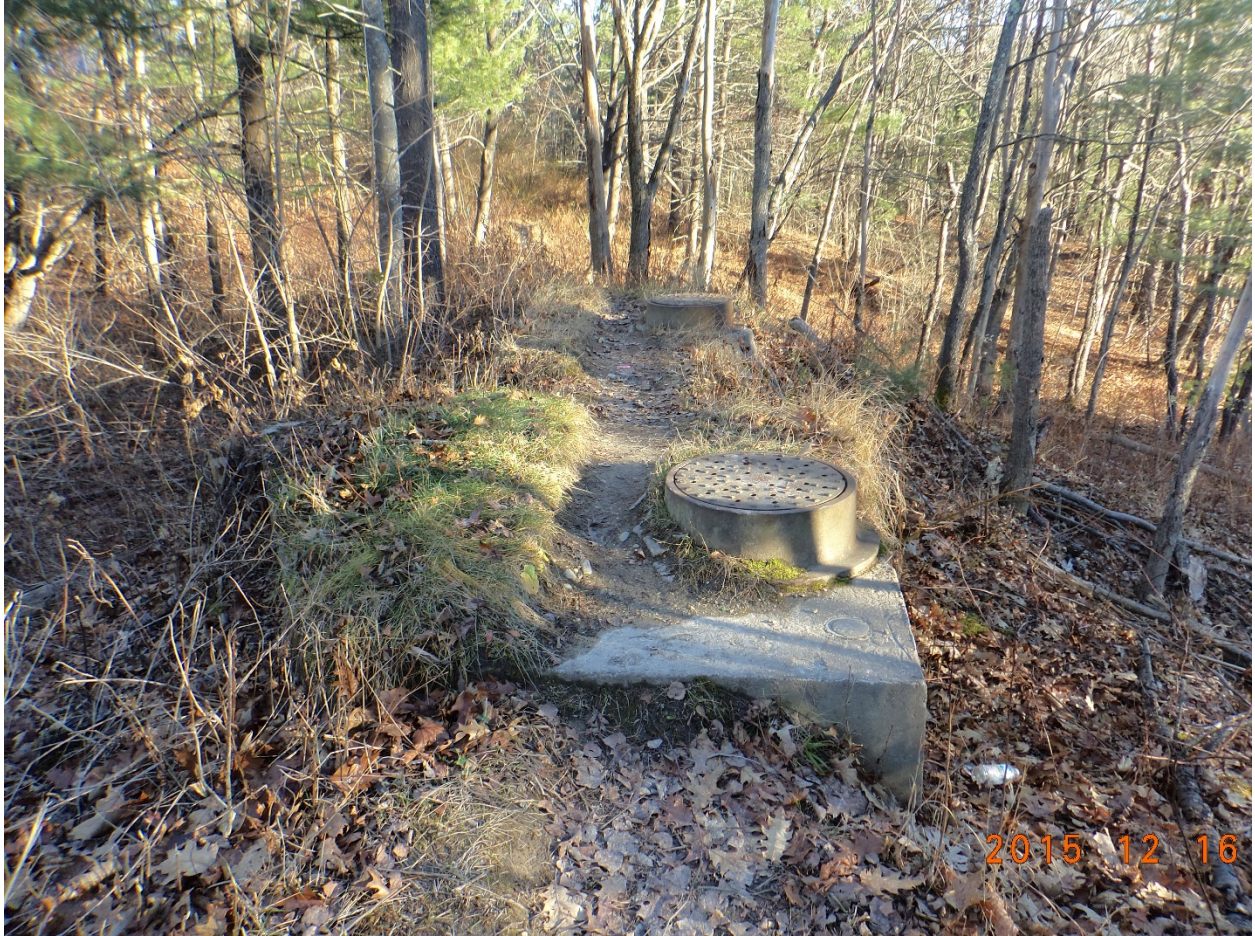
Photo 5: Fore river sewer interceptor pipe CSO Structure. Access road will be constructed to left. Light clearing will be required to complete the access road.
