ASBESTOS MATERIALS INSPECTION

**RITE AID
373 ALLEN AVENUE
PORTLAND, MAINE**

NTC JOB #10436-2007

February 22, 2007

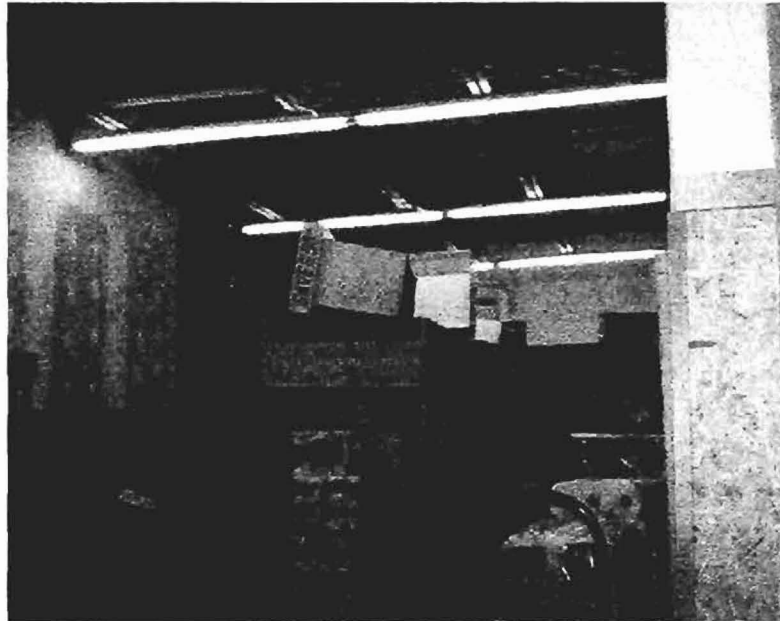
View of typical rear storage area.

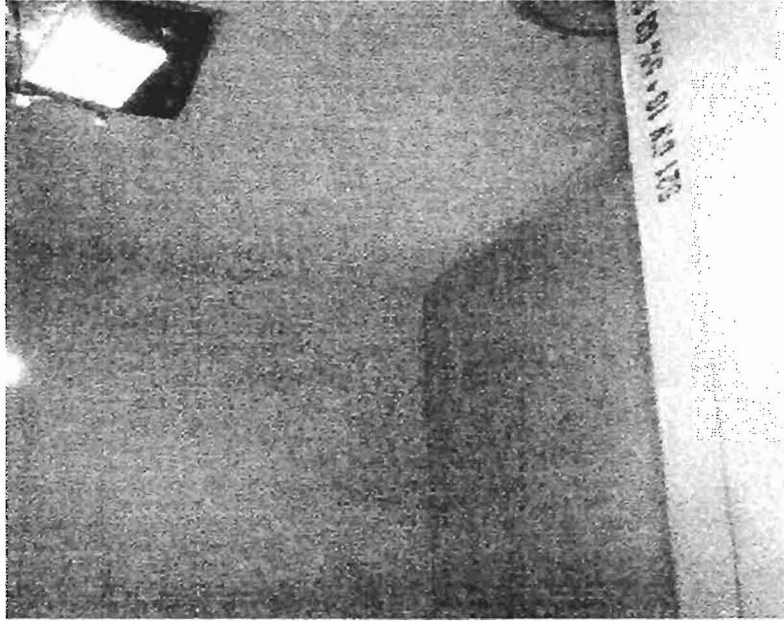
View of textured ceiling in Men's Room.

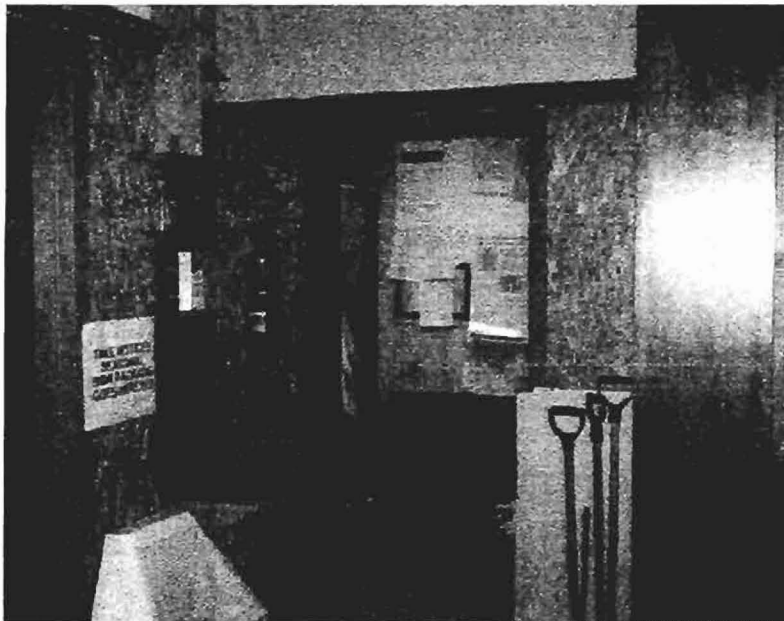
View of office area illustrating sheetrock and wood sheeting overlays.

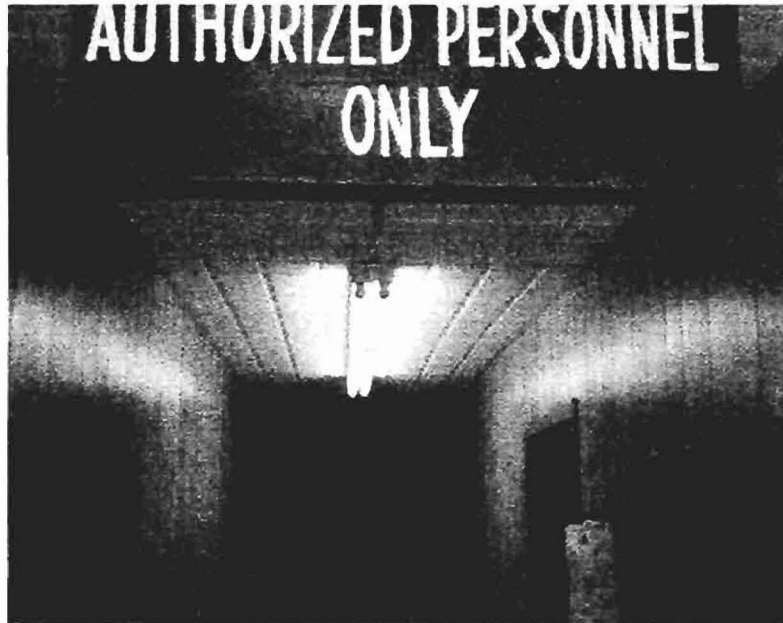
View of hallway area illustrating 2' x 4' ceiling panels.

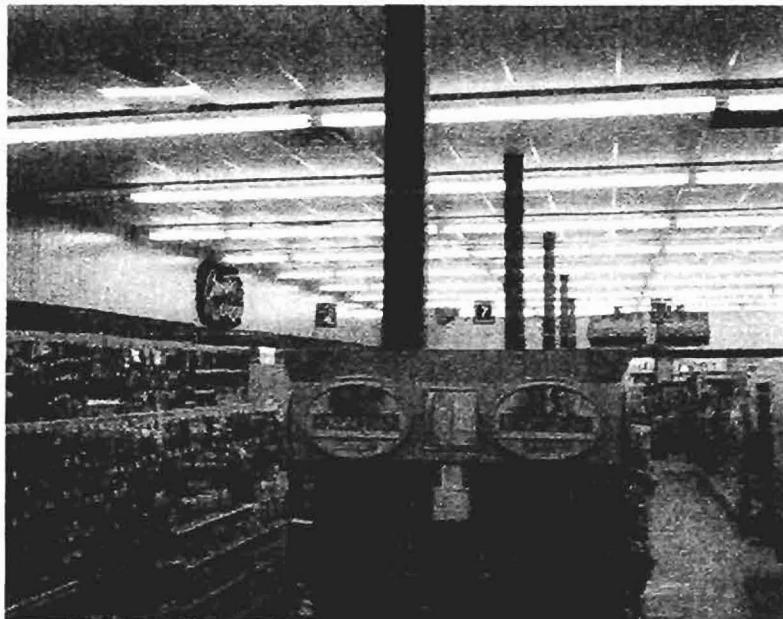
View of retail sales area illustrating ceiling and floor systems.

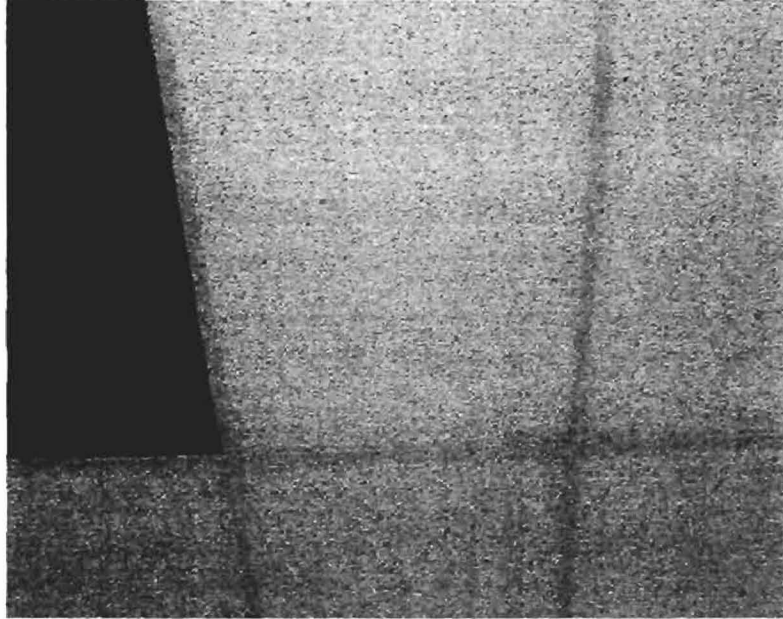
Close up of ceiling tiles in retail area, 2'x 4' tile with fissures & pinhole patterns.

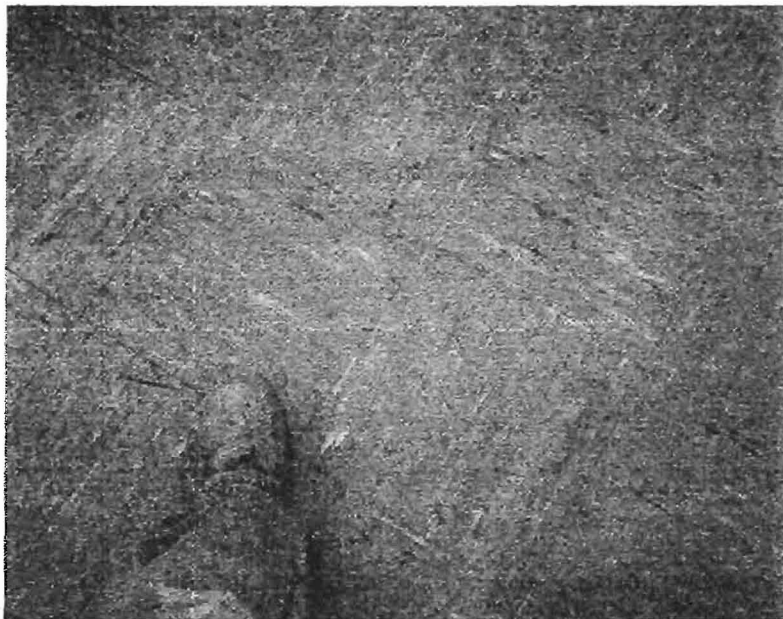
Close up of typical floor tile application in structure, 12" x 12" tan tile with streaks.

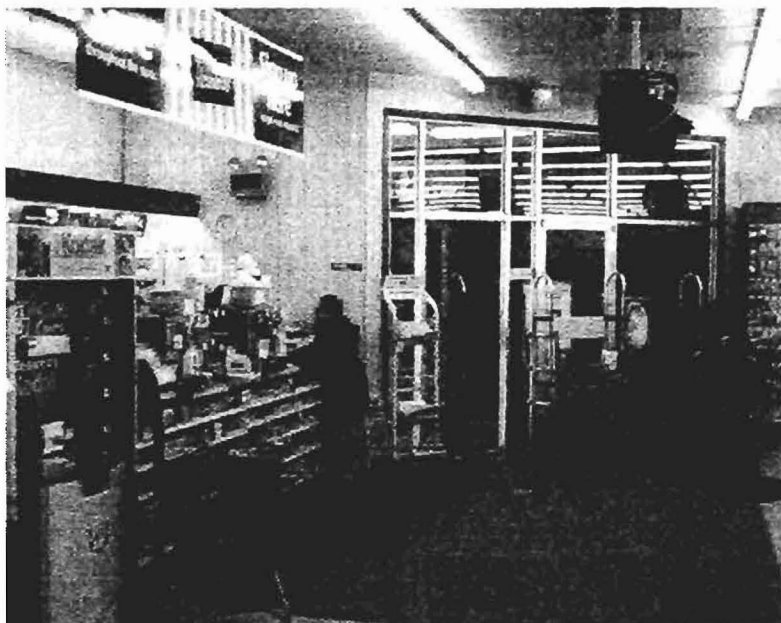
View of front area of store with 8" x 8" brick patterned floor tile.

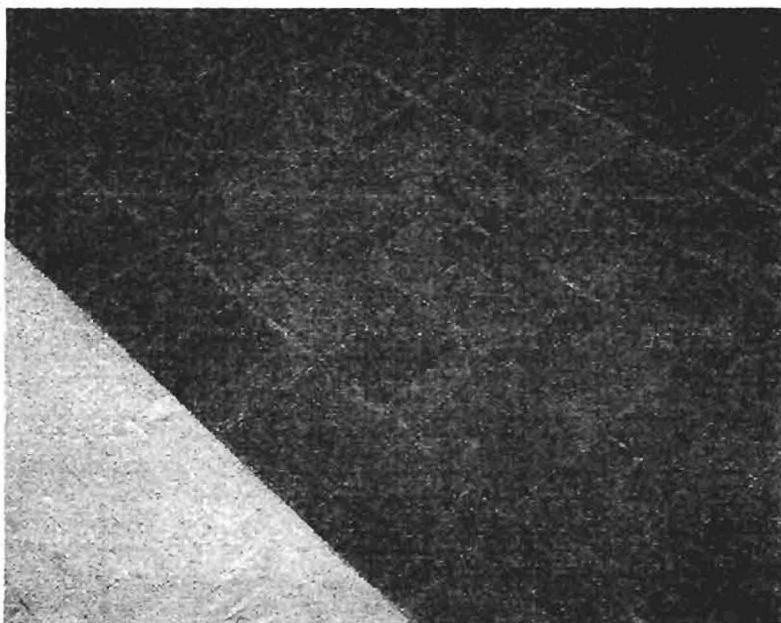
Close up of previously mentioned brick patterned floor tile.

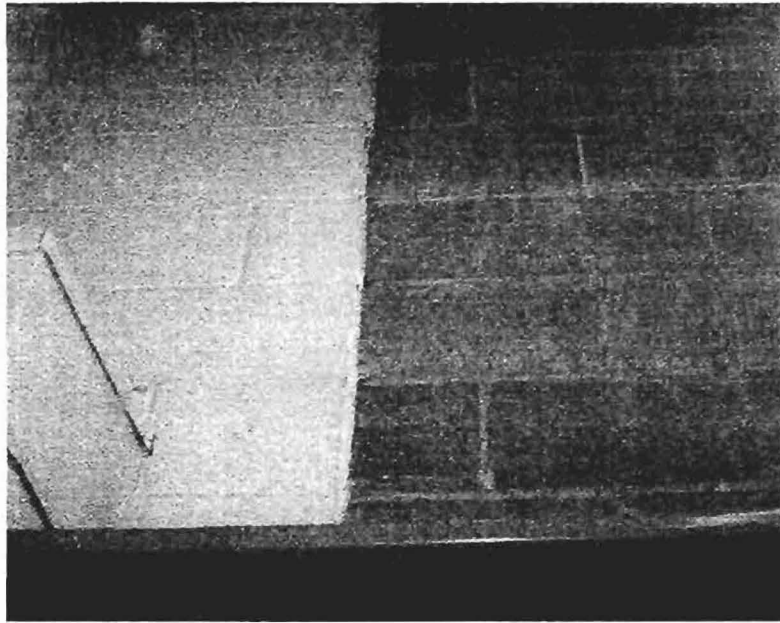
View of masonry caulking.
