Re: Inspection of State Pier

TEC Associates inspected the piles, bracing, and underside of the deck of the Maine State Pier on Tuesday 11 March 2014. The inspection was limited to the area between bents 15 and 17 and between column rows "c" and "b" as labeled on the attached inspection drawing. TEC employees Tim Dermody, EI and Bret Grenier, EI, performed the inspection.

MAINE STATE PIER PORTLAND, MAINE	
PIER INSPECTION NOTES	
	CONSULTING ENGINEERS SOUTH PORTLAND, MAINE 04106
SCALE AS SHOWN 1:500	N.T.S. DATE 3/13/2014
DRAWN BY B.R.G.	CHECKED BY -
	DRAWING NO. 1 OF 1

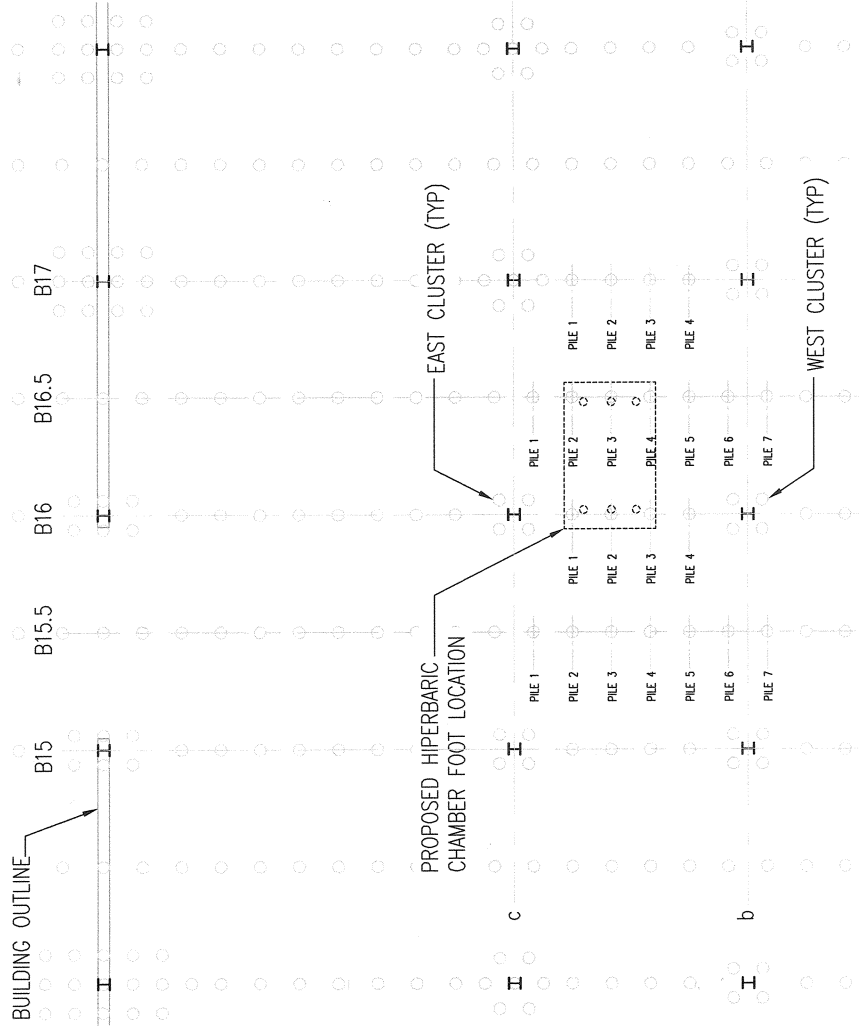
**PLAN VIEW**

- BENT 15.5 PILE 2 - HEART ROTTED AT LOWER BOLT HOLE, APPROX 40% EFFECTIVE.  
 PILE 3 - ROTTED HEAVY, APPROX 10% EFFECTIVE...  
 PILE 5 - HEART ROTTED, APPROX 50% EFFECTIVE.  
 BRACE - NORTH AND SOUTH TRANSVERSE BRACING MISSING.

- BENT 16 EAST PILE CLUSTER- (4) PILES  
 - MINOR SPALLING AT CORNERS OF CONCRETE CAP.  
 - SHIMS BETWEEN PILES AND CONCRETE ARE VERY WEATHERED.  
 - NORTHEAST PILE SLACKS 1 1/2" AT TOP.  
 PILE 2 - ROTTED HEAVY, APPROX 25% EFFECTIVE.  
 PILE 3 - MINOR ROT AT BOTTOM ON EAST FACE.  
 BRACE - NORTH AND SOUTH TRANSVERSE BRACING MISSING.

- WEST PILE CLUSTER- (4) PILES  
 - BOTTOM CORNERS SPALLING SOME. HEAVIER SPALLING ON NORTH AND SOUTH CORNERS.  
 - NORTHWEST PILE SLACKS 1 AT TOP.
- SPAN 16 MINOR SPALL ON BOTTOM OF CONCRETE SLAB ADJACENT TO EAST CLUSTER.  
 MINOR SPALL ON BOTTOM OF CONCRETE SLAB ADJACENT TO WEST CLUSTER.

- BENT 16.5 BRACE - NORTH AND SOUTH TRANSVERSE BRACING MISSING.  
 PILE 7 - ROTTED HEAVY, APPROX 40% EFFECTIVE.
- BENT 17 EAST PILE CLUSTER- (8) PILES  
 - ONLY (4) PILES ARE BEARING.

- MINOR SPALLING AT CORNERS OF CONCRETE CAP.  
 - MOST SHIMS BETWEEN PILES AND CONCRETE ARE MISSING.  
 - NORTHWEST PILE ROTTED AT WATERLINE, APPROX 25% EFFECTIVE.

- SOUTHEAST CORNER PILE ROTTED SOME, APPROX 60% EFFECTIVE.  
 BRACE - NORTH AND SOUTH TRANSVERSE BRACING MISSING.
- WEST PILE CLUSTER- (4) PILES  
 - NORTHWEST PILE ROTTED HEAVY, APPROX 25% EFFECTIVE.

- SPAN 17 MINOR SPALL ON BOTTOM OF CONCRETE SLAB ADJACENT TO EAST CLUSTER.  
 MINOR SPALL ON BOTTOM OF CONCRETE SLAB ADJACENT TO WEST CLUSTER.

The enclosed inspection drawing indicates our recommendation for the location of Hiperbaric unit. The piles within this area are adequate to support the loads imposed by the Hiperbaric unit and it is within the area you indicated. The final location of the unit should position the feet as close to the bent lines as possible, centered between bent line 16 and 16.5.
