**Project:** Casco Bay PG – Stair/Elevator Tower Restoration  
**Project #:** WO 3604  
**Date/Time:** May 31, 2016, 9:30 a.m.  
**Observers** Joshua Martin-McNaughton, Author (BSE)

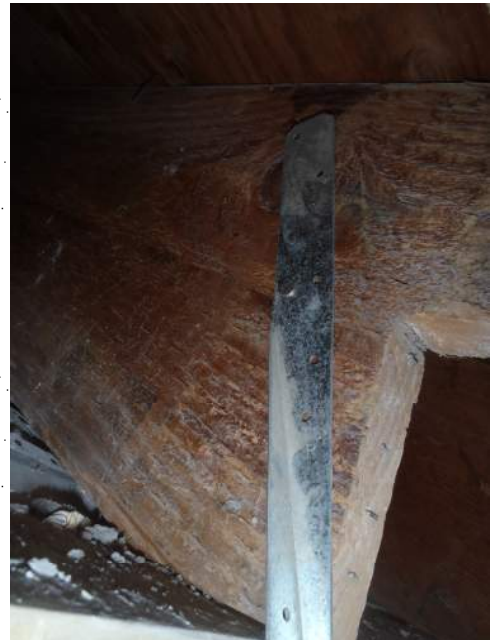
1. The twisted straps securing the roof wood framing to the 2x10s securing need additional nails within the ceiling cavity. Most of the straps only had 1 or two nails. Reference the strap manufacturer for fastening requirements. See adjacent photo.

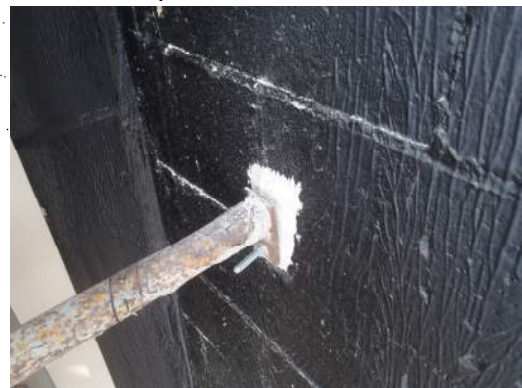
8. Where the scaffolding is attached to the CMU, the exposed CMU needs to be coated in air/vapor barrier. See adjacent photo.
9. Some of the sealant that was applied to the window perimeters and steel angle lintel were damaged from the adjacent welding and needs to be repaired. This occurs where the steel plate bands were welded to the steel angle lintels.

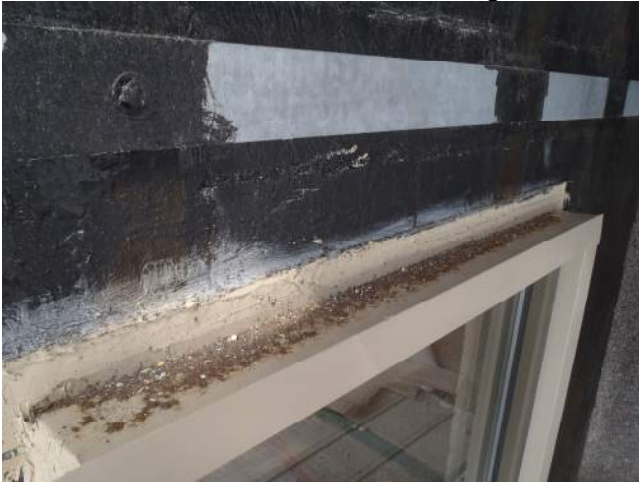
10. Before the wall panels are installed, the exterior needs to be washed down to remove debris so it isn't stuck behind the siding once installed. See photo below

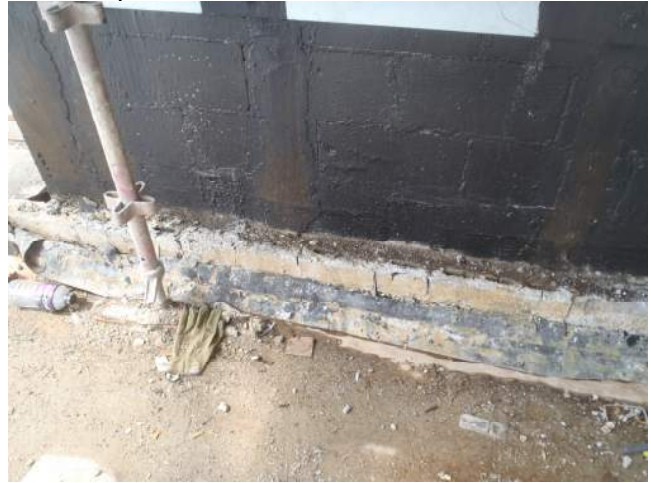
11. Before the wall panels are installed, at the flat roof level, this area needs to be cleaned up and reworked with wood blocking as necessary to install the roofing flashing tie-ins and thru wall flashing. See photo above. Reference BSE drawings and wall panel shop drawings for further information.

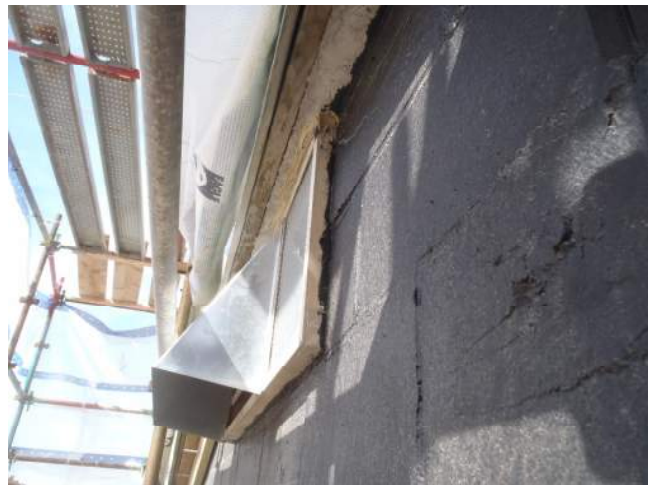
13. The louver at the top of the elevator shaft will have to be removed and reset to be incorporated with the wall panel system. See adjacent photo and reference the wall panel shop drawings.
