Project: Casco Bay PG – Stair/Elevator Tower Restoration
Project #: WO 3604
Date/Time: June 13, 2016, 1:30 p.m.
Observers Joshua Martin-McNaughton, Author (BSE)

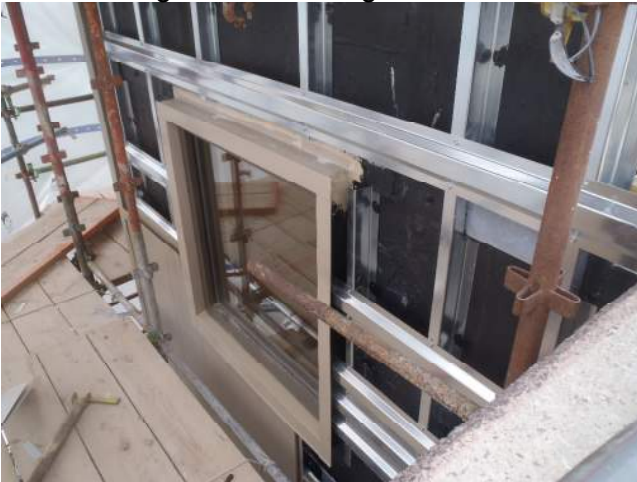
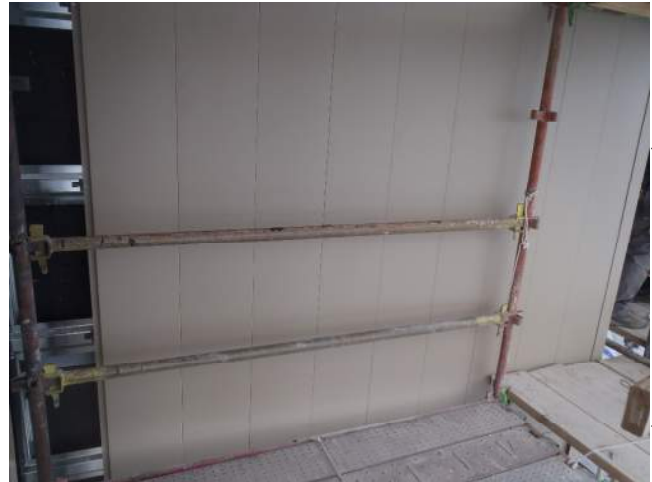
1. The roof clip angles securing the roof framing spacing is not correct and need to be spaced at a maximum 24" O.C. Justin the foreman onsite was notified that this needs to be corrected prior to the installation of the wall panels. As of 6/15/16, KISC indicated that this has been completed.
2. The metal wall panels and supporting framing have begun to be installed, see photos below. The metal wall panels have had to be shimmed from the sub framing due to the misalignment and irregularities of the CMU wall.

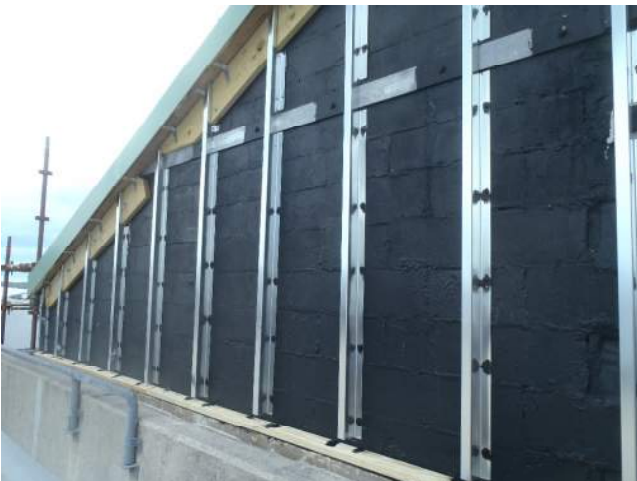
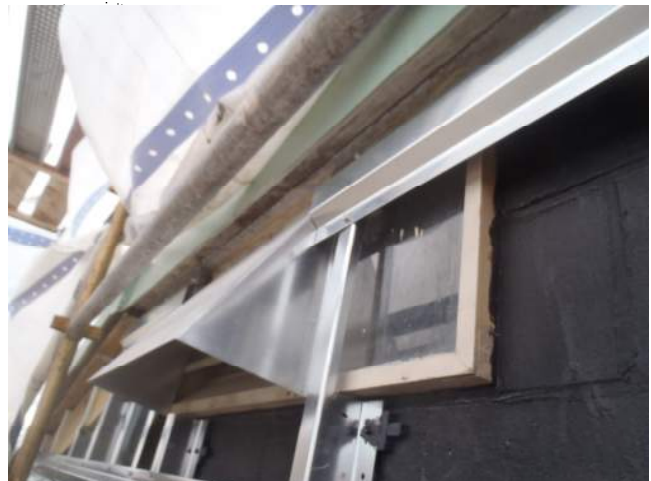
3. The fasteners securing the Z-girts to the CMU wall have had an air/vapor barrier detail coat applied to the fastener heads, see photo below.

4. The metal wall panel installers have installed the Z-girts over the elevator shaft louver, see photo above. The louver needs to be removed and reset per the shop drawings and incorporated with the wall panel system. As of 6/15/16, KISC indicated they would provide framing for the louver.
5. BSE requested that weeps be drilled into the face of the horizontal end lap flashing 16" O.C. to alleviate any water that might collect within the flashing, see photo below.

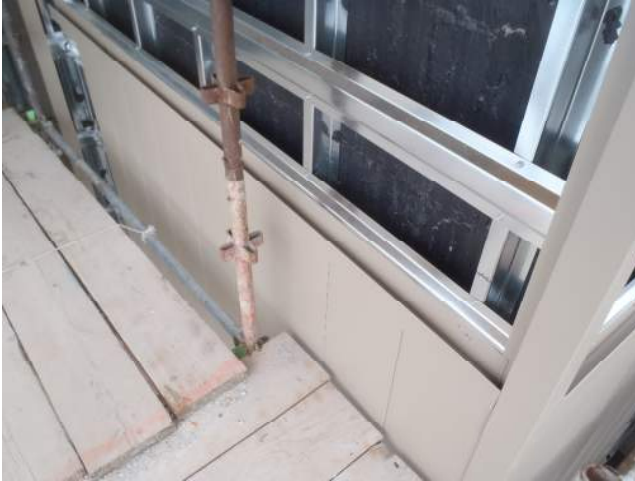
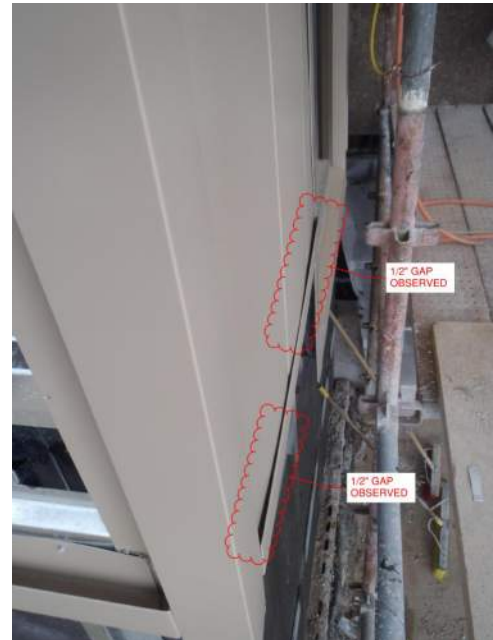
6. At a few locations there is a 1/2" gap between the metal wall panel and horizontal end lap flashing. To prevent an excessive amount of water from getting into the wall system the panel and flashing should be tight to one another. Adjust the flashing as necessary to reduce the gap.
