Field Report #1

No. 3604

Project: Casco Bay PG – Stair/Elevator Tower Restoration
Project #: WO 3604
Date/Time: January 28, 2016, 1:30 p.m.
Observers Josh Martin-McNaughton, Author (BSE), Tim Rich (KISC),

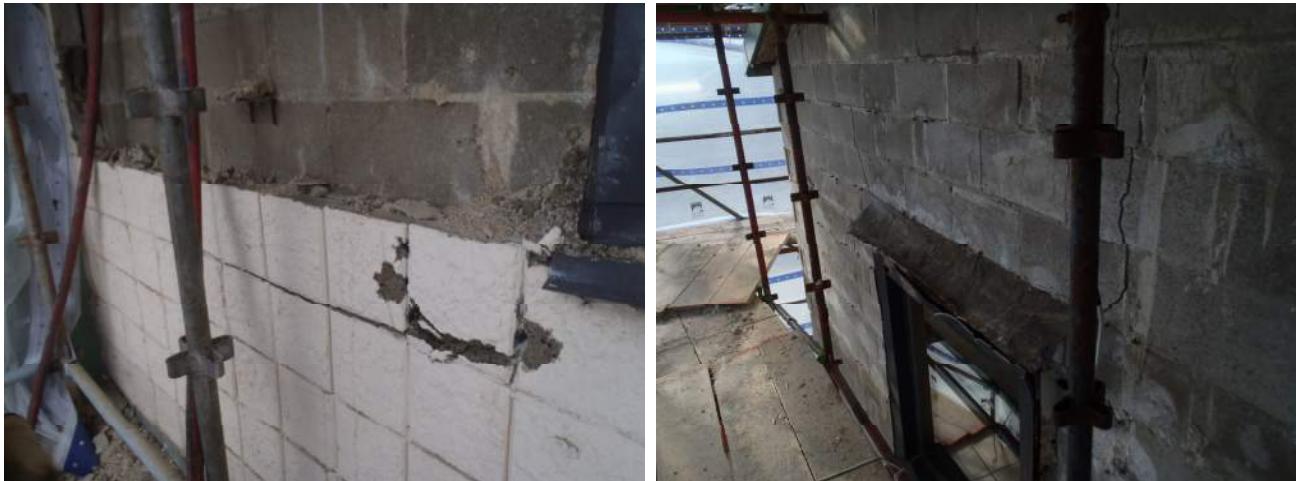
1. KISC has mobilized to the site and installed staging along three sides of the stair tower. Barrier fencing has been installed along the work site perimeter.
2. KISC has begun to remove the split face block façade, see photos below. The split face block was easily removed due to the poor condition of the mortar joints. The removal the façade will continue into next week.

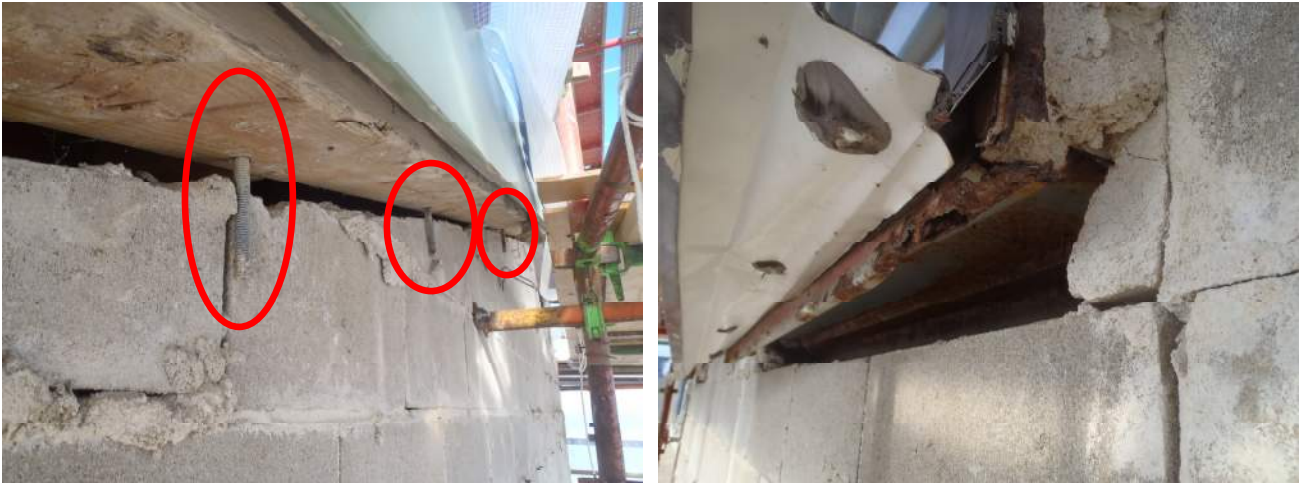
4. Anchor bolts securing the wood roof framing were installed in the cavity between the CMU back up wall and split face block and not anchored into grouted cells as is typical construction practice, see photo below with unsecured anchor bolts circled in red. BSE will

5. The majority of the window metal frames have deteriorated with rust pack causing cracking of the surrounding CMU block, see photo above. The windows, frames and flashing are scheduled to be replaced and the surrounding CMU repaired.

provide KISC with a detail on anchoring the roof framing to the wall. The roof framing appears to be in good condition with no rotted or deteriorated wood sections observed.

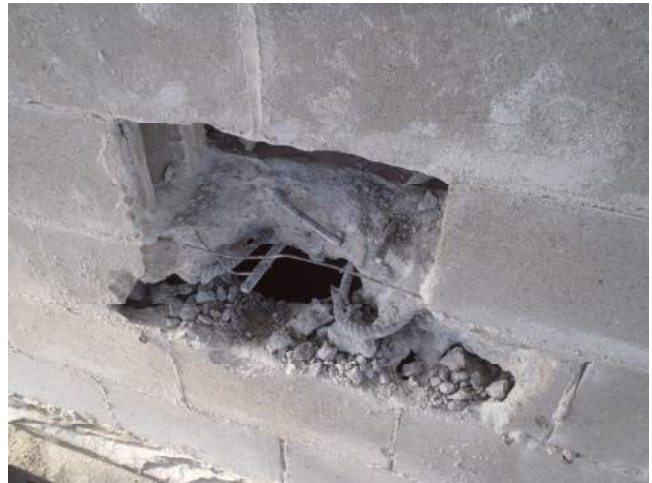
6. BSE requested that KISC remove sections of CMU wall at the 5th level to verify/inspect the condition between the lobby concrete slab and CMU wall, see adjacent photo. It appears that during original construction the CMU wall was notched so slab reinforcement could extend into the wall and the concrete slab placed, with the CMU cell interior used as a pour stop. Looped (bottom) and straight (top) reinforcing bars were observed as shown in the adjacent photo. A bond beam was not observed in the CMU wall as detailed and noted in the original drawings.
