Field Report #2

No. 3604

Project: Casco Bay PG – Stair/Elevator Tower Restoration
Project #: WO 3604
Date/Time: February 3, 2016,9:30 a.m. & February 9, 2016,9:30 a.m.
Observers Adam, Sampson, Author on 2/3/16 (BSE), Tim Rich (KISC),
Joshua Martin-McNaughton, Author on 2/9/16 (BSE)

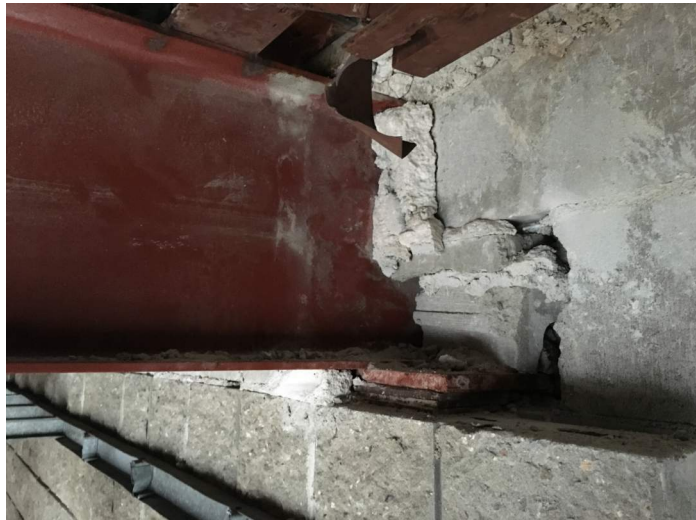
1. KISC has removed the majority of the split face block façade and found the CMU to be in fair condition. The corners at each level exhibited deterioration with open cells and cracks. The corner CMU also do not align up with one another which make it difficult to place vertical reinforcement within the cells. These areas will likely have to be rebuilt. Many of the CMU wall joints will have to be pointed to create a uniform surface for the moisture barrier that is to be applied.
2. The soffit between the tower and the ferry terminal was removed to expose the supporting flat roof structure. KISC removed the split face block at the roof beam (beam supporting the flat roof structure) bearing into the tower wall. The steel beam was found to be bearing on the split face block façade and partially on the CMU wall. (See photo below).

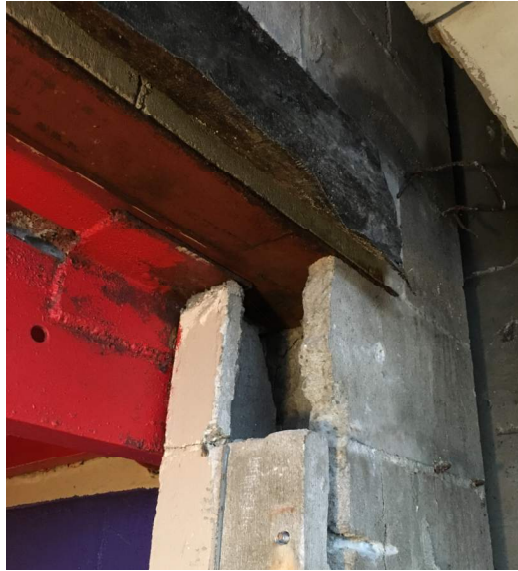
3. BSE's noted that the exposed steel angle door lintels at the grade level are in good condition and do not have to be replaced. All exposed steel should be cleaned, prepped and coated. The existing lintels have a large bearing length (8" to 12") and potentially interfere with the proposed vertical reinforcement. BSE to provide KISC with guidance. (See photo below).

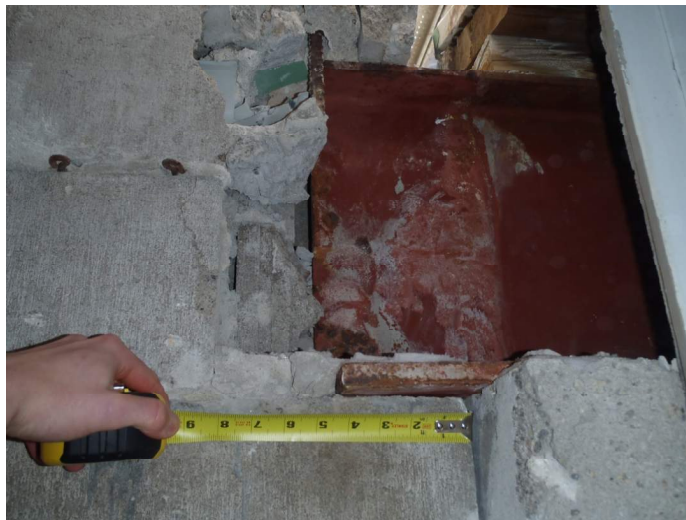
4. KISC removed the split face block facade at the high steel beam picking up the sloped roof members between the tower and ferry terminal. The beam was found to be bearing on the CMU wall approximately 4" +/- and partially on the split face facade. The lower steel beams extending from the HSS column and bearing into the CMU wall are in fair to good condition. Rusted sections need to be cleaned, prepped and coated. (See photo below).

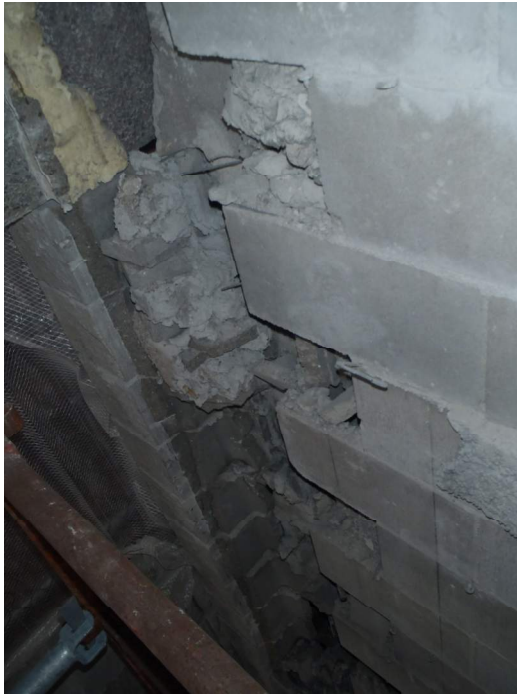
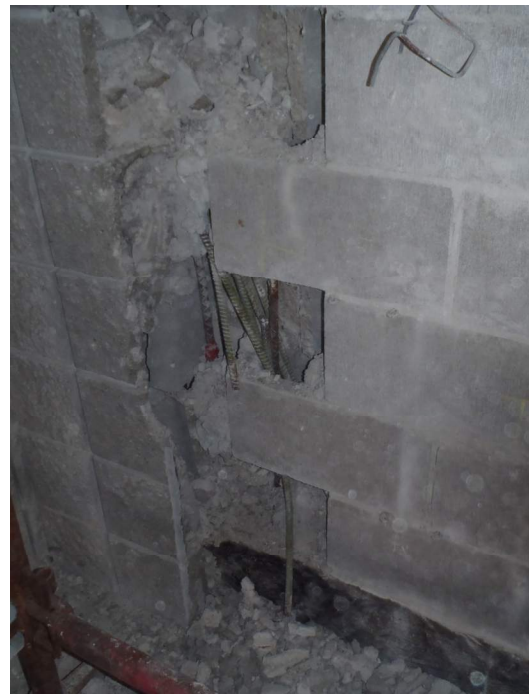
5. KISC has shored the sloped metal roof and the adjacent flat membrane roof due to the unknown steel beam bearing conditions. KISC to expose the bearing conditions for BSE inspection.
6. At the northwest corner of the grade level wall, the corner CMU was chipped away to accommodate the 8" split face block facade during original construction. This corner, which extends from grade to the underside of the sloped roof, will have to be rebuilt. At one section of the corner a bunch of (8) 3 to 4 foot lengths of rebar were observed stuck into open CMU cells. This is representative of the poor quality of the original construction that has been consistent throughout the tower. (See photos below).

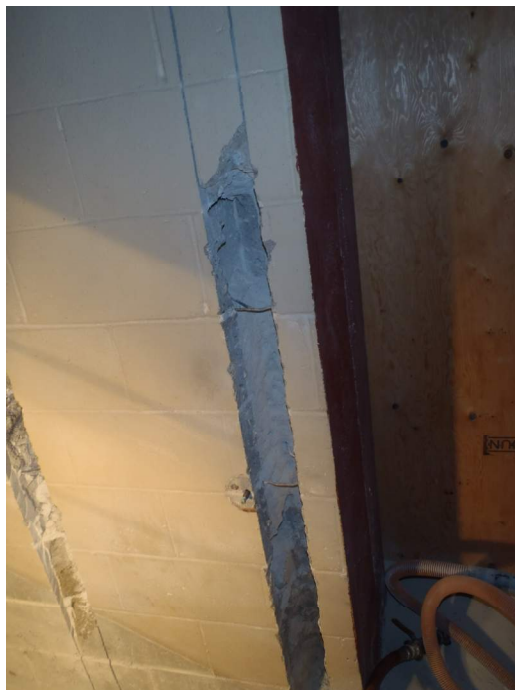
7. KISC has begun to open the face shells of the CMU block to install vertical reinforcement in the stair tower. Of the three areas opened two were fully grouted and one was partially grouted. None of the CMU cells had any vertical reinforcement within them. (See photo below).
