## Field Report #3

No. 3604

**Project:** Casco Bay PG – Stair/Elevator Tower Restoration  
**Project #:** WO 3604  
**Date/Time:** February 25, 2016, 10:45 a.m.  
**Observers** Adam Sampson (BSE), Joshua Martin-McNaughton, Author (BSE)

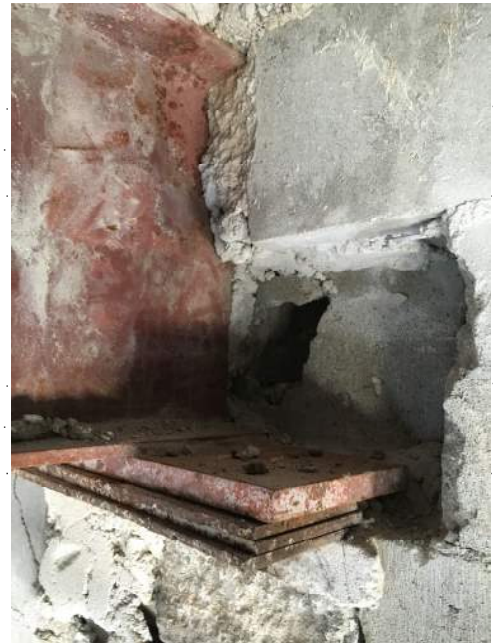
3. The two flat roof W-shape beams that are supposed to be supported by the CMU wall have minimal bearing (less than 2 inches). See adjacent photo. It appears that the demolished split face block provided the support for the beams. KISC has temporarily shored the beams. BSE is looking into options for supporting the beams and may include an HSS column extending down to the existing foundation. The alteration to support the beams will require a change order.

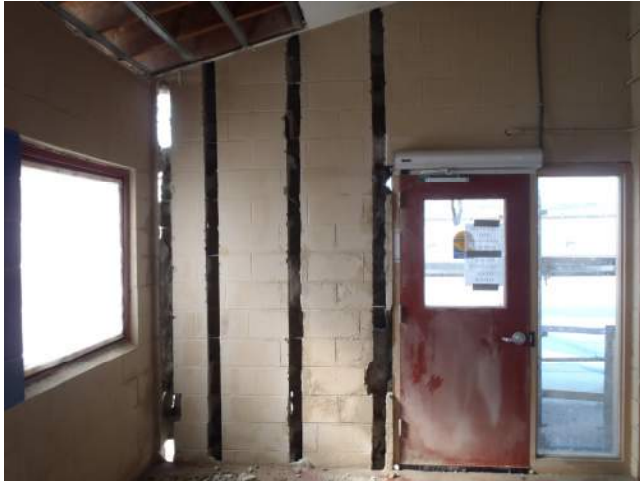
5. KISC has saw cut and removed material from approximately 80% of the vertical cells. See photo below. KISC has begun to install vertical reinforcement within the cells. Spot checks of the rebar laps lengths were performed. If the existing rebar is in good condition and is in the correct location within the cells it is to be reused. Forming and grouting of the vertical cells is anticipated to take place next week.

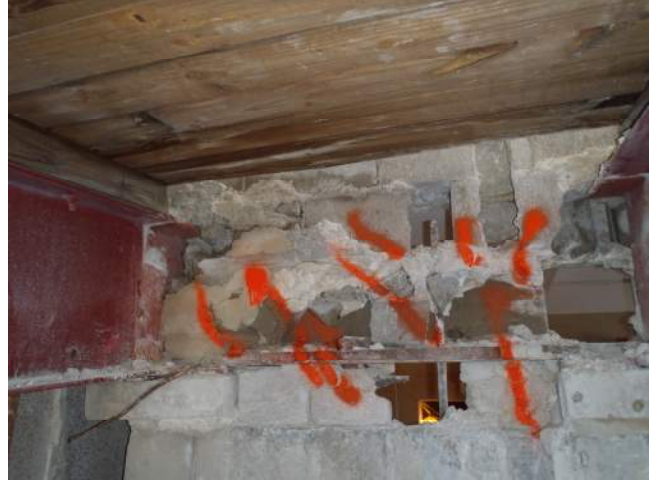
6. Between the sloped roof steel beams an area of CMU wall rebuilding is required. BSE marked the area with orange spray paint. See the photo above.
7. During demolition of the vertical cells the interior face block at a few locations blew out at the interior. KISC will place formwork on the interior when the cells are grouted. See photo below.

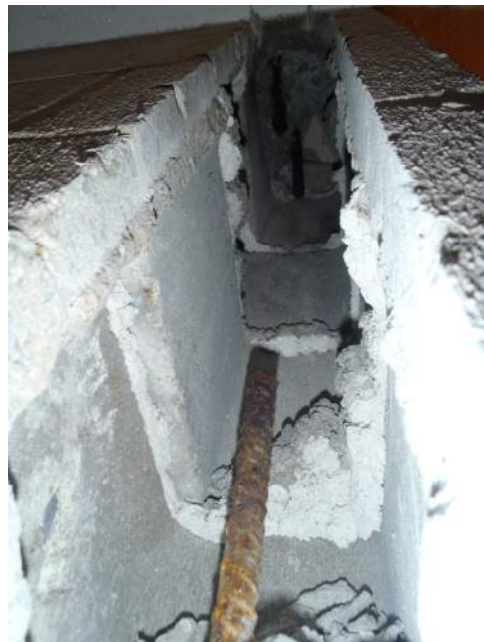
8. KISC has exposed varying cell conditions. Some of the cells are reinforced with and without grout or are partially grouted. At the majority of the reinforced locations adequate laps lengths were not provided during original construction and gaps between the rebar were observed. See photo above. KISC noted that at one location a bunch of 8 foot lengths of rebar were stuck into an ungrouted cell.
