Project: Casco Bay PG – Stair/Elevator Tower Restoration

Project #: WO 3604

Date/Time: March 15, 2016, 11:00 a.m.

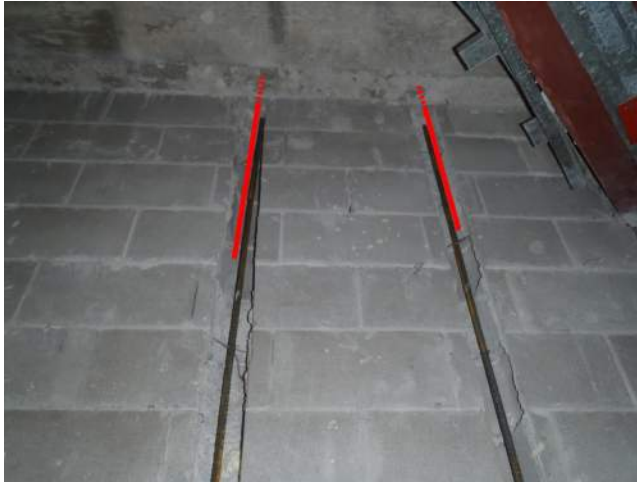
1. At grade level at the underside of level 2 at the exposed slab the vertical reinforcement needs to be epoxied and doweled into the slab, reference Section 7/S8. See photo below.

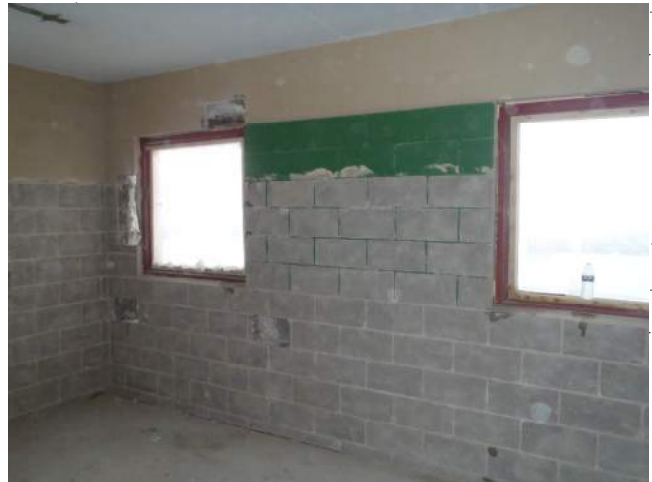
2. KISC has begun to prep the interior walls for painting by grinding down the repair areas and removing the existing paint down to bare CMU block. See photo above.
3. KISC has shored the 5th floor wood framed roof and begun the demolition of the 5th floor west lobby wall. See photo below. KISC will tooth in the CMU masonry at the “T” intersection between the south wall and elevator door wall. The scope of wall rebuild will extend until sound masonry is found. Reinforced bond beams will be installed at all new wall rebuild areas and steel plate banding will lap the bond beams.

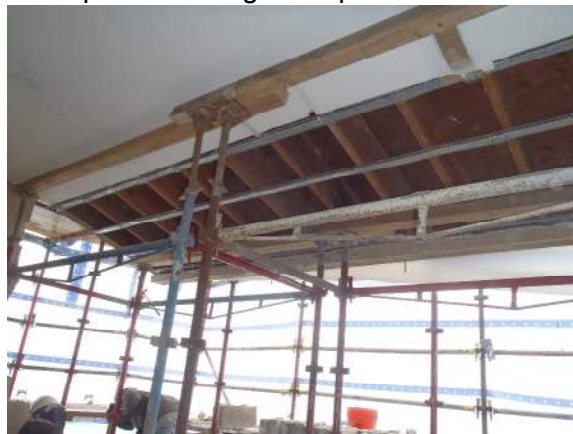
4. Trash and paper bags were observed in some of the CMU cells at the demolished 5th floor lobby wall. No vertical reinforcement was observed at the demolished areas with the exception of short 1 foot long bars that the laborers found in ungrouted cells.

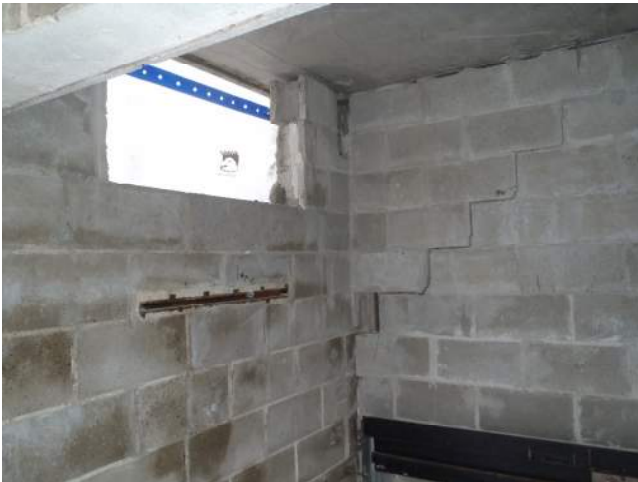
9. The elevator shaft concrete roof slab does not appear to have consistent bearing along the four supporting sides. See photo below. BSE to provide a sketch for bearing and attachment of the roof slab to the CMU walls.

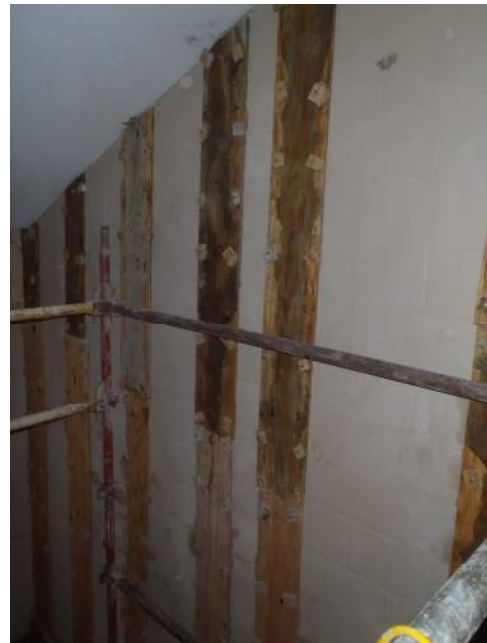
10. KISC is continuing to grout the vertical reinforcement within the stair and lobby interior. See adjacent photo.
11. BSE requested that the sloped roof beams coming in at the second level be grouted solid between the bearing plate and CMU.
12. BSE observed doweling of the vertical reinforcement into the foundation.
