Project: Casco Bay PG – Stair/Elevator Tower Restoration
Project #: WO 3604
Date/Time: April 7, 2016, 1:30 p.m.
Observers Joshua Martin-McNaughton, Author (BSE)

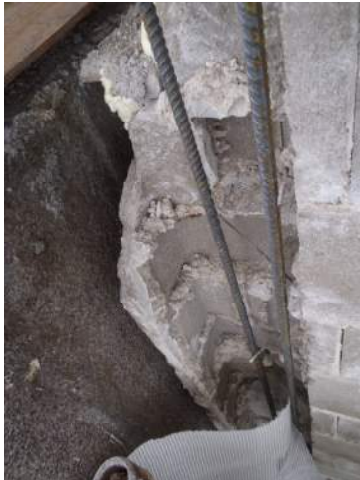
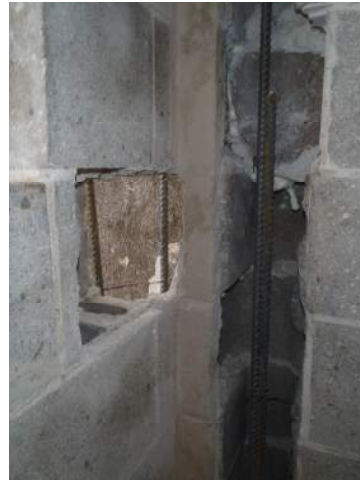
1. KISC has begun to rebuild each of the tower corners, see photos below. Portions of the corners were demolished and will be formed with plywood, vertical reinforcement installed and grouted solid. The corner repairs are expected to be completed by the end of next week. At two locations observed the vertical reinforcement lap length was not adequate. KISC will install reinforcement couplers at these locations to rectify this issue.

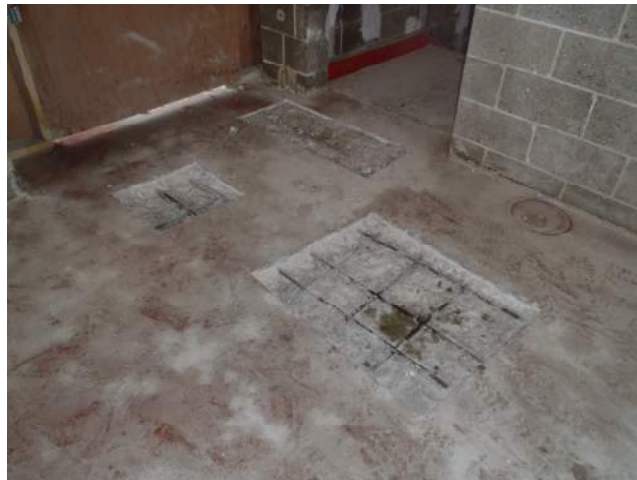
2. KISC has begun demoing the delaminated concrete at the lobby concrete slab at each level, see photo below. The exposed reinforcement has good concrete cover but shows signs of corrosion. KISC is to clean and coat the reinforcement and place the concrete repair material flush with the existing surfaces.

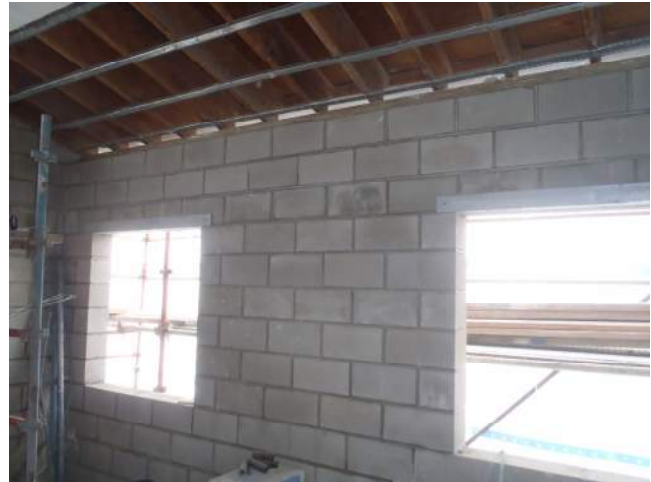
3. KISC has completed the CMU wall rebuild at the 5th level lobby and into the elevator shaft, see adjacent photo. BSE to provide KISC with sketches to secure the wood roof framing to the CMU wall.

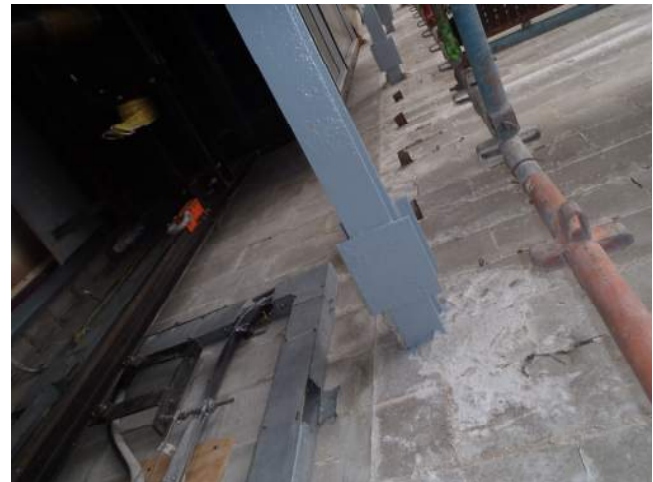
7. The existing steel beams supporting the curtain wall were cleaned of rust/corrosion and painted, see adjacent photo.
