Project: Casco Bay PG – Stair/Elevator Tower Restoration
Project #: WO 3604
Date/Time: April 21, 2016, 1:30 p.m.
Observers Joshua Martin-McNaughton, Author (BSE)

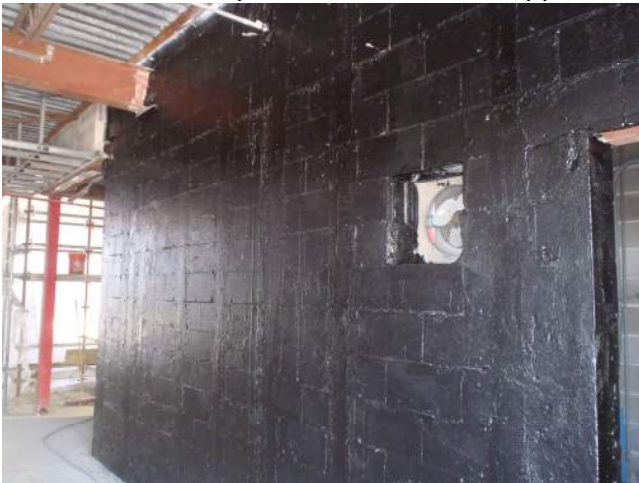
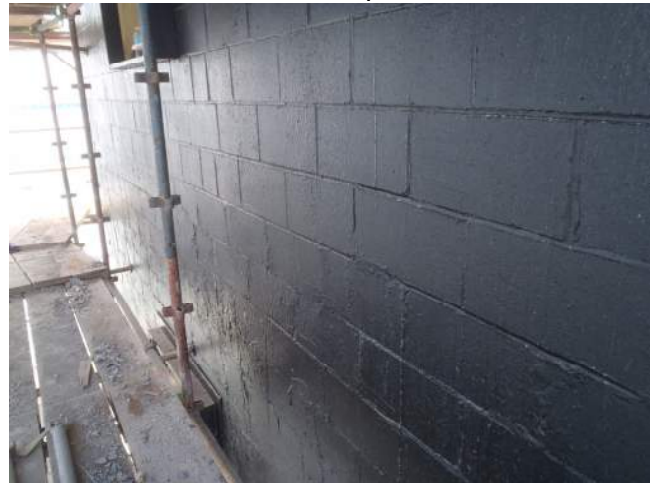
1. All vertical CMU reinforcement and repairs to the stair tower corners have been completed.
2. There is an approximate 2-3 week lead time for the windows to arrive onsite and for installation to begin.
3. The air/vapor barrier has been applied to the exterior CMU walls. See photos below.

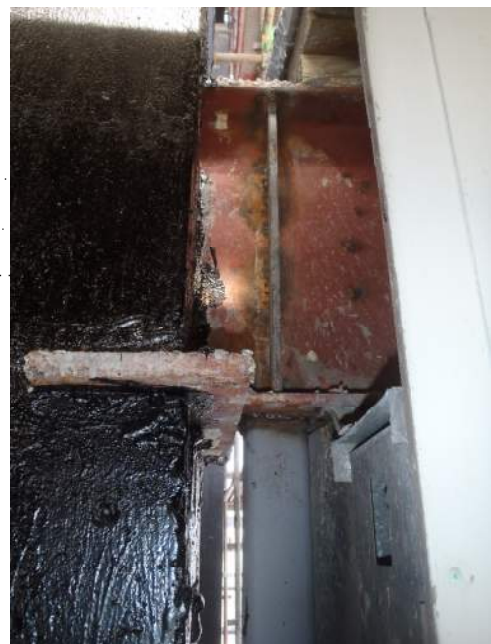
4. Priming and painting of the interior walls has begun.
5. The stiffeners installed at the upper beam supporting the canopy and lower beam supporting the flat roof need to be continuously welded (from Sketch SK2). See adjacent photo. The work affected by the welding of the new stiffeners and HSS post needs to be primed and painted. Remove weld slag prior to priming.

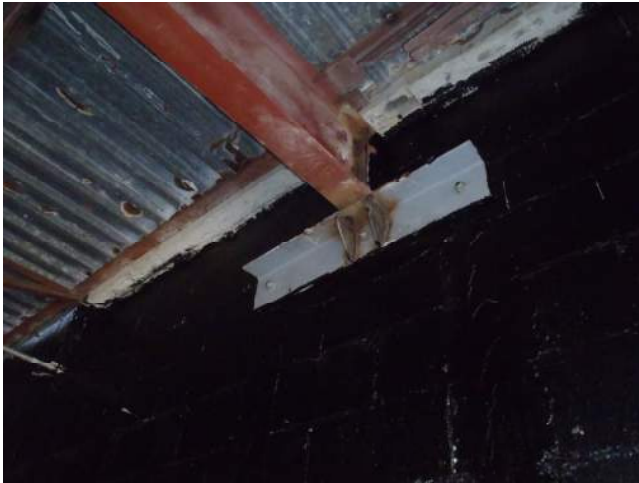
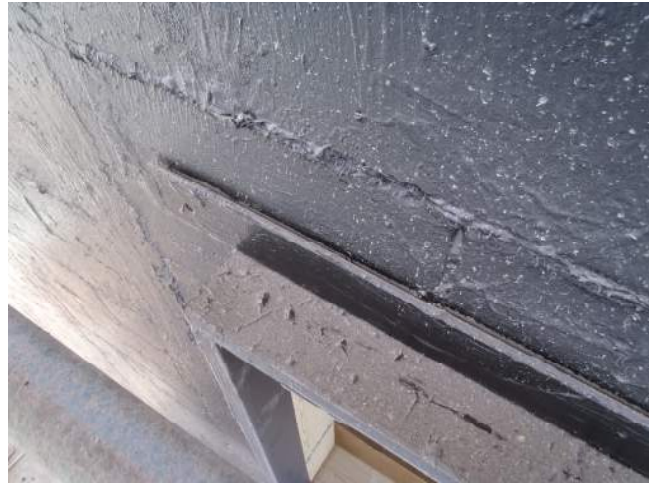
6. The welded stiffeners at the angle installed to support the flat roof beam need to be primed and painted (from Sketch SK3). Remove weld slag prior to priming. See photo below.

7. BSE asked that the top of the steel angle lintels above the window openings be sealed with sealant to prevent potential water intrusion if water to run down the sides of the exterior wall. See photo above. The sealant must be compatible with the air/vapor barrier.

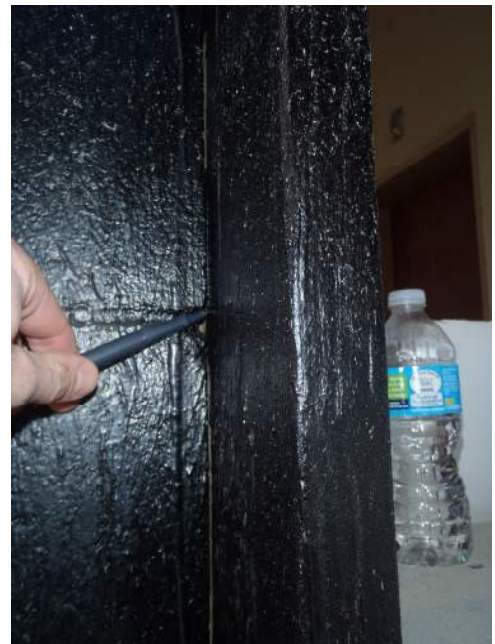
8. The window and curtain wall opening have been framed with treated wood nailers. As the CMU openings are irregular, the air/vapor barrier cannot bridge the small gap (<math><1/8''</math>) between the CMU opening and wood nailers and an open joint has formed. See adjacent photo. Sealant and backer rod compatible with the air/vapor barrier must be used to seal this joint at all four sides of the opening per manufacturer recommendations.
