Project: Casco Bay PG – Stair/Elevator Tower Restoration
Project #: WO 3604
Date/Time: April 27, 2016, 9:00 a.m.
Observers Joshua Martin-McNaughton, Author (BSE)

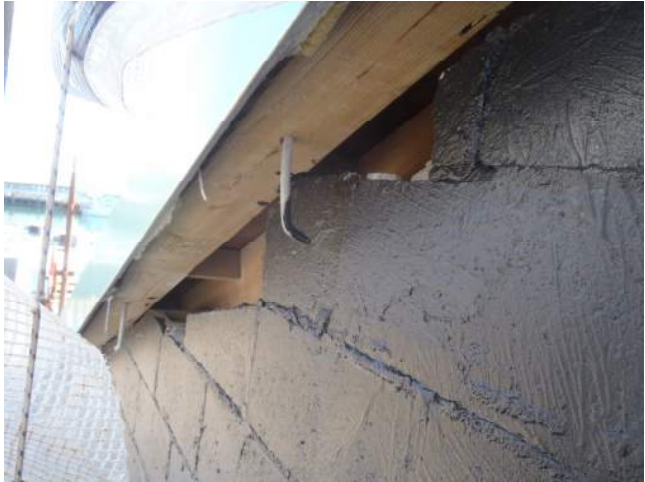
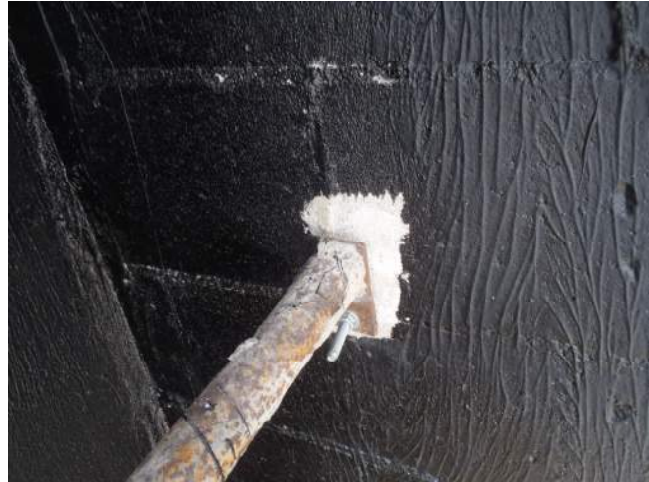
1. CMU masonry will need to be infilled along the north wall to provide a substrate for the metal wall panel to attach too. See photo below. BSE to provide a sketch for the attachment of the roof framing to the CMU walls.

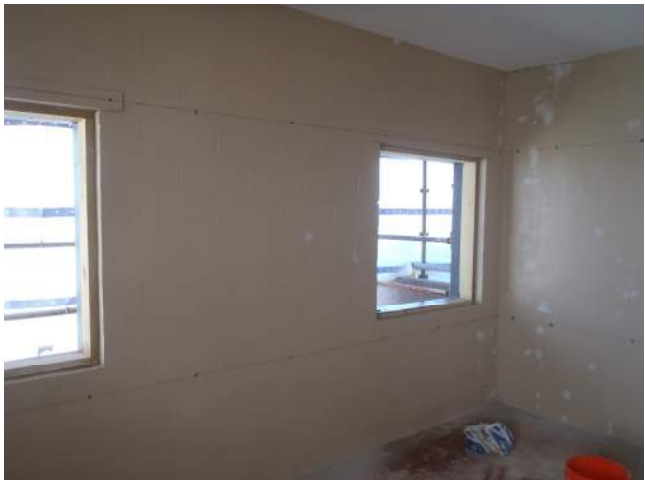
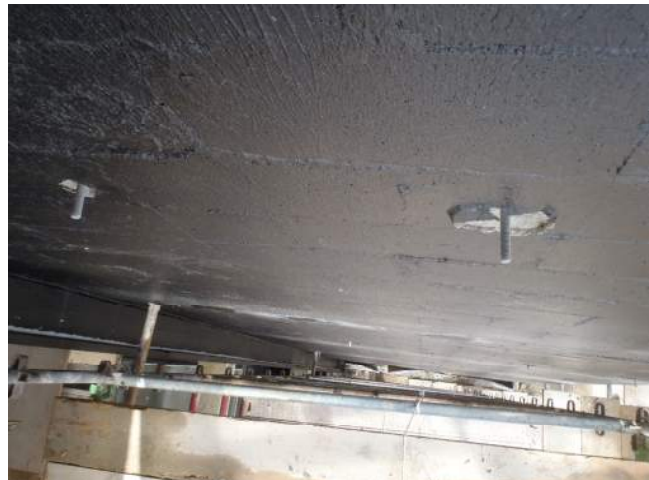
2. Once the staging attachments/anchors are removed from the exterior wall the CMU will be coated with air/vapor barrier. See photo above.
3. KISC has begun to drill the bolt holes through the CMU for the steel bands. See photo below.

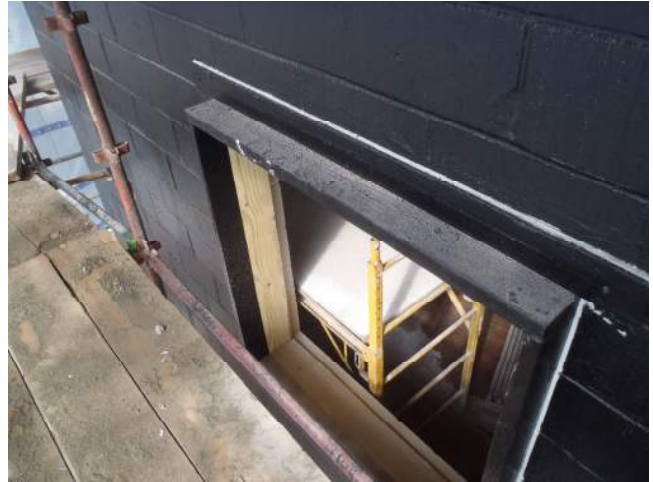
4. Where the steel bands bolt holes have been drilled through the CMU wall, a few blow outs of the CMU occurred. KISC has and will continue to repair the blowouts with repair grout and recoat with air/vapor barrier. See photo above.
5. The window perimeters and steel angle lintels were in the process of being sealed. BSE asked that the sides of the steel angle lintels be sealed also. See adjacent photo.
6. Where the steel bands are aligned behind precast garage spandrels, KISC indicated that they still would be able to install the steel bands and nuts.
7. Interior painting of the CMU walls and stair framing is ongoing.
