**RE:** 934 Ocean Avenue – Dragon Products Company

1. Date / Time: 10-4-06	
2. Client / Project <b>Dragon Products Company - Ocean Avenue Batch Plant - Roof Repairs</b>	
3. Project Number: 343-020	
4. <b>Who was contacted at the site:</b> (name and firm) Emile- Keeley Construction, Kermit - Dragon Products

Portland Batch Plant Roof Collapse – Stabilization of Existing Structure

Project: DRAGON - PORTLAND BATCH PLANT ROOF

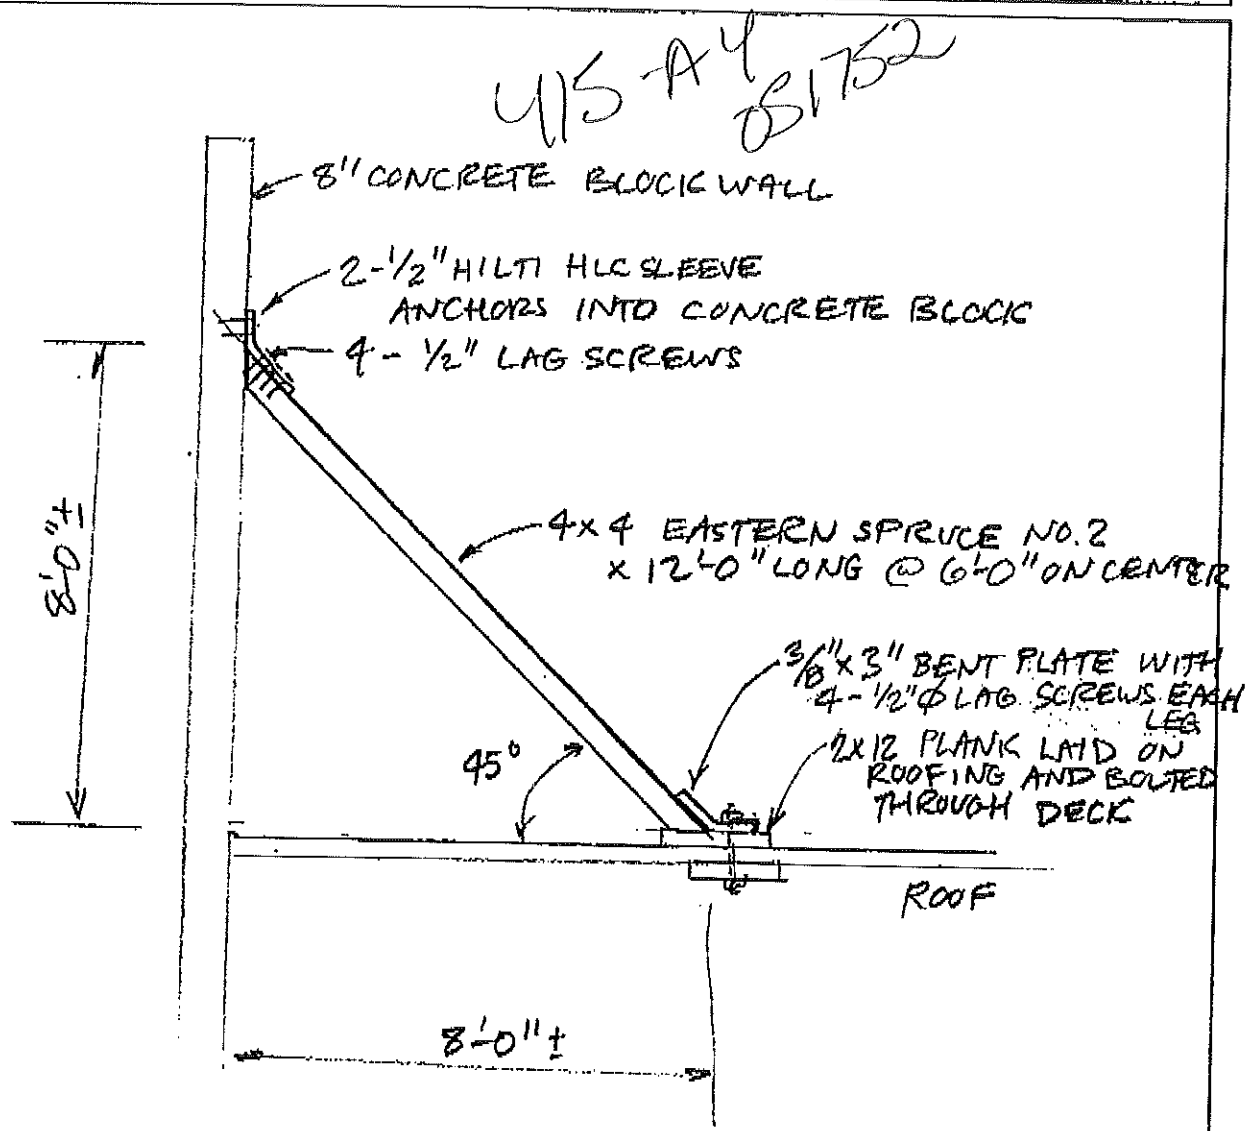
Subject: TEMPORARY WALL BRACING DETAIL

## BRACING OF EXISTING MASONRY WALL DURING ROOF RECONSTRUCTION

2. Stabilization of the masonry wall on the garage side of the structure.

Our recommendation was to install a standard construction pipe scaffolding along this wall, sitting on the lower roof of the garage, and bolt the wall to the scaffolding as a measure to stabilize it against wind or other lateral loading. We didn't determine the exact details for attachment but a through bolt and plate washer installed through the wall at each frame of the scaffolding, near the top, should be adequate. The scaffolding legs can sit on two rows of wood planks laid over the roof. The scaffolding will also allow access for removal of debris and for working on the edge of the new roof when that is installed.

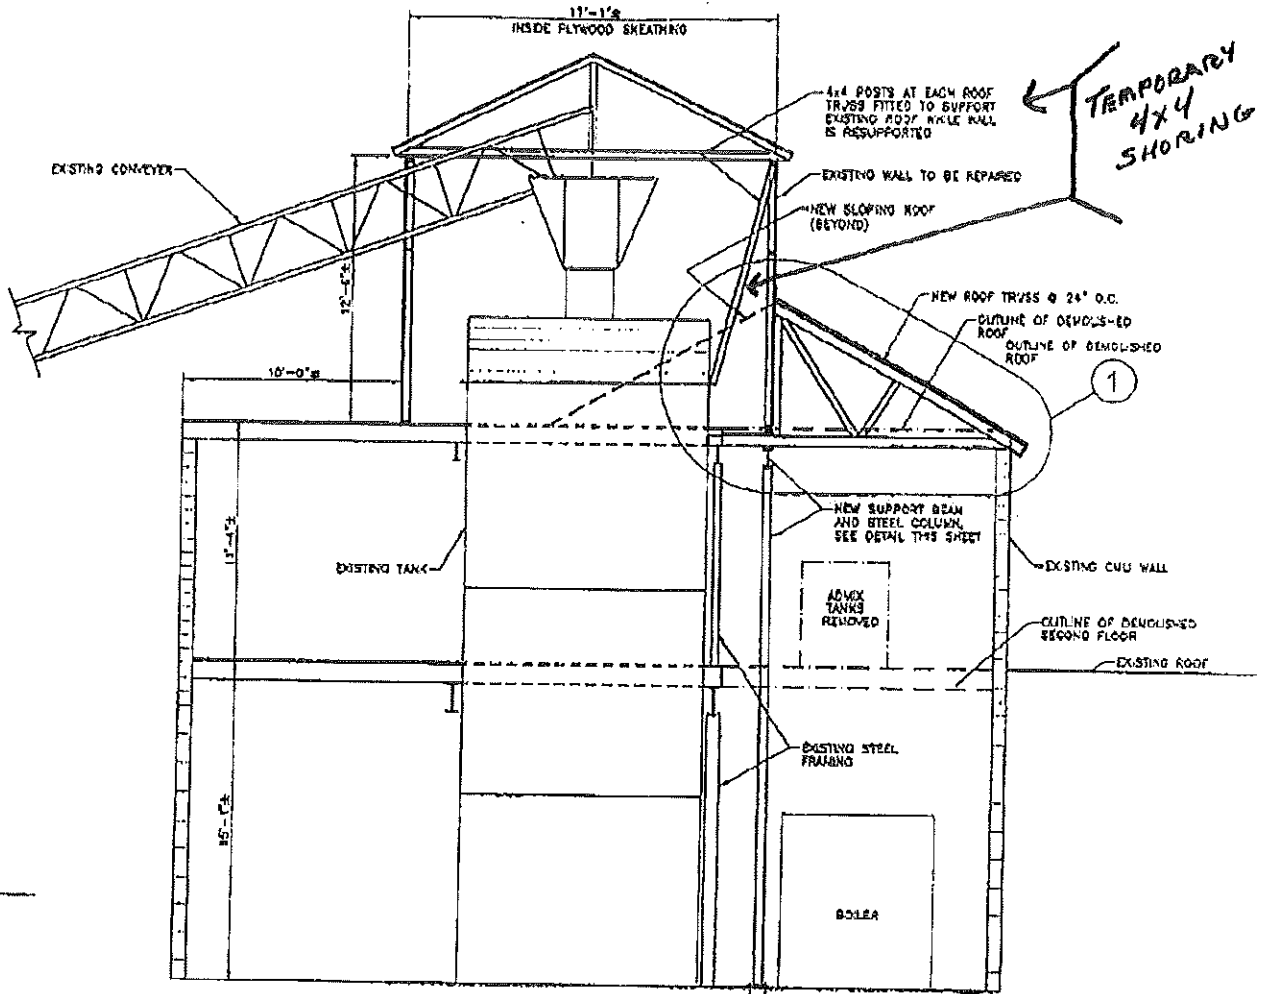
TEMPORARY  
 4x4  
 SHORING

I am enclosing a preliminary Kleinschmidt drawing of final roof repairs to our building that shows the temporary 4x4 posts from the cupola wall header to a steel flange on the steel aggregate bins of the batch plant. The 4x4s will be installed, as per Kleinschmidt's recommendation, at each roof truss to the steel flange on the aggregate bins, where a bracket will be welded to encompass each 4x4. This shoring will be left in place through clean up and final repairs to the building that is to be approved by you at a later date.

We recommend installation of 4x4 wood posts from the batch plant top edge member up to the underside of the top plate of the wall. This will support the weight of the wall and roof, and if any snow loading occurs should prevent further collapse. The wooden wall will be resupported later, but will be able to hang temporarily from the top plate.
