CITY OF PORTLAND BUILDING PERMIT

Located at
9 ST LAWRENCE ST

PERMIT ID: 2012-65574

has permission to **Complete demo of existing structure on property**
provided that the person or persons, firm or corporation accepting this permit shall comply with all of the provisions of the Statutes of Maine and of the Ordinances of the City of Portland regulating the construction, maintenance and use of the buildings and structures, and of the application on file in the department.

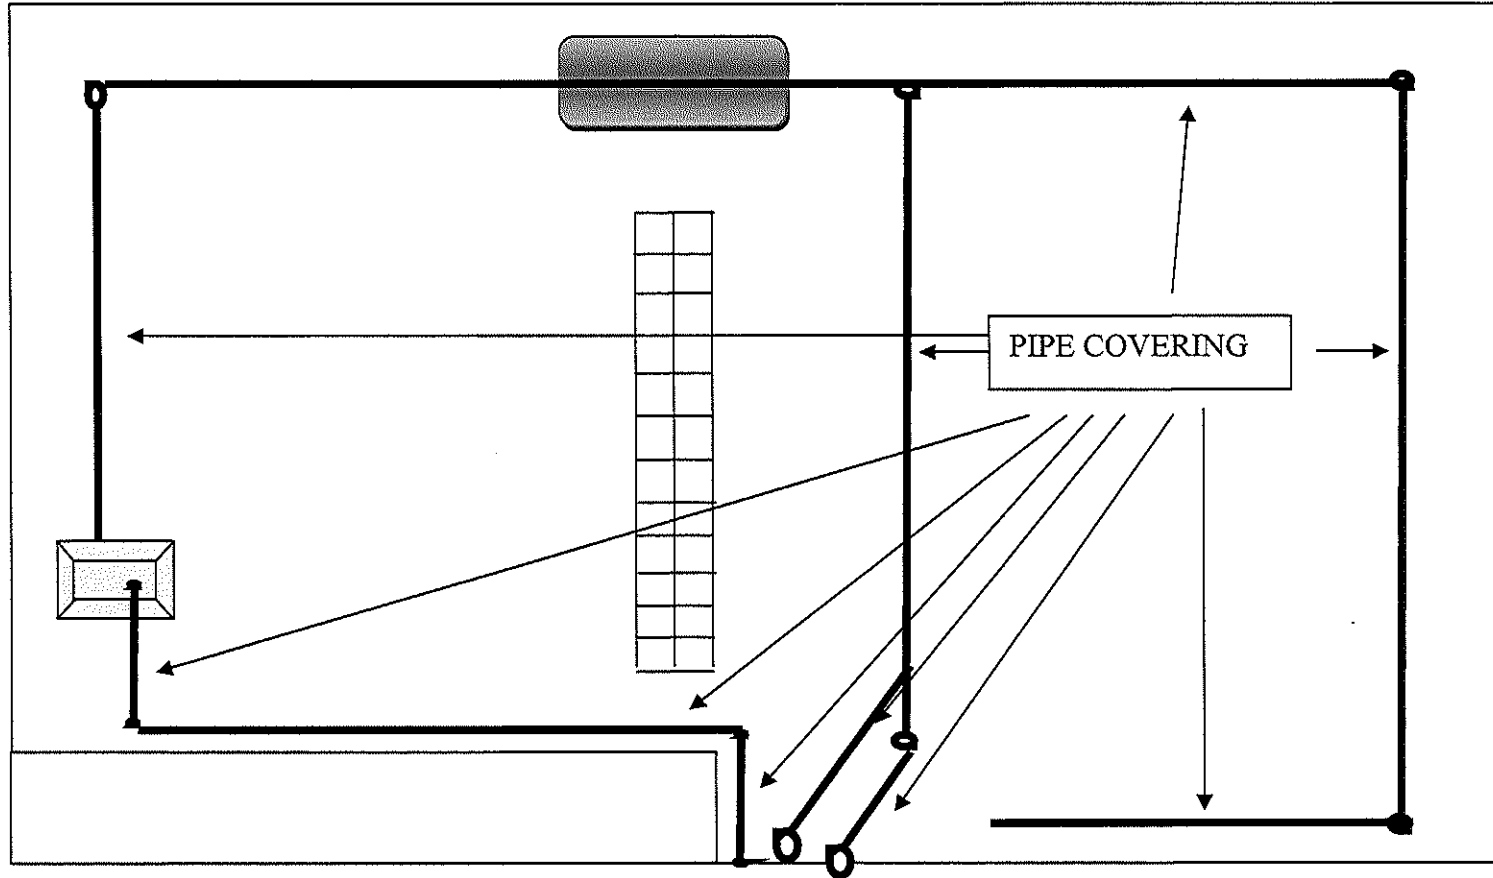
9 ST. LAWRENCE STREET – PORTLAND (#12 - 0754)

The only material found in the rear building to be **POSITIVE FOR ASBESTOS** was the pipe covering in the basement.. All of the other material sampled in the rear building was found to be **NEGATIVE FOR ASBESTOS**. It is my recommendation that the pipe covering be removed using the wrap-and-cut technique.

REAR BUILDING:

BASEMENT

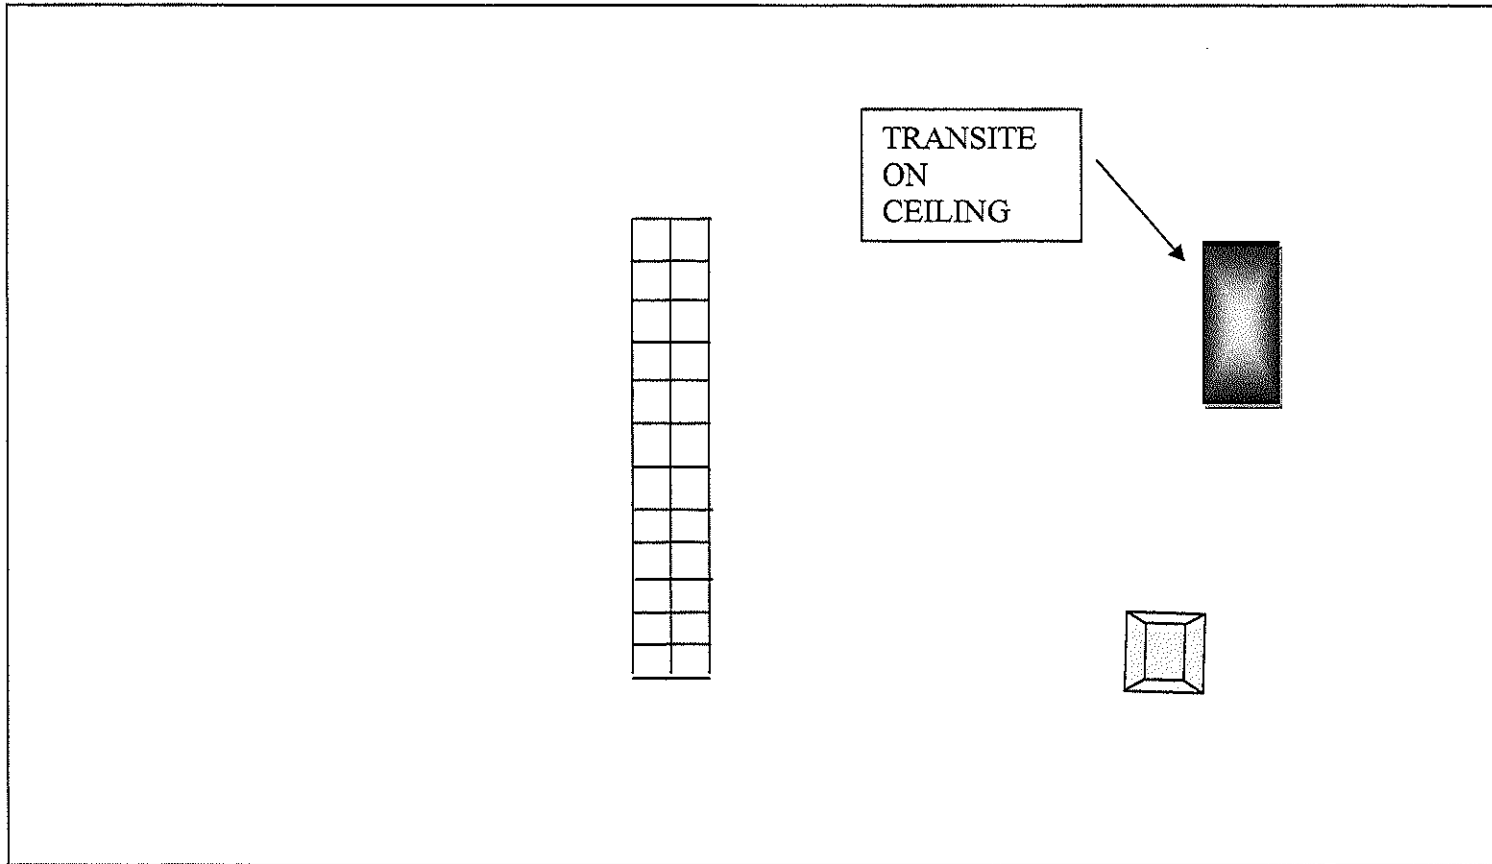
9 ST. LAWRENCE STREET – PORTLAND (#12 - 0754)

The material in the front building that was found to be **POSITIVE FOR ASBESTOS** was the cementitious board (transite) on the ceiling in the basement. The same material was found on the third floor in room #1 on the wall covering what looks like a chimney. The remainder of the materials sampled in the building was found to be **NEGATIVE FOR ASBESTOS**.

FRONT BUILDING:

BASEMENT

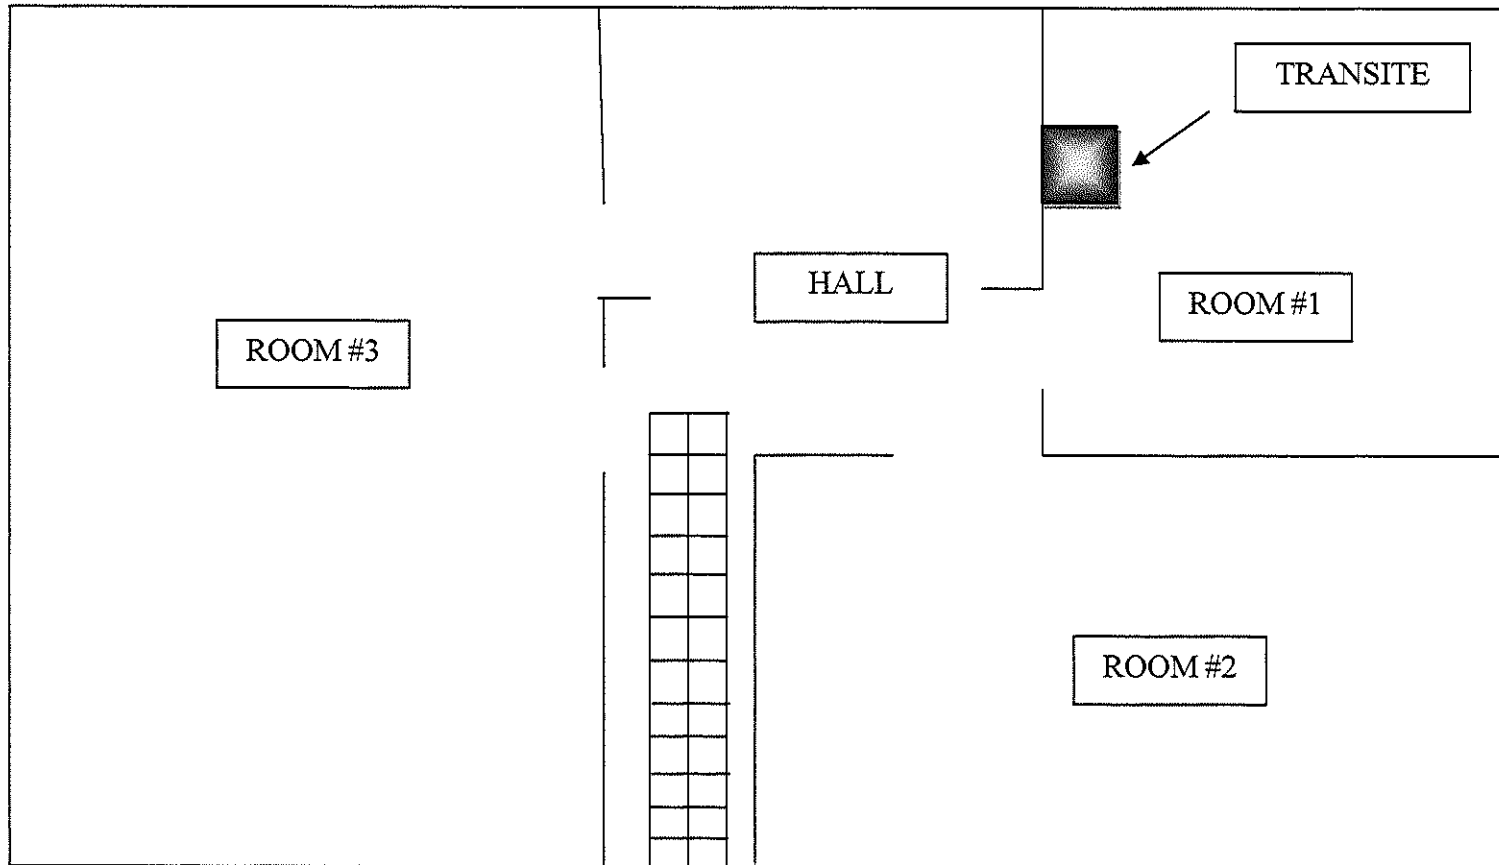
9 ST. LAWRENCE STREET – PORTLAND (#12 - 0754)

FRONT BUILDING:

THIRD FLOOR
