**City of Portland, Maine - Building or Use Permit Application**  
389 Congress Street, 04101 Tel: (207) 874-8703, Fax: (207) 874-8716

Past Use: Multi Use / Commercial; 1st floor, offices and 2nd floor, residential.	Proposed Use: Multi Use / Repair water damage and rot.	Permit Fee: \$184.00	Cost of Work: \$22,200.00	CEO District: 3
Proposed Project Description: Repair water damage and rot.		FIRE DEPT: <input checked="" type="checkbox"/> Approved <input type="checkbox"/> Denied	INSPECTION: Use Group: R/B Type: 5B 10/31/02	
		Signature: <i>[Signature]</i>	Signature: <i>[Signature]</i>	
PEDESTRIAN ACTIVITIES DISTRICT (P.A.D.)				
Action: <input type="checkbox"/> Approved <input type="checkbox"/> Approved w/Conditions <input type="checkbox"/> Denied				
Signature: _____ Date: _____

## **Summary of Findings for 14 Welch St., October 25<sup>th</sup>, 2002.**

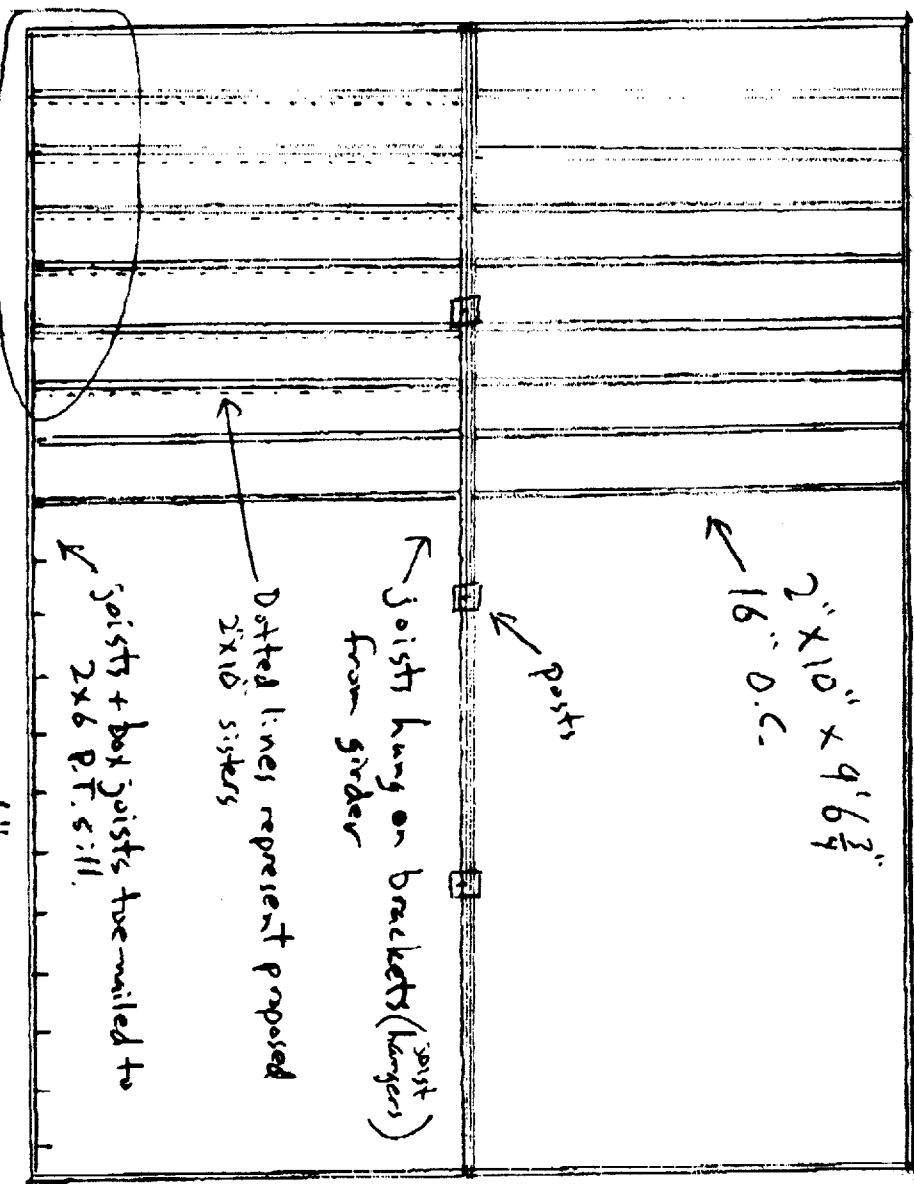
I have made notes on it to indicate the  
amount of rot found in the southeast corner.

approximate 2' x 8'  
area of rot  
(P.T. sill  
is still sound) →

- Box Rim joists to be replaced to beyond rot sign
- Regular joists to be treated with fungicide and fully sizered, hung off the girder with double-wide brackets
- Subfloor to be replaced in the rot area

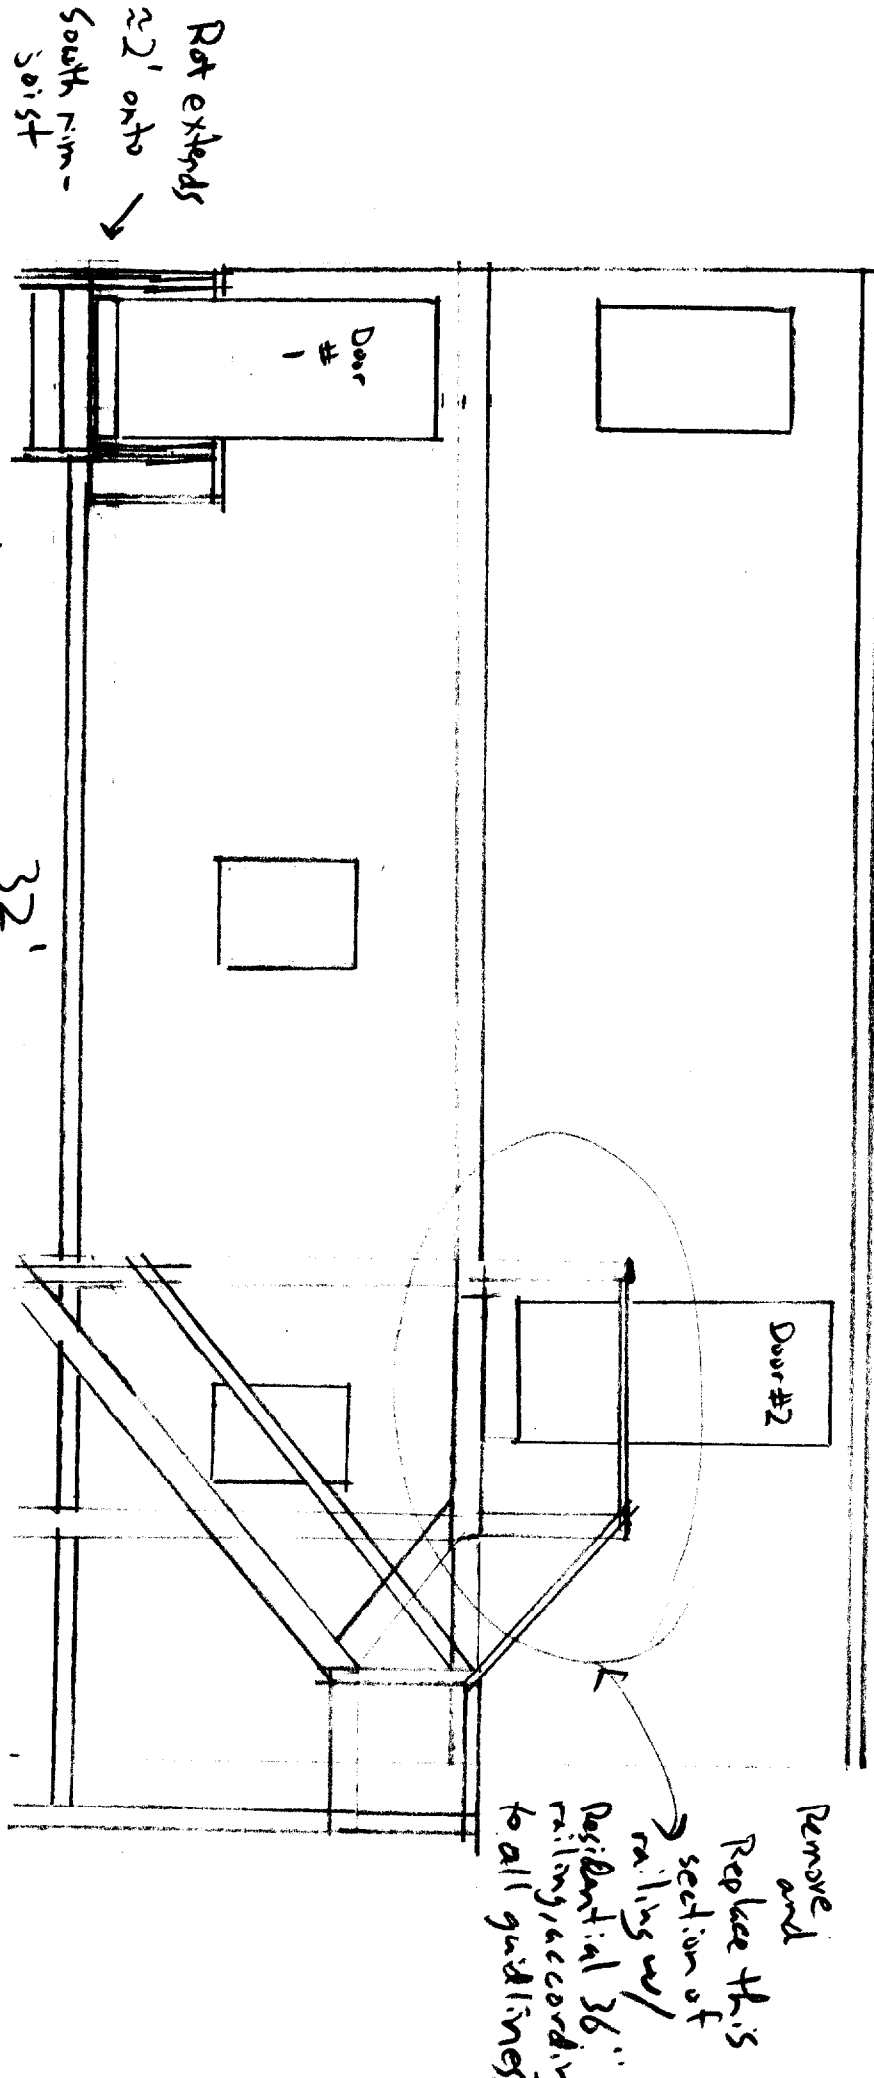
# 14 Welch St. East Wall Elevation

- Highlighted areas show expected areas of rot

**Door #1:** The first floor east wall damage, as noted in the previous repair estimate, appears to extend approximately three feet in each direction from the door opening. Damaged elements include doorjamb trim and threshold, top-flooring, sub-flooring, and joists (including east box joist and south rim joist). The bottom plates, studs and exterior sheathing at the east and south exterior walls are also damaged. (It is presumed that the exterior walls are filled with fiberglass insulation that has been wicking water into the walls. However, poor siding condition is also a likely contributing factor to the sheathing damage.)

**Door #2:** The second floor east wall entrance shows signs of water damage very similar to those of the first floor entrance. Preliminary exploration reveals a two-foot section of rot immediately beneath the door. This rot has obviously damaged the sub-floor. It also extends to both the second floor box joist and the top plate of the first floor exterior wall. Inspection of the first floor box joist, via the basement, shows severe rot in a ten foot section directly beneath the second floor entrance. It is probable that this damage was caused by water running down the inside of the wall from the second floor doorway. It is likely that there is also damage to the first floor studs, bottom plate and sheathing, along the path of the descending water.

**Door #3:** The first floor west wall entrance shows fewer signs of damage than the other two entrances. The subfloor is still mostly intact. However, six feet of box joist beneath the doorway is heavily damaged as viewed from the basement. It is likely that the exterior sheathing and bottom plate are also rotten.

Procedure for Repair: Detach decks. Remove Doors/jamb. Remove siding + sheathing. Brace walls, lifting slightly. Support joists from inside of building with well secured beams + posts. Remove rotted sections of rim joist. Replace. Remove rotted subfloor + bottom plate. Replace. Remove rotted studs. Replace. Replace sheathing. Reside (w/ Building wrap, Flashing, Red cedar, etc.) Reattach Decks. Replace disturbed section of railing so as to meet codes.

Note: Door #3 is similar in layout to Door #1. We will match procedure.
