**Benjamin Wallace - Re: FW: 2211 Congress St - Unum HO1 - permit 2013-00458**

**From:** Benjamin Wallace [<mailto:wallaceb@portlandmaine.gov>]  
**Sent:** Thursday, April 25, 2013 11:01 AM  
**To:** Brian Curley  
**Cc:** Jeanie Bourke  
**Subject:** 2211 Congress St - Unum HO1 - permit 2013-00458

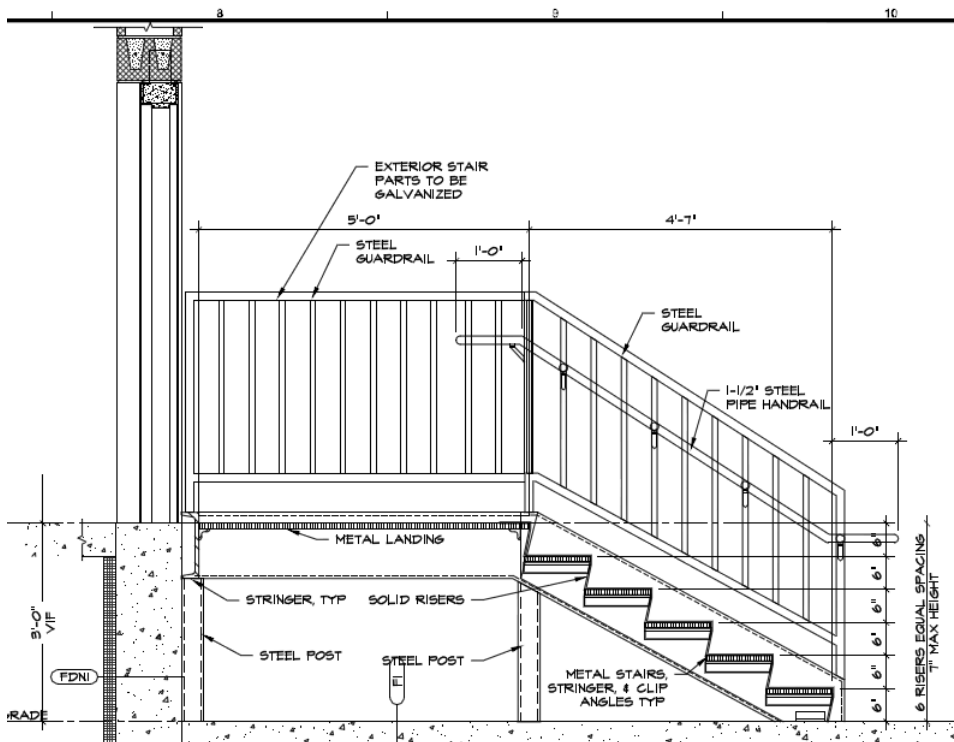
ITEM 1 -The extensions have been added see diagram below.

- Sheet A-504, detail 13 shows a handrail arrangement that doesn't comply with NFPA 101:7.2.2.4.4.10.
  - The bottom of the handrail is still not correct. Please make the required correction(s) to sheet A-504.

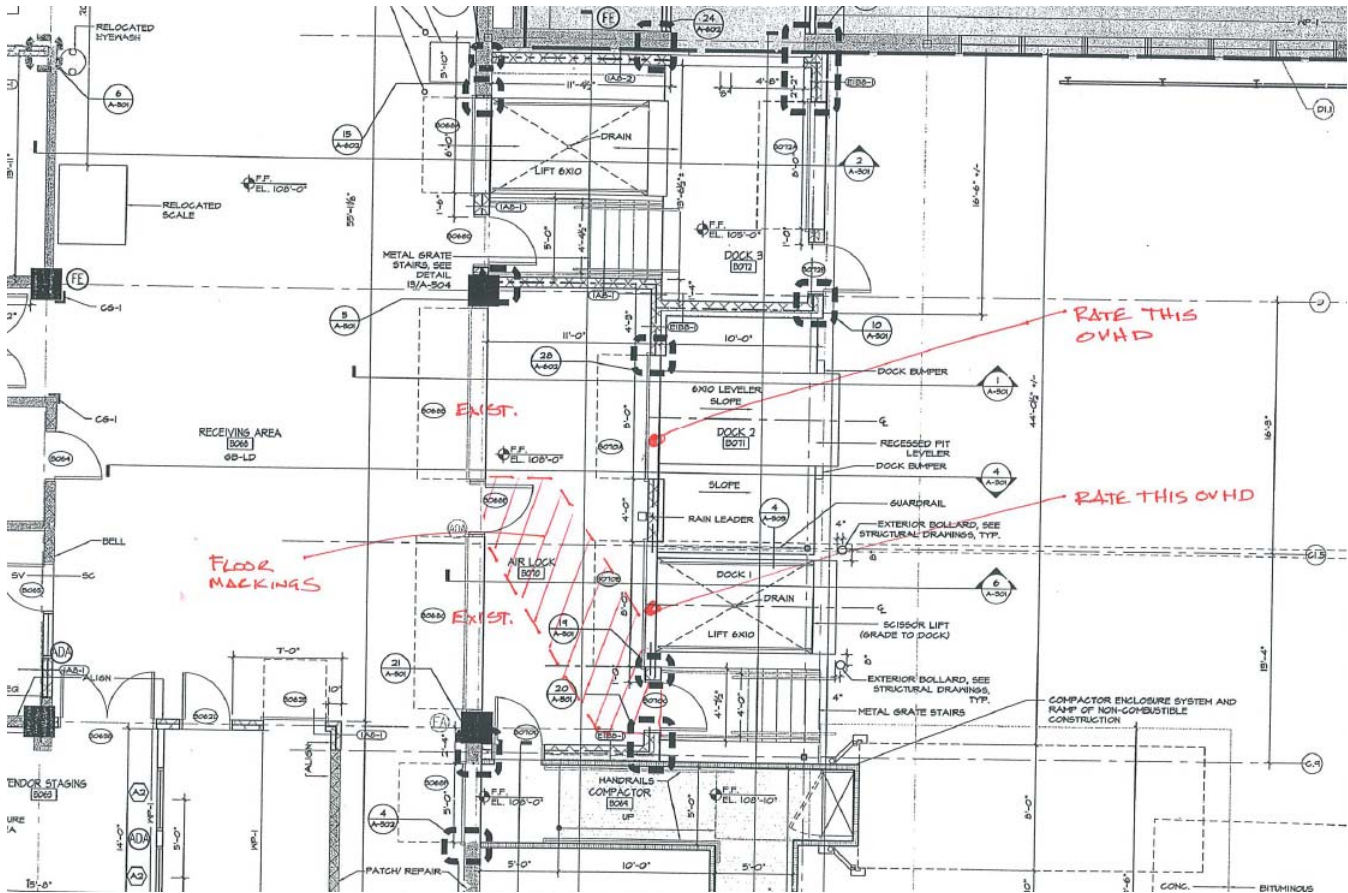
- The door schedule does not indicate a fire resistance rating for B068C. The wall it penetrates is indicated as a 1-hour assembly per sheet A-001. The fire resistance rating of that door assembly must comply with NFPA 101:8.3.4 (minimum 45-minutes and self- or automatic-closing).

ITEM 3 - We would like consideration for rating the exterior OVHD doors (B070A and B070B ) to the Air Lock B070, Posting the described signage and stripping the floor(discussed in item 6). Door B068C is an existing Overhead Door. Below is diagram. **Ok.**
