**Fwd: PHA Riverton Head Start - Interior Exit Stair (URGENT)**

Attached are drawings for review that indicate the removal of the exterior stair and show construction of a new 1-hour fire barrier at the existing second floor corridor and east stairwell. This is for the second means of egress from the 2nd floor Head Start classroom.

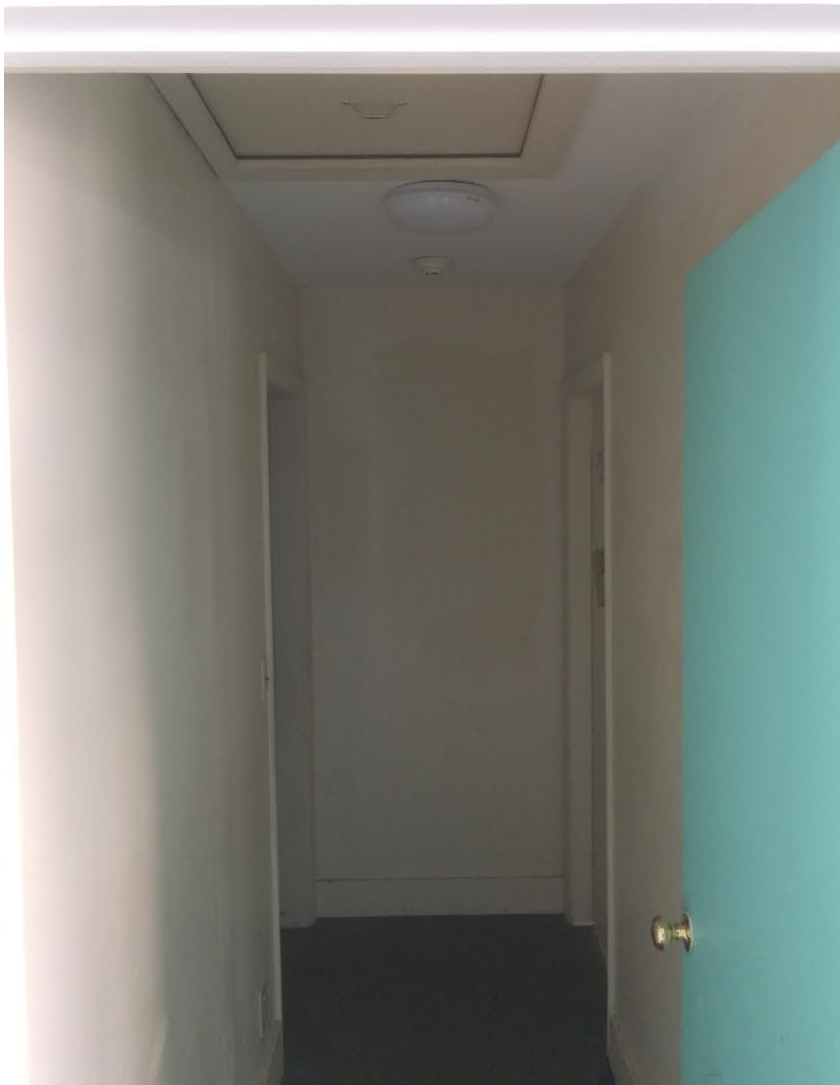
Can we just add a layer of 5/8" Type X drywall to the underside of the existing hard ceiling in the corridor and East stair or will you require us to protect/encase the secondary wood support members that are in the attic? The attic is wood framed and filled with blown-in insulation. Getting drywall into that space would be difficult as there is only a small ceiling hatch. The hatch can be replaced with a fire-rated unit. Please see attached photos.

***2nd floor corridor with attic access hatch in ceiling***

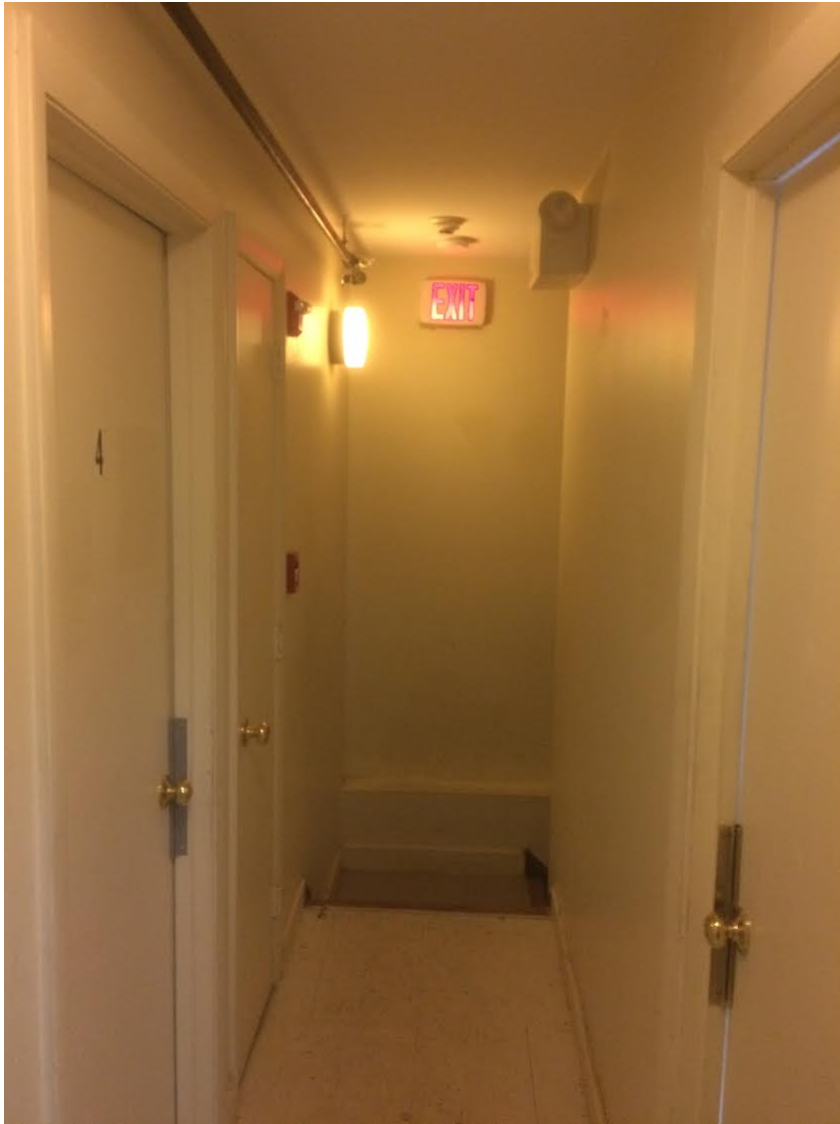
***2nd floor corridor leading to East stairwell***

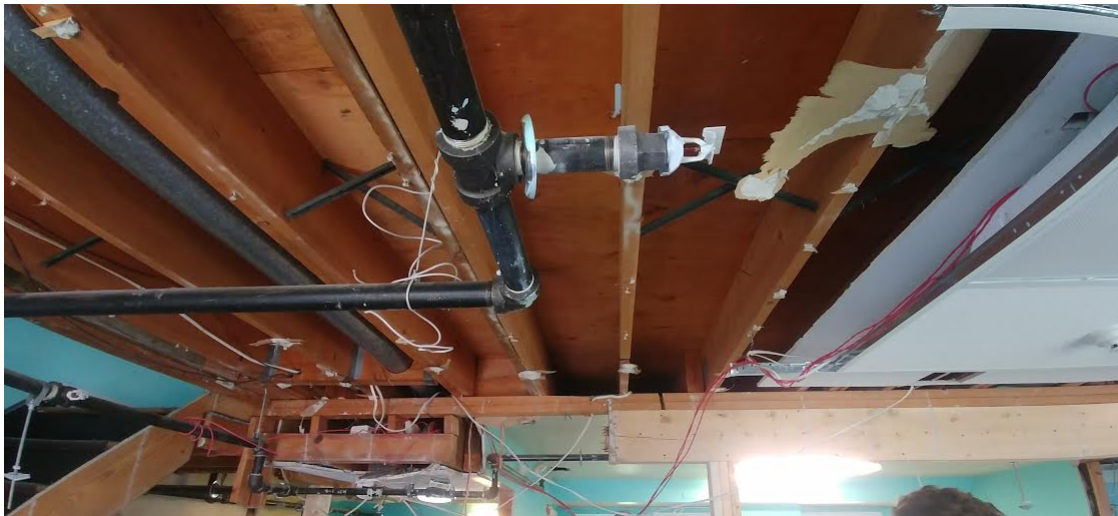
**2nd Floor supports, looking up from 1st Floor level**

We can specify encasement of the wood floor joists below the exit corridor with a 1-hr drywall assembly as well to provide protection.
