BURNHAM AND MORRILL RETAINING WALL REPLACEMENT
1 BEANPOT CIRCLE, PORTLAND, ME

September 6, 2018
18-0955 S

Explorations and Preliminary Geotechnical Services

Existing Sinkhole Investigation
B & M Baked Beans Facility
1 Beanpot Circle
Portland, Maine

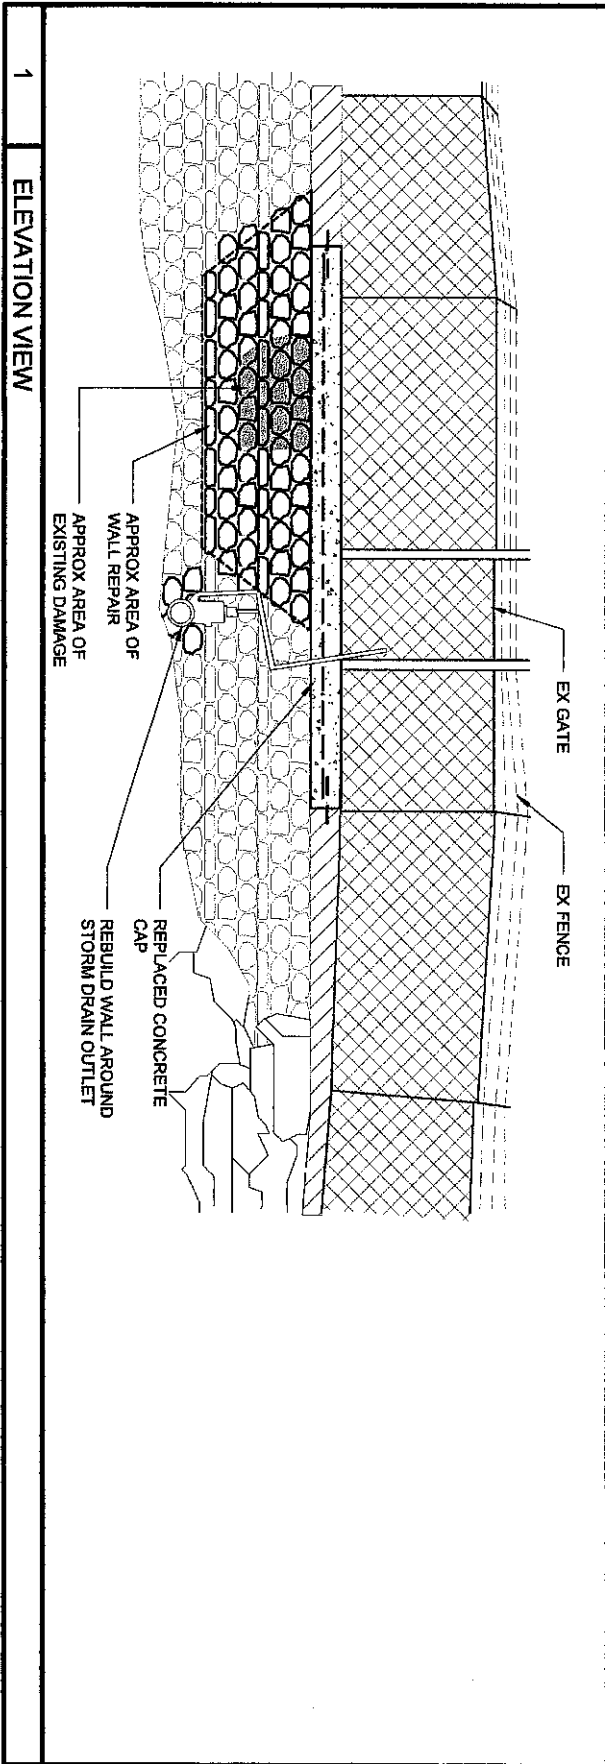
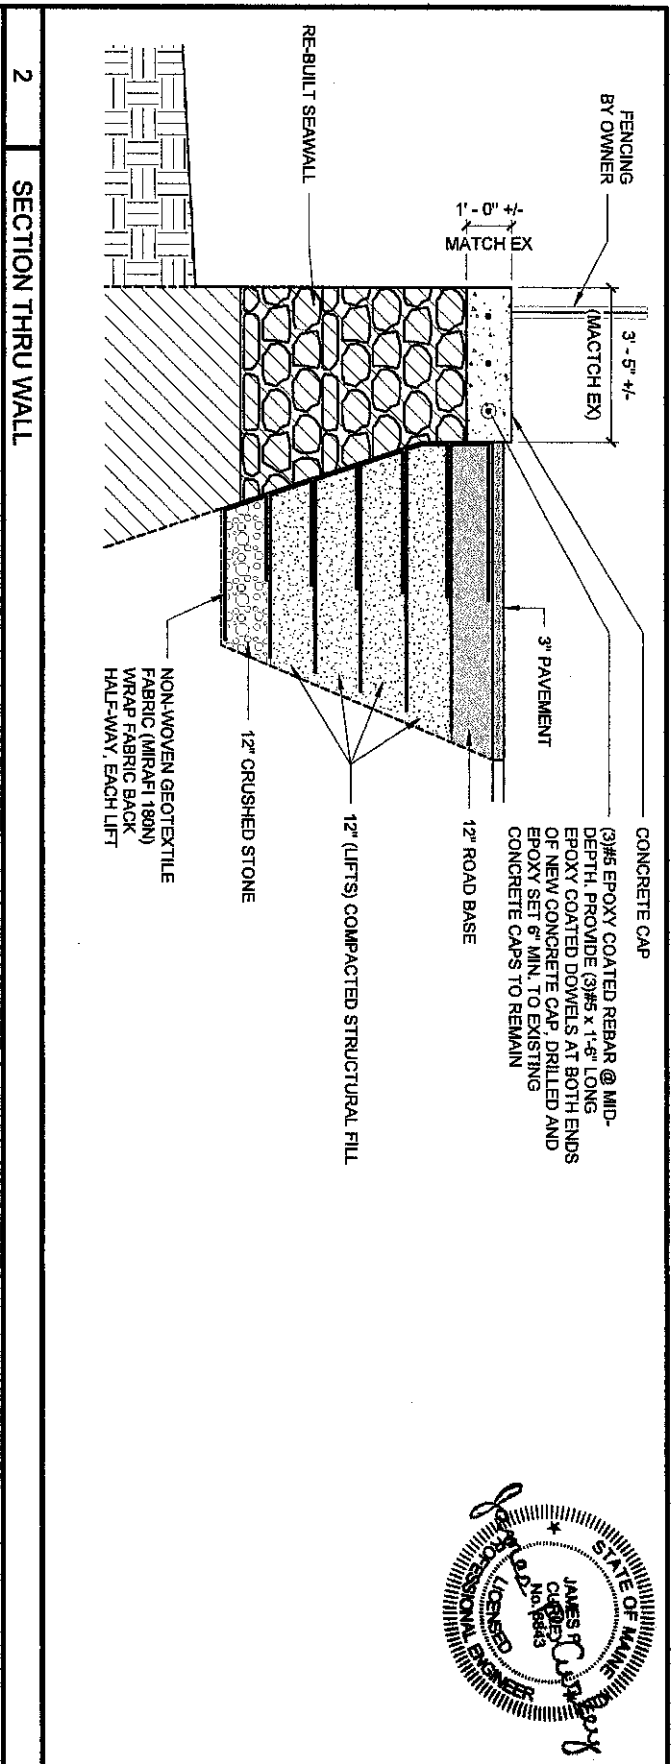
S-200	SEAWALL ELEVATION AND SECTION		
	BURNHAM AND MORRIL RETAINING WALL REPLACEMENT 1 BEANPOT CIRCLE, PORTLAND, ME		
Scale: As indicated	Date: 09/19/18	Project No: 18035	CAD File: 18035_S.rvt

3. The concrete cap has cracked and dropped a few inches in the subject area due to the loss of stone in the wall. It is our opinion the wall could collapse near the sinkhole area, if not repaired or replaced.

- NOTES:**
1. EXCAVATE ALONG DRIVE SIDE OF SEAWALL IN ORDER TO INSTALL SOILS AND GEOTEXTILE FABRIC AS SHOWN IN SECTION THRU WALL (APPROX. LENGTH OF EXCAVATION = 35')

2. REMOVE UPPER PORTION OF STONE WALL AT DAMAGED AREA DOWN TO AN ELEVATION WHERE THE STONE WALL IS IN GOOD CONDITION - REBUILD THE WALL TO MATCH EXISTING.

3. REMOVE DAMAGED PORTION OF CONCRETE CAP (APPROX LENGTH = 15 +/-) REPLACE AS SHOWN IN SECTION THRU WALL. REMOVE / REPLACE PORTION OF EXISTING FENCE / GATE IMPACTED BY FENCE REMOVAL.

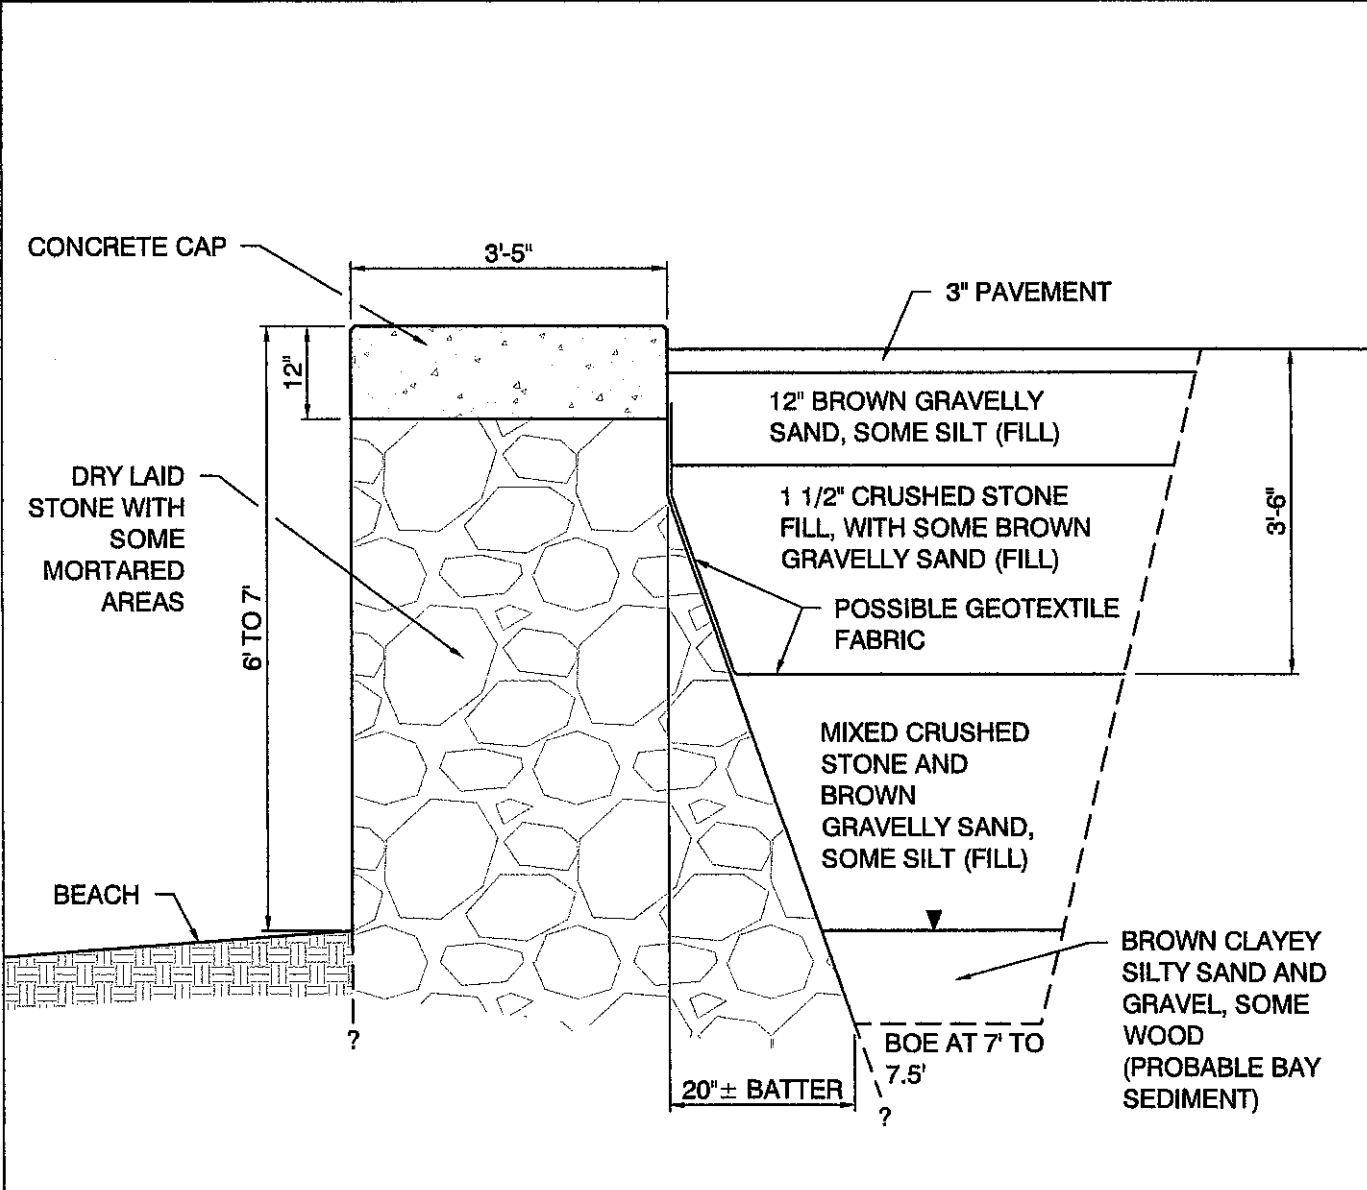
TEST PIT TP-1

3 inches of asphalt pavement overlying about 12 inches of gravelly sand with some silt (pavement base material) overlying granular fill consisting of about 3.5 feet of 1.5 inch crushed stone with some gravelly sand overlying a woven geotextile fabric overlying a mix of the crushed stone and the gravelly sand (fill) overlying what appears to be bay sediments. The bay sediment was encountered at a depth of about 6.5 to 7 feet below the pavement surface. The geotextile fabric also appeared to be placed up on the back side of the wall, but did not appear to be overlapped well. Bedrock was not encountered within the depth explored. We observed that the back side (north side) of the wall was near vertical for the top approximate 2 feet and then tapered out to the north with depth. The wall tapered out about 20 inches within the depth explored. The bottom of the wall was not observed. The test pit was terminated in the bay sediments at a depth of about 7 feet below the pavement surface. The test pit exploration could not be further advanced due to potential collapse of the wall where the larger void in the stone exists. The test pit was backfilled with the excavated soils.

The test pit was made during approximate low tide. Saturated soils and free water were encountered at a depth of about 6.5 to 7 feet below the pavement surface at the time of the exploration. It should be anticipated that groundwater levels will fluctuate in response to tidal fluctuations, precipitation and snowmelt, as well as changes in site use.

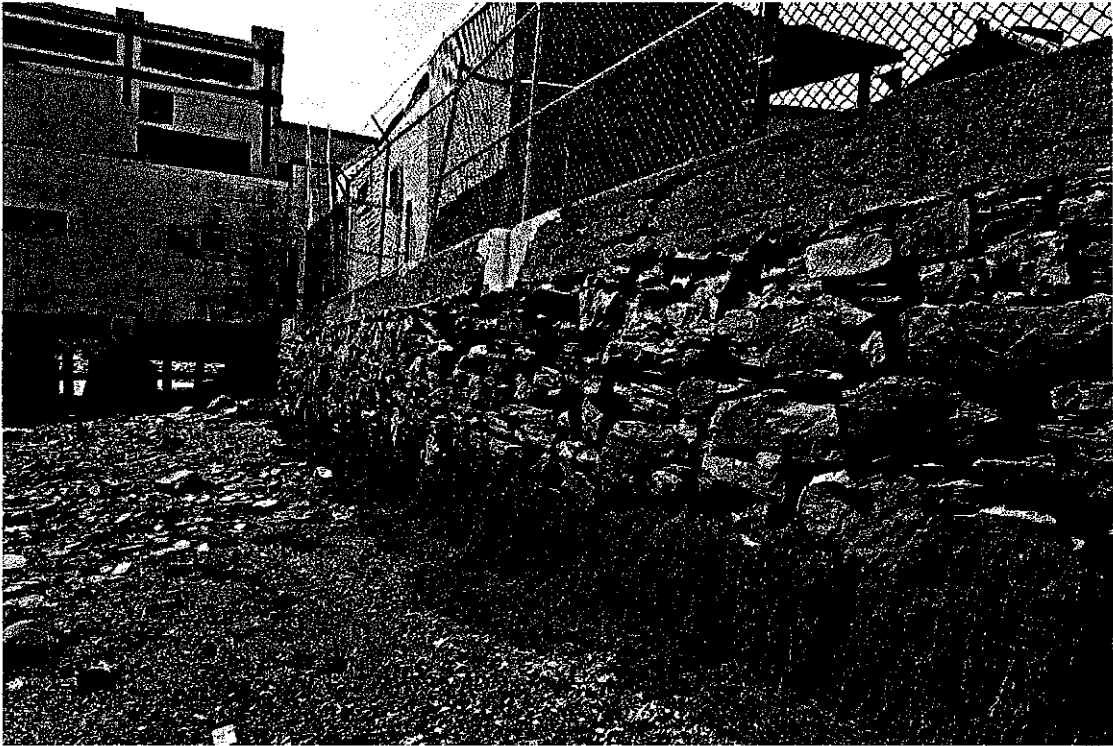
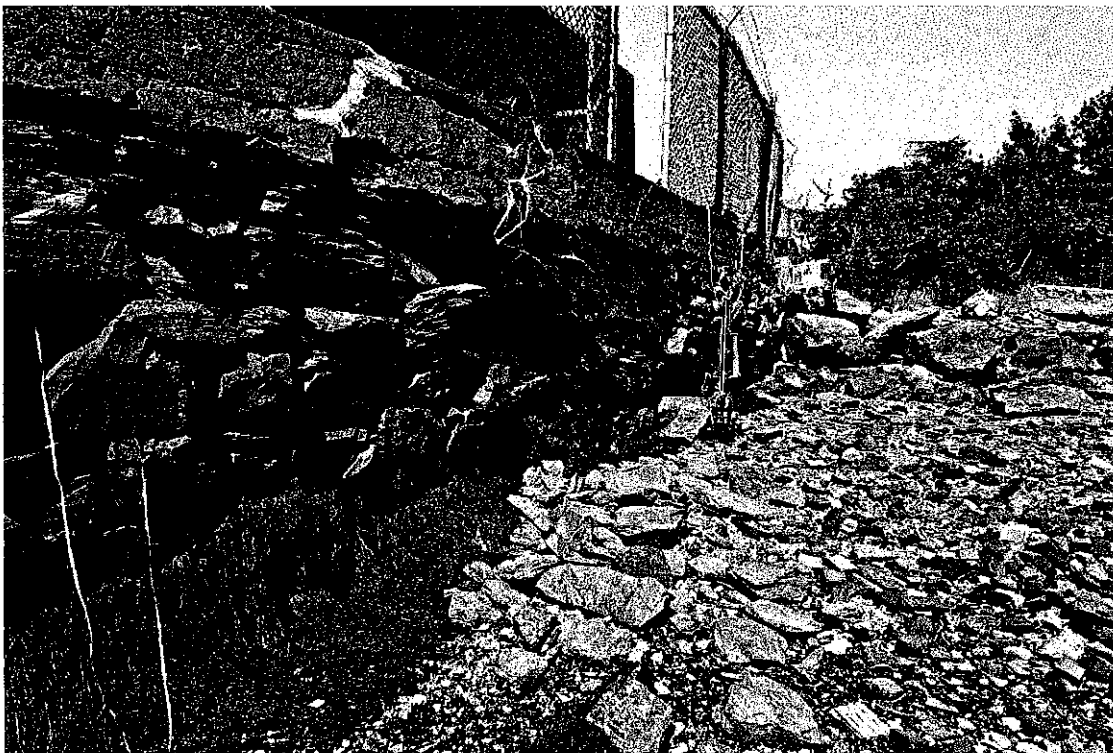
Wall

1. Based on the findings at the test pit and observations made of the existing seawall in the subject area, it appears the sinkhole was caused by erosion and piping of the soils from behind the stone wall which created a void beneath the pavement and eventual collapse of the pavement.

2. Two locations were observed where the wall has lost a significant amount of stone; one larger location near the sinkhole and one location around the outlet pipe of the existing storm water catch basin, also near the sinkhole. It appears the soils are being eroded through these locations where the stone wall has failed. It appears there have been prior issues with the stone wall in this area since some stone is missing in other areas and some mortar has been used in an attempt to repair the wall. The length of wall in apparent need of repair or replacement is about 35 feet in length measured from the easterly end, but should be verified by the client.

5. As previously discussed, we offer the following options for consideration. Other options may also be feasible:
 - Totally remove the existing wall in the subject area and replace with a new stone or cast in place concrete wall with a thickened mat foundation. Supplemental test borings would be needed to assess deeper soil and bedrock conditions. The existing bay sediments may not be suitable for support of a new wall.

- Remove the upper portion of the stone wall down to an elevation where the wall is still in good condition and have an experienced contractor/mason rebuild the wall to match the existing wall section. Granular fill, crushed stone and geotextile fabric would be needed as backfill.

- Drive sheet piling on the outside face (south side) of the existing wall to encapsulate the existing wall and backfill soils to support the existing paved area. The sheet pile wall would likely need tiebacks or dead-man anchorage for lateral support. Supplemental test borings would be needed to assess deeper soil and bedrock conditions.
