City of Portland, Maine - Building or Use Permit Application

Proposed Use:	Commercial Restaurant/PortHole - Interior Renovations to Update Fire Codes	Proposed Project Description:	Interior Renovations to Update Fire Codes
---------------	--	-------------------------------	---

SUBJECT: Porthole Tavern Restaurant / Comedy Connection: 2 Hr. Floor assembly reference

SUBJECT: Harbour's Edge/Comedy Connection/Porthole Tavern Life Safety Plans and Evaluation

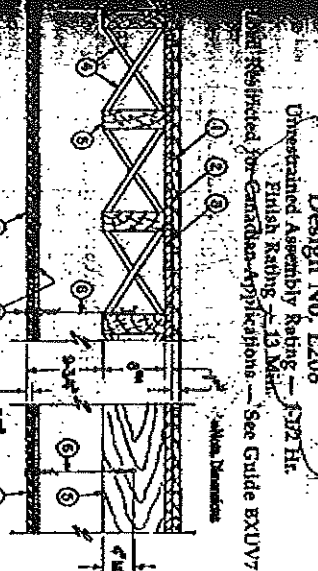
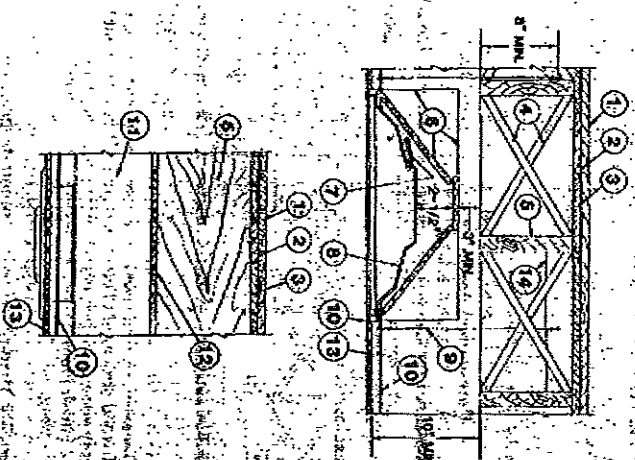
Design No. E208

The actual floor/ceiling assembly directly above the referenced restaurant/night clubs has 1x4 wood flooring over 2-1/2 tongue and groove wood decking which would give you a better fire rating than the L208 assembly listed. Assembly Design No. L208 is a 1-1/2 hr floor/ceiling assembly that when (1) layer of 5/8" Type X Firecode GWB was secured to the bottom of the timber floor framing would, in my opinion, equal to or exceed a 2 hr. floor/ceiling assembly. I discussed this with Steve Dodge at the office of the State Fire Marshall and he concurred with this proposal.

Please note that the floor members must be cross braced and solid blocked at their endpoints to attain this rating. *
