#226-920 CONGRESS ST. LAMP (PAPER LAMP)  
COR. CHINA ST.

PROJECT PARKING GARAGE, MAIN MEDICAL CENTER

PROJECT PARKING GARAGE, MAINE MEDICAL CENTER File No. 2701  
PORTLAND, MAINE Report No. 37  
 CLIENT O.M. MARTINSON, NEW YORK, NEW YORK Date 10 April 1972  
 CONTRACTOR O.M. MARTINSON, NEW YORK, NEW YORK Page 1 of 1  
 Weather Fair Temp. 55° Inspection Time 1000 - 1430 Hours 4  
 Other time (travel, ~~preparation, etc.~~)                      TOTAL: 8 hours

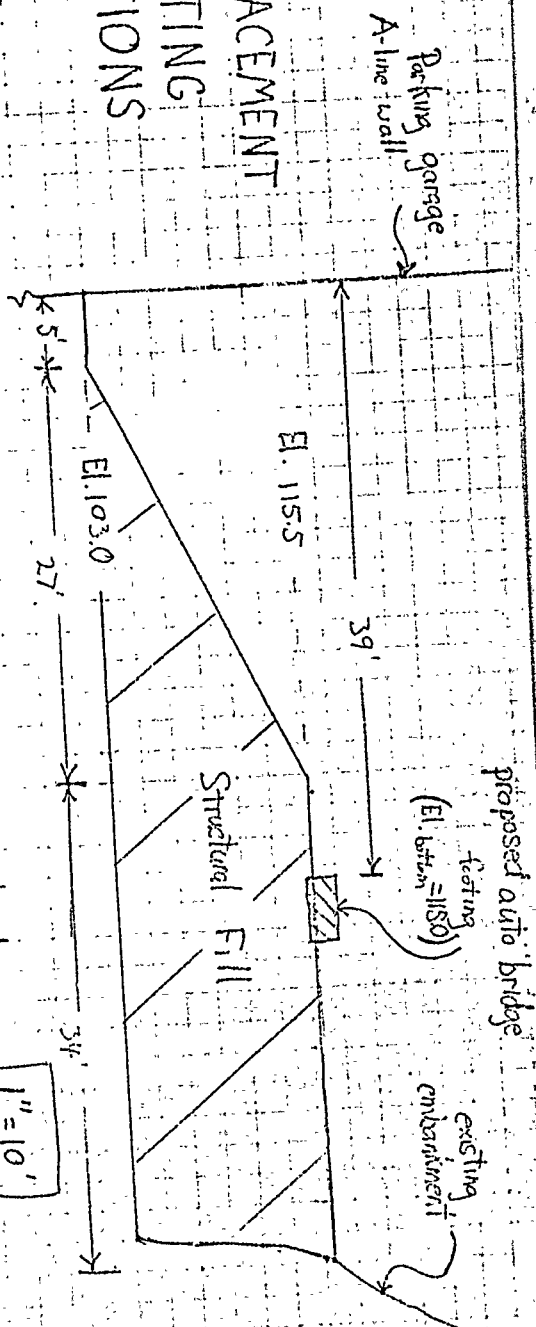
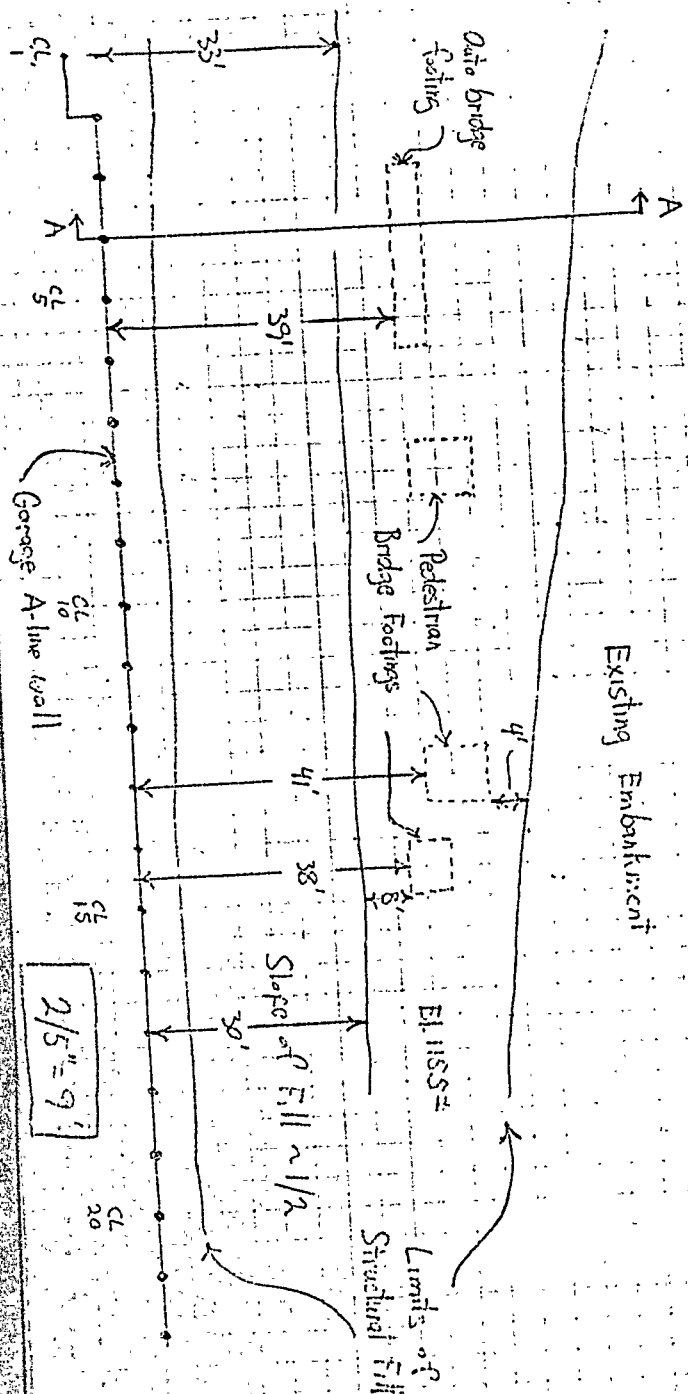
# FILL PLACEMENT & FOOTING LOCATIONS

The Contractor used a vibratory roller to compact material placed on 7 April in the fill area on the A-line side of the garage.

Current Elev. of compact fill - 115.5+

Proposed Elev. of bottom of pedestrian and auto bridge footings - 115.0

The Inspector observed the above stated operations of the Contractor and performed 3 Field Unit Weight tests with the results shown on the attached sheet.

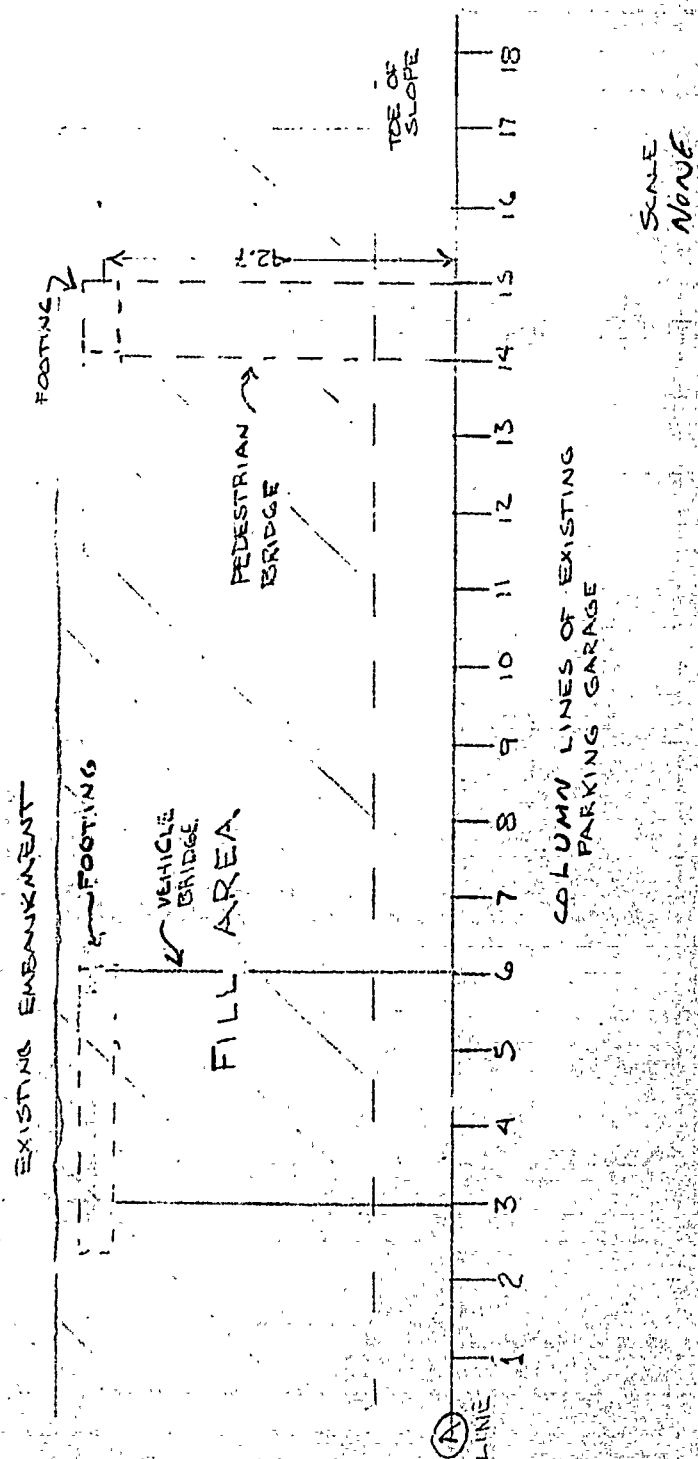
FIG. 1

1. Filling and Compacting
2. Frost and Loose Fill Removal
1. Granular fill was placed for the proposed bridge footings between column lines 2 and 16, along the A-line side of parking garage (see Fig. 1). It was then spread in 10.0" lifts by H-11 Allis Chalmers Bulldozer, and compacted with vibratory roller and the bulldozer making systematic coverages.
2. Frost and loose fill was scraped from existing embankment between column lines 15 to 18 and deposited on area between lines 20 to 23 (see Fig. 1).

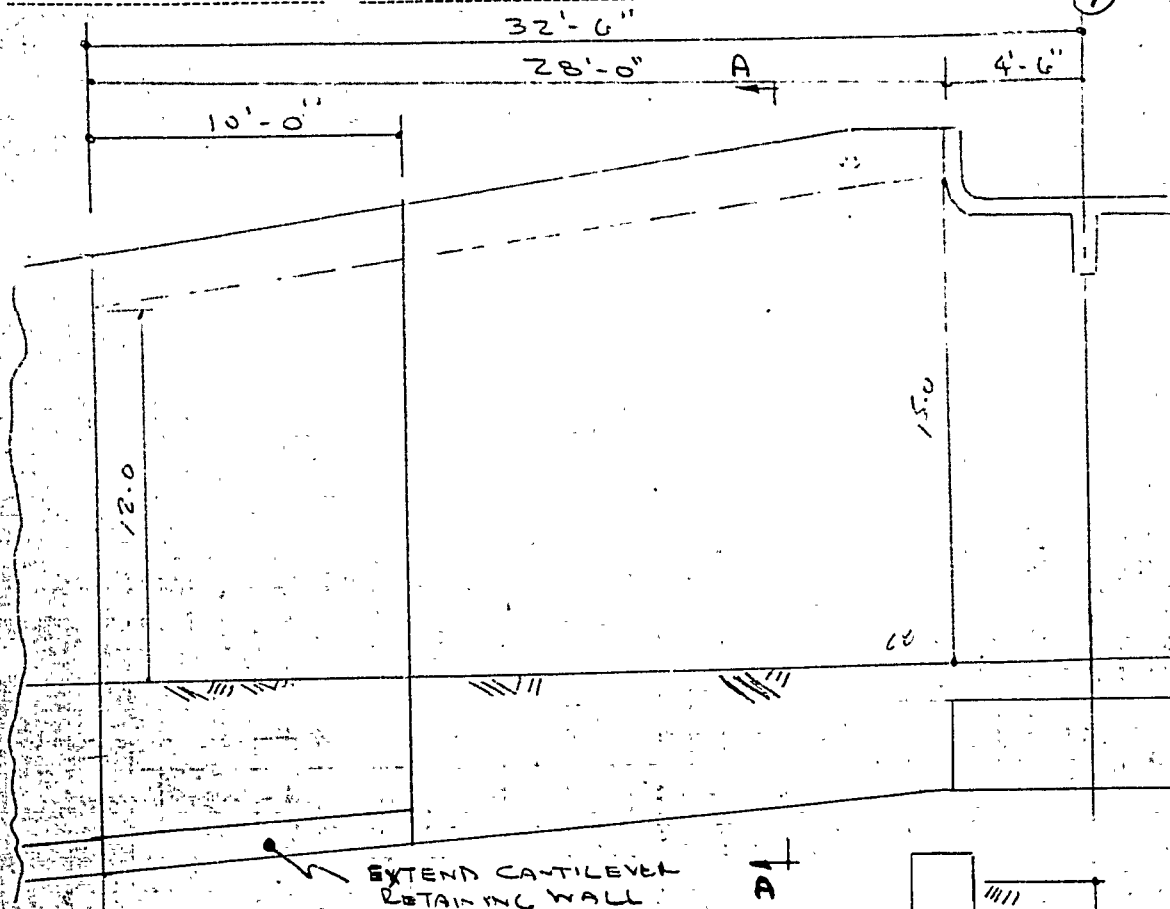
BY RP DATE 9/16/71 SUBJECT B LINE WALL  
CHKD. BY \_\_\_\_\_ DATE \_\_\_\_\_ OUTSIDE OF COL B-1

$H = 13.5 \text{ FT AY}$   
 $P_{AV} = 2.6 \text{ K/FT}$   
 $P_{\text{Total}} = 28 \times 2.6 = 73 \text{ K}$   
 $M = 73 \times \frac{28}{2} = 1020$
