PROJECT NAME
**3 UNIT APARTMENT BUILDING
 162 EASTERN PROMENADE**

DETAILS & SECTIONS

A10

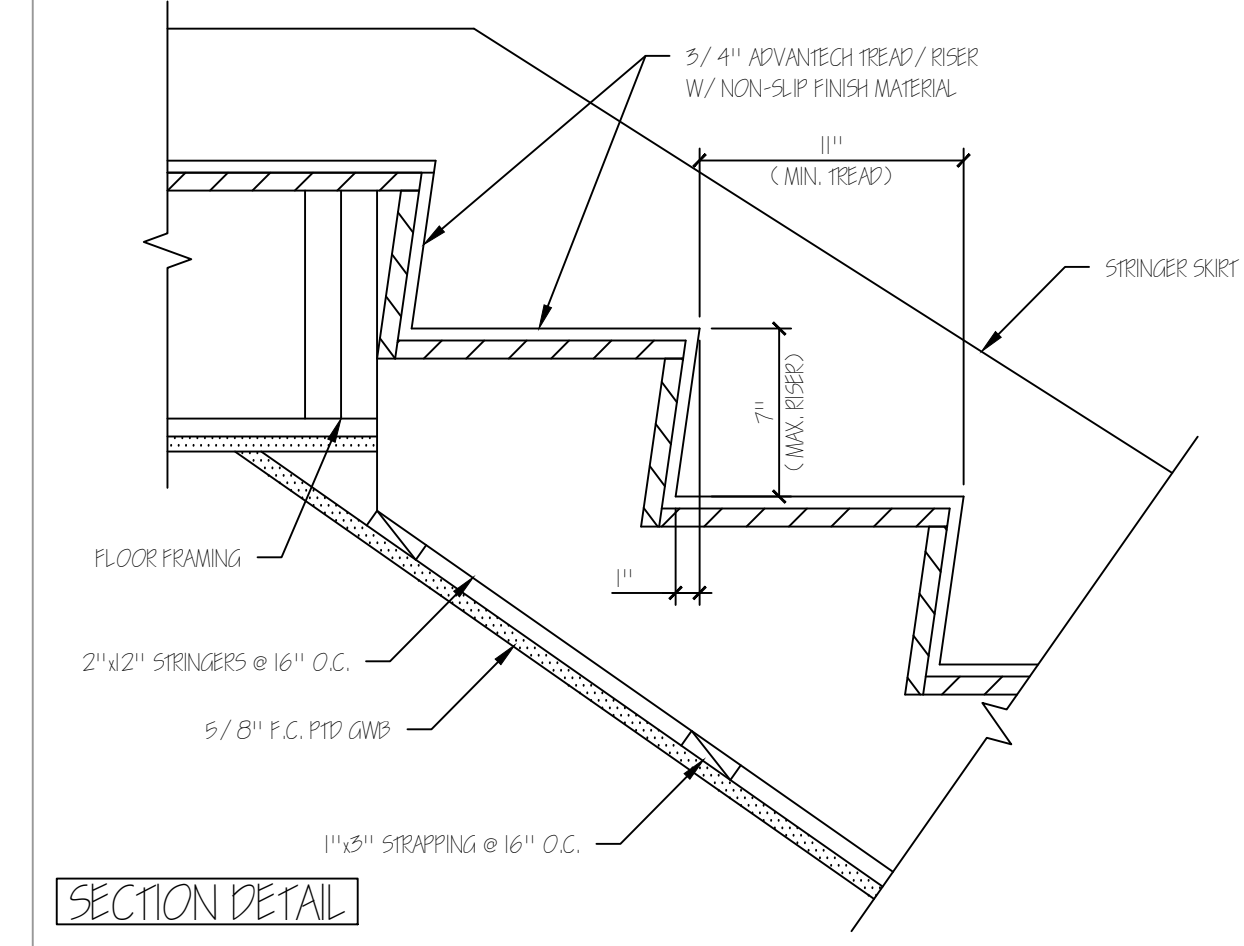
1 INTERIOR STAIR RISER/ TREAD DETAIL 1 1/2"=1'-0"

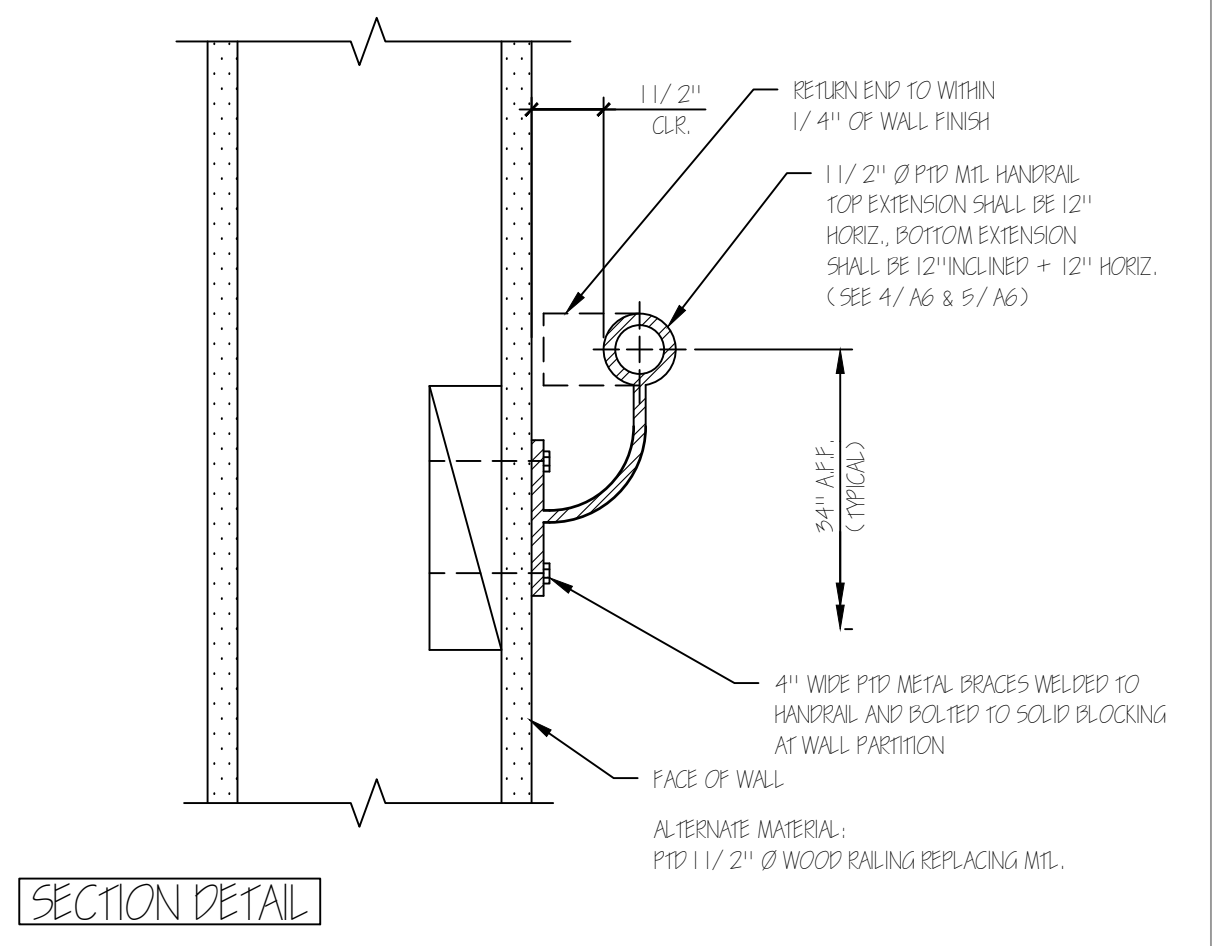
2 TYPICAL WALL HANDRAIL SECTION 3/4"=1'-0"

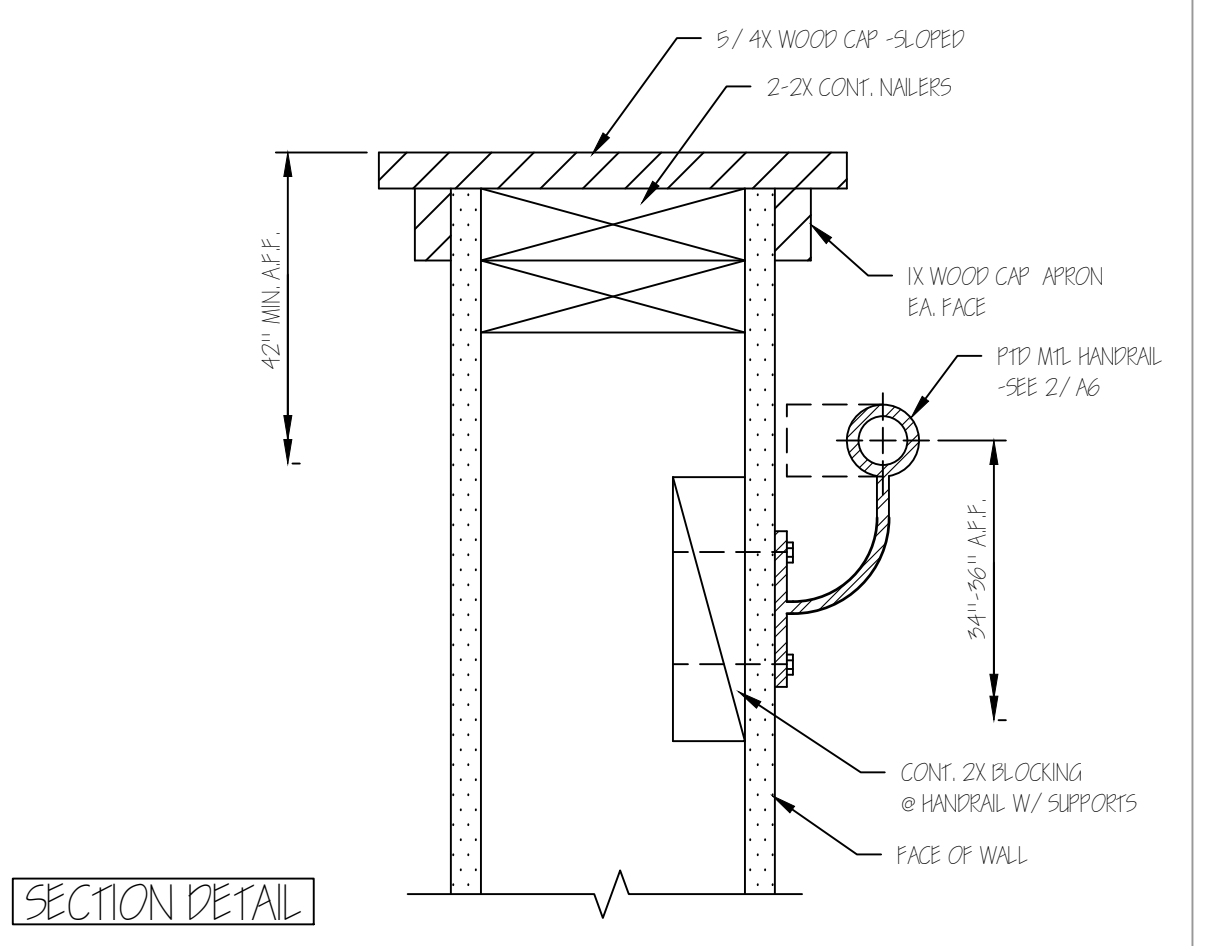
3 STAIR GUARDRAIL 3/4"=1'-0"

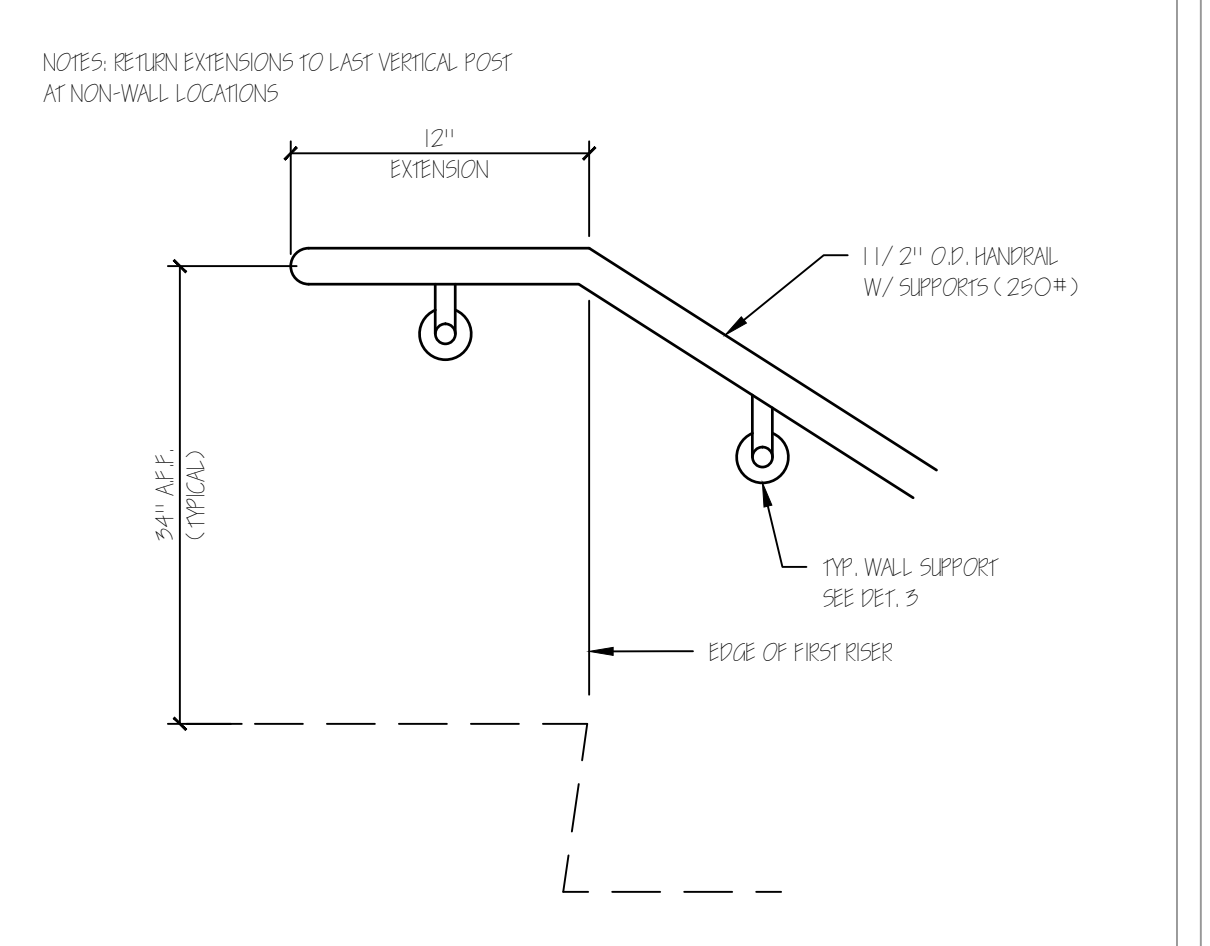
4 TYPICAL WALL HANDRAIL-TOP 3/4"=1'-0"

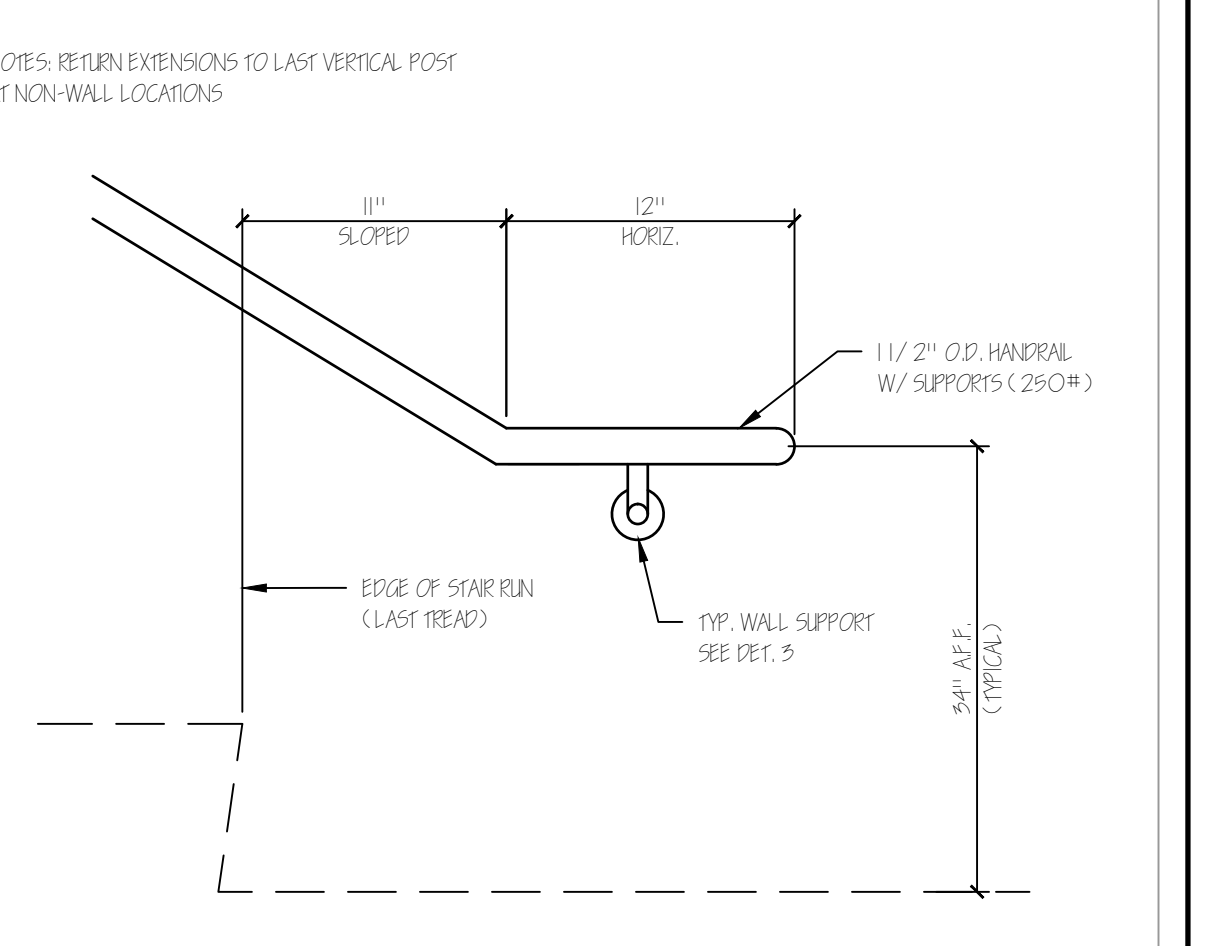
5 TYPICAL WALL HANDRAIL-BOTTOM 3/4"=1'-0"

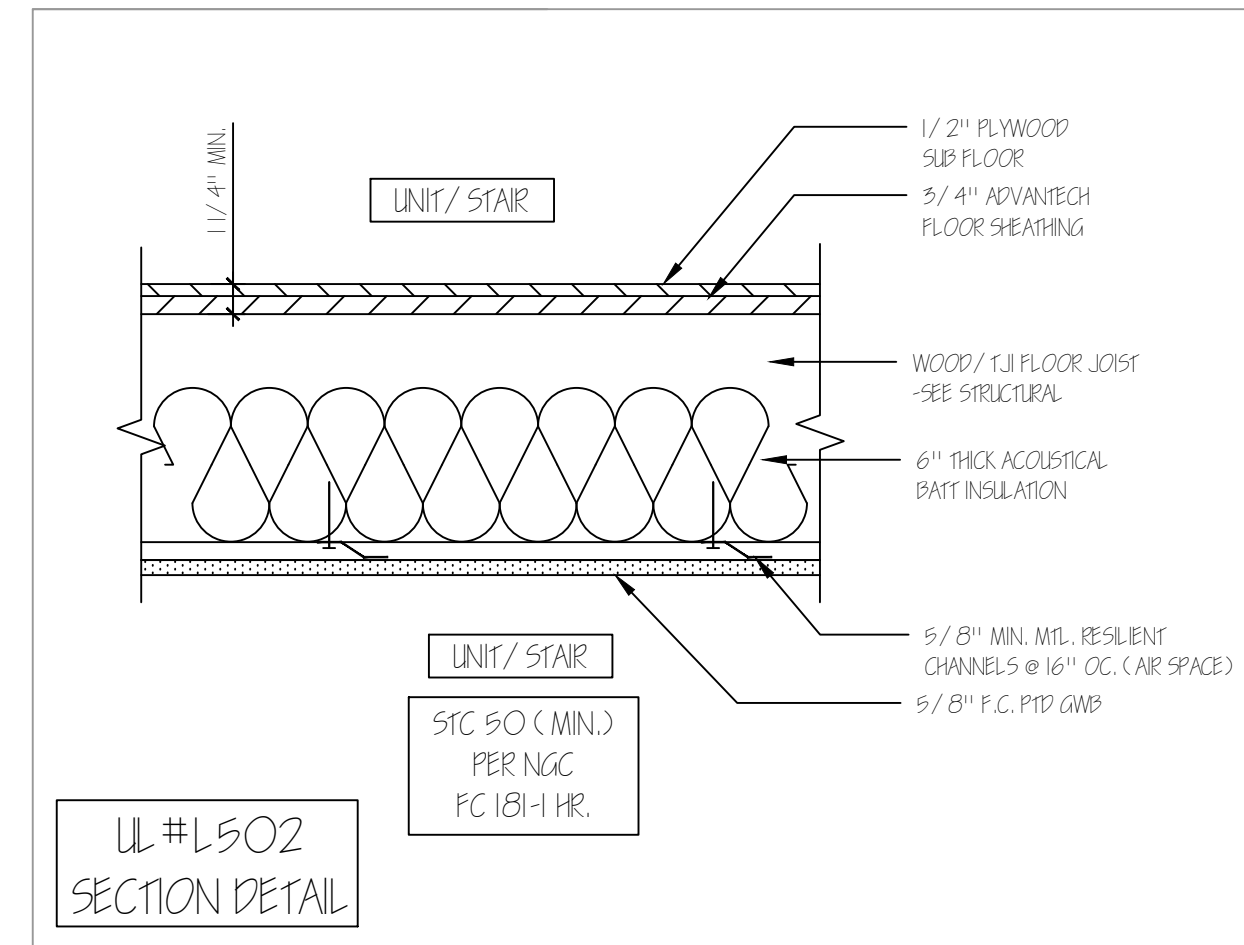
6 1 HR RATED FLOOR/ CEILING ASSEMBLY 1 1/2"=1'-0"

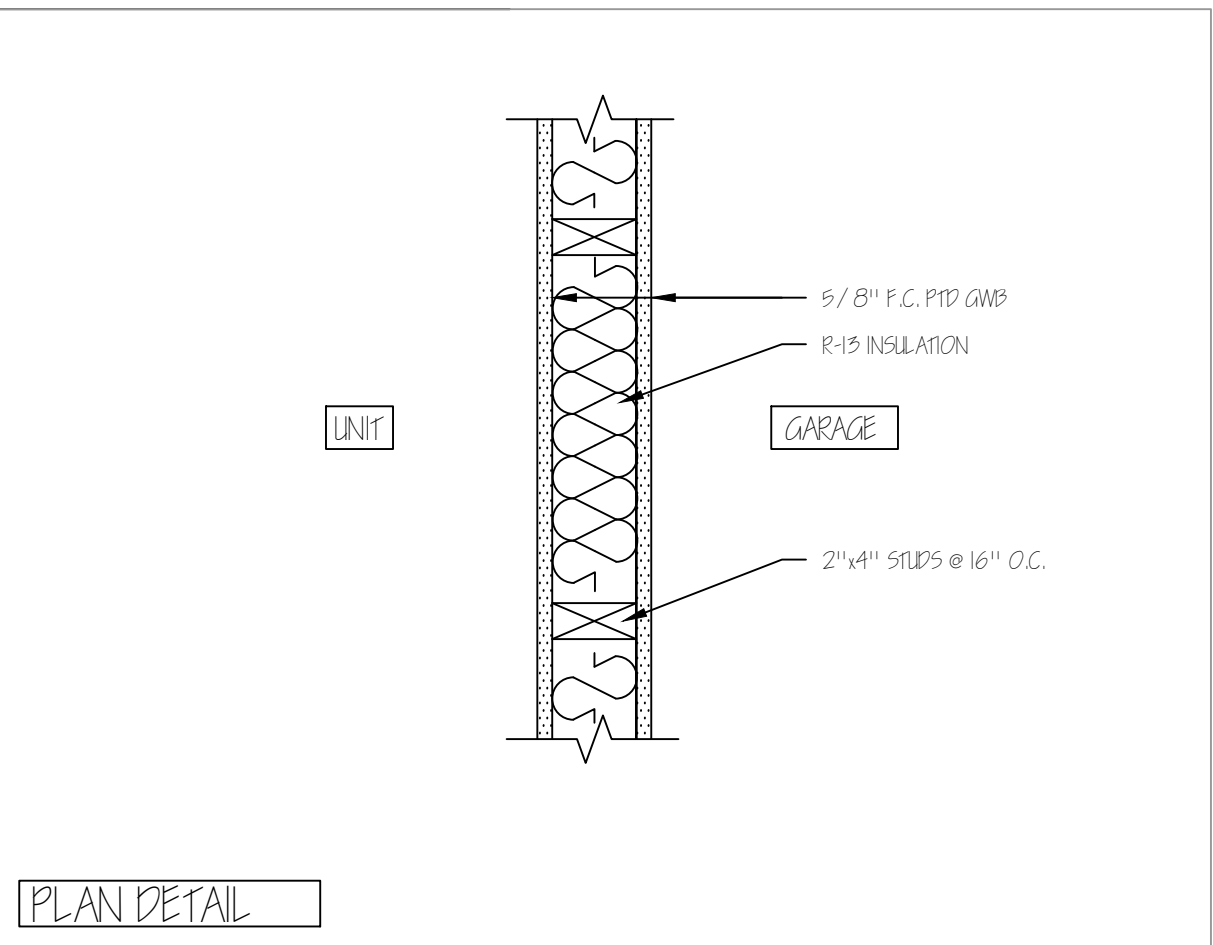
7 1 HR RATED WALL 1 1/2"=1'-0"

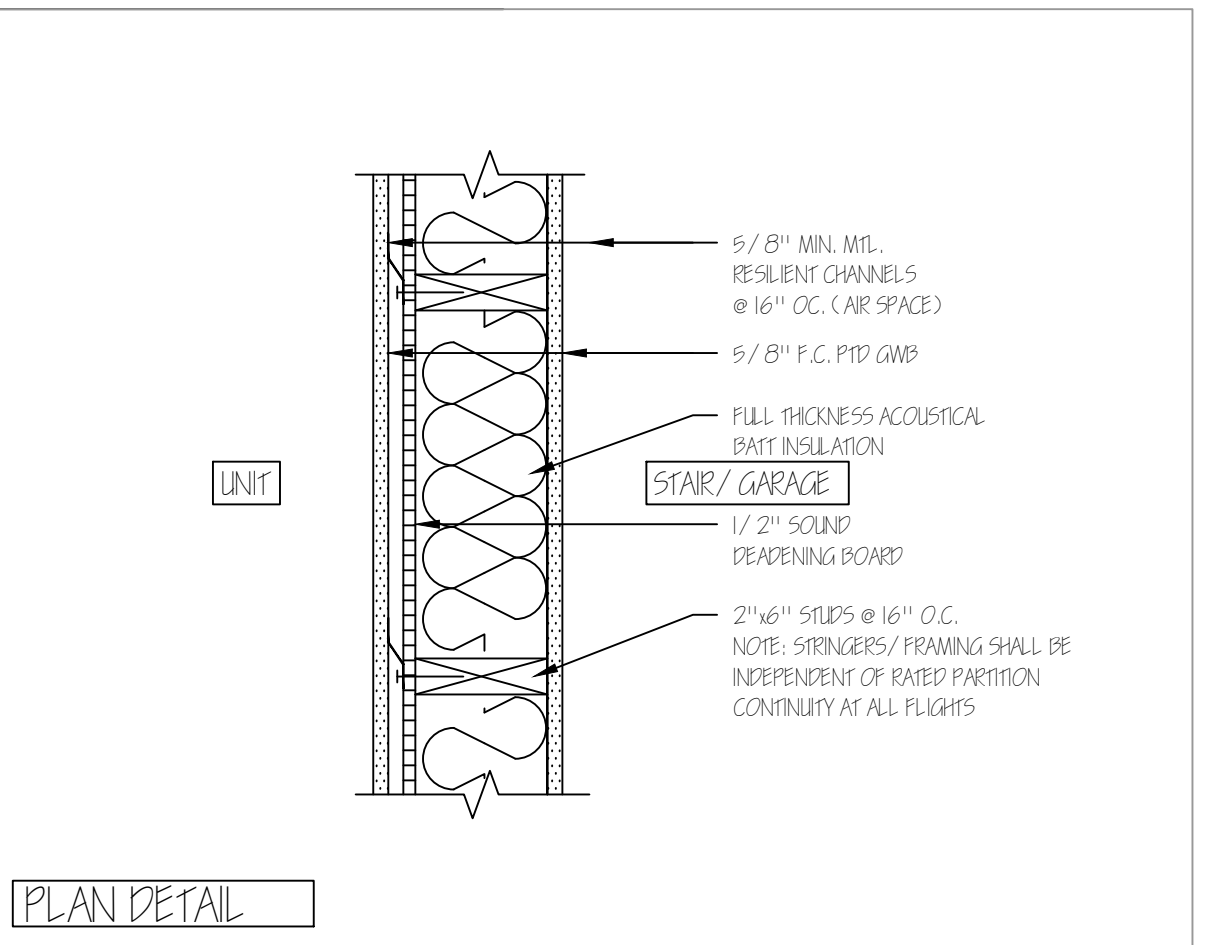
8 1 HR RATED PARTITION AT STAIR/ GARAGE 1 1/2"=1'-0"

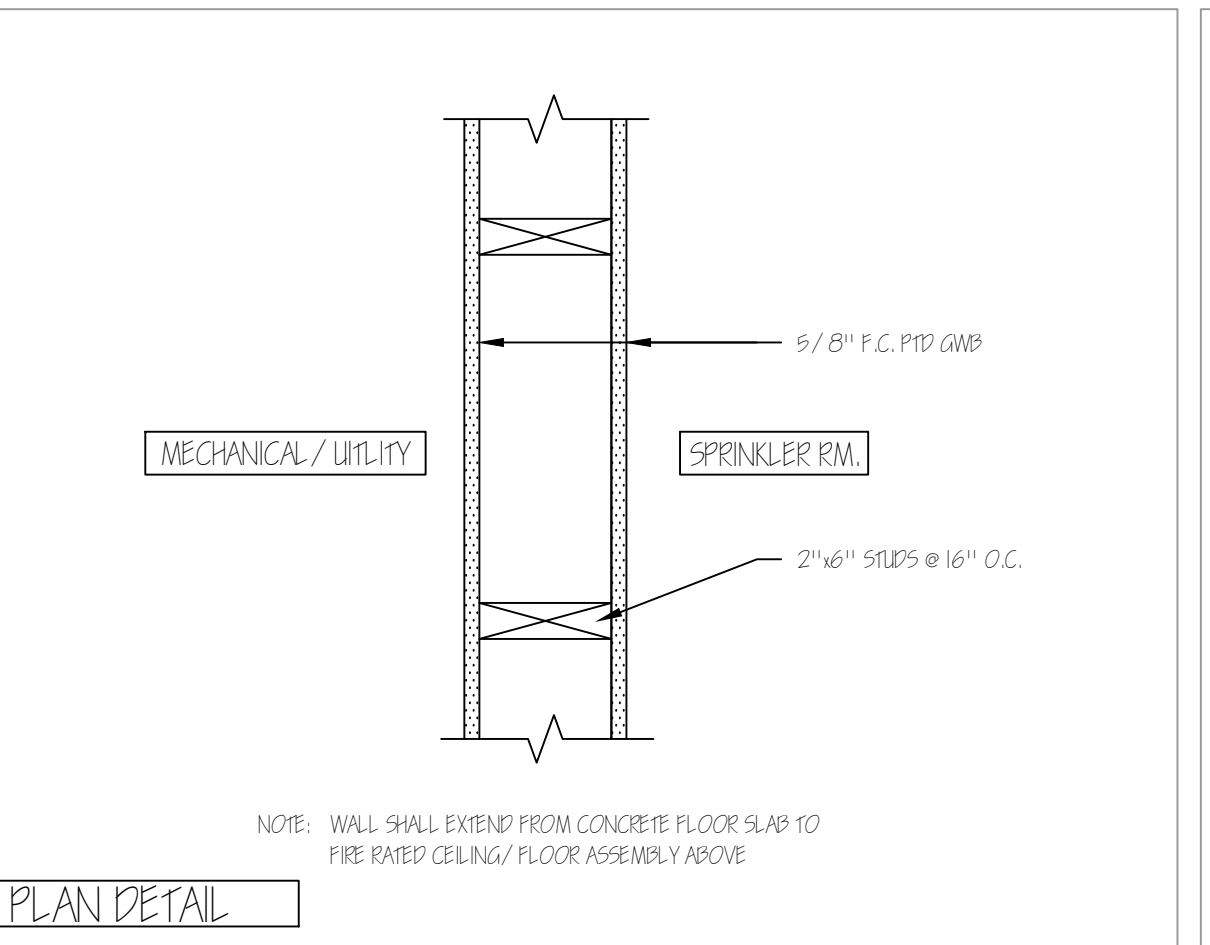
9 1 HR RATED PARTITION AT SPRINKLER ROOM 1 1/2"=1'-0"

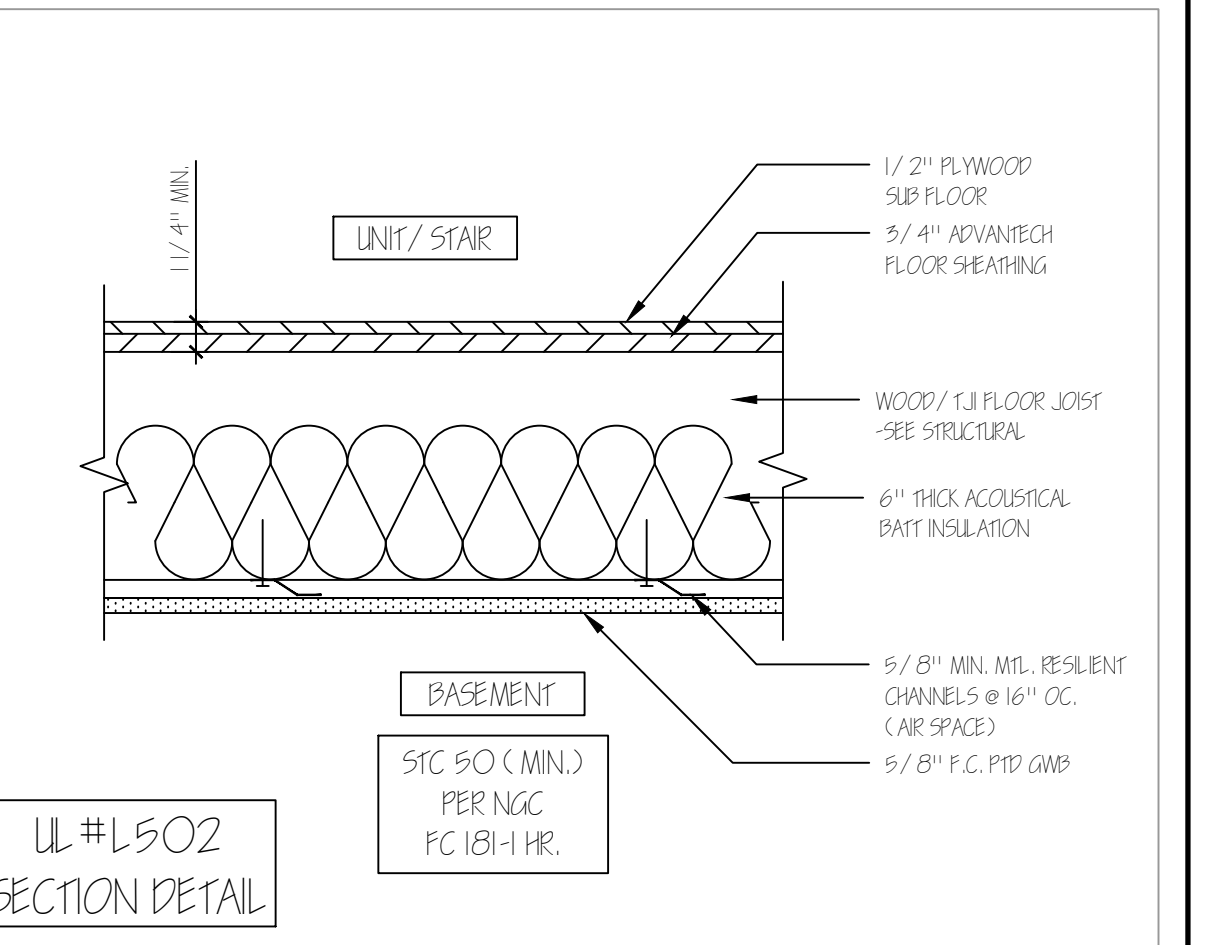
10 1 HR RATED FIRST FLOOR ASSEMBLY 1 1/2"=1'-0"

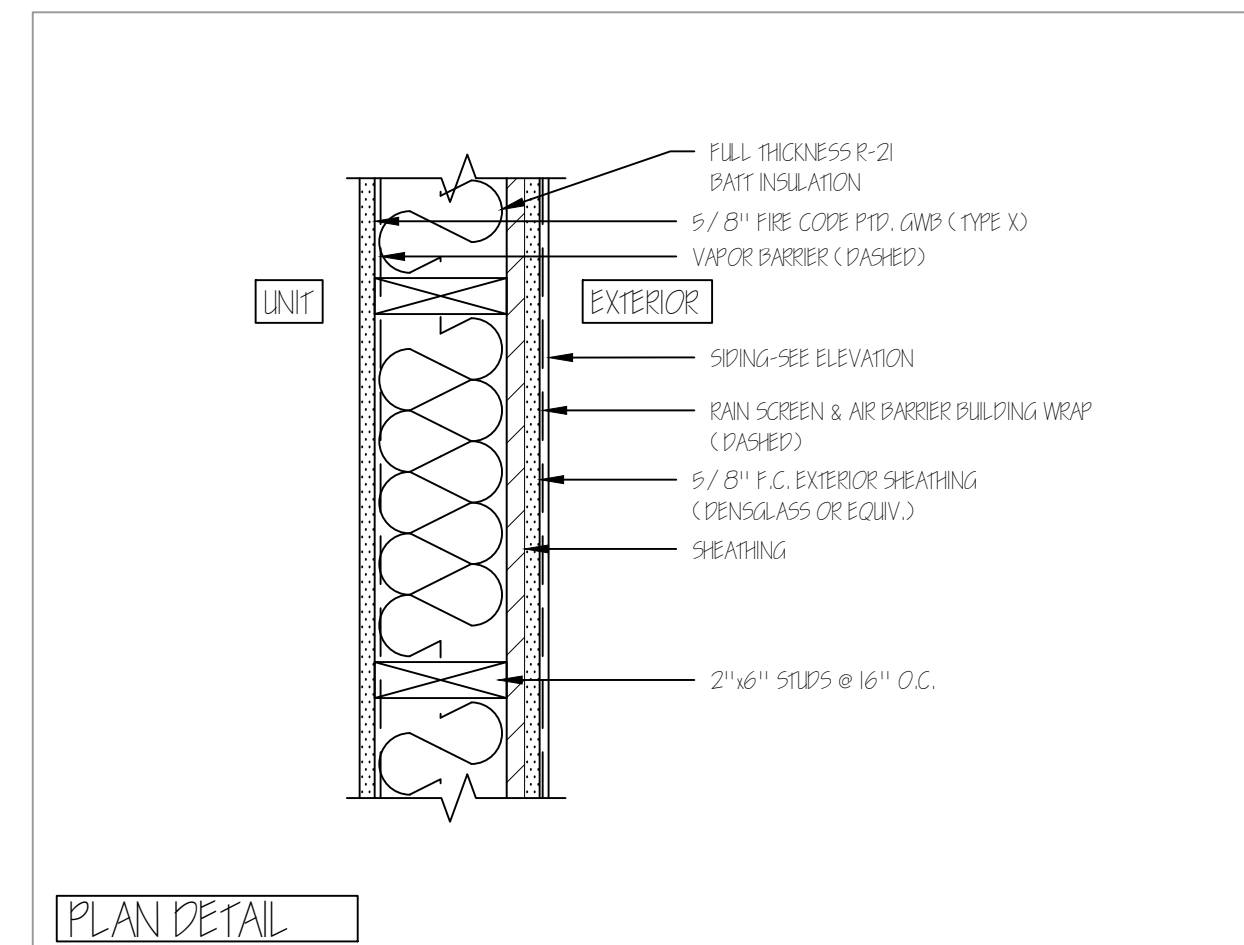
11 1 HR RATED EXTERIOR WALL ASSEMBLY 1 1/2"=1'-0"

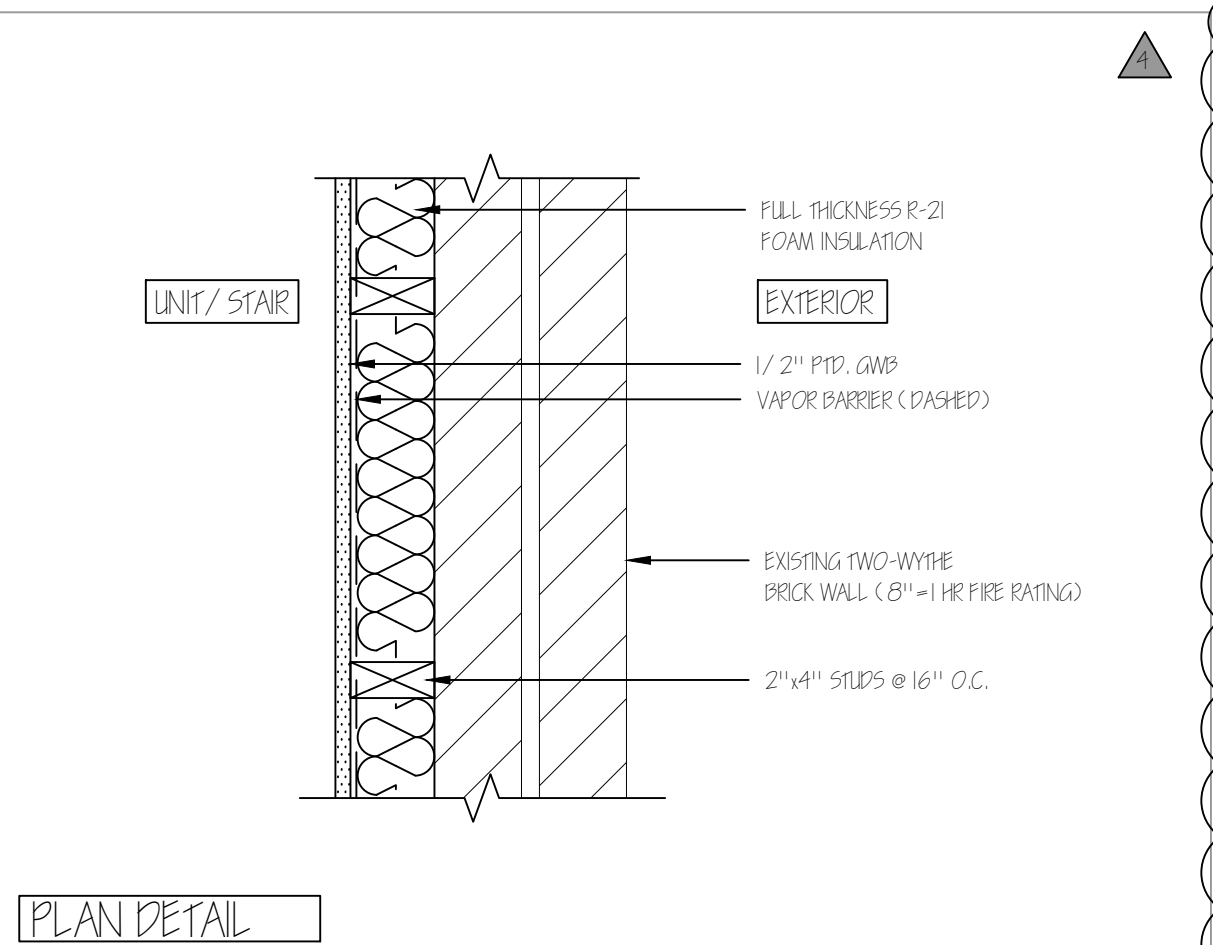
12 EXTERIOR WALL @ 1 HR MASONRY (8" BRICK) 1 1/2"=1'-0"

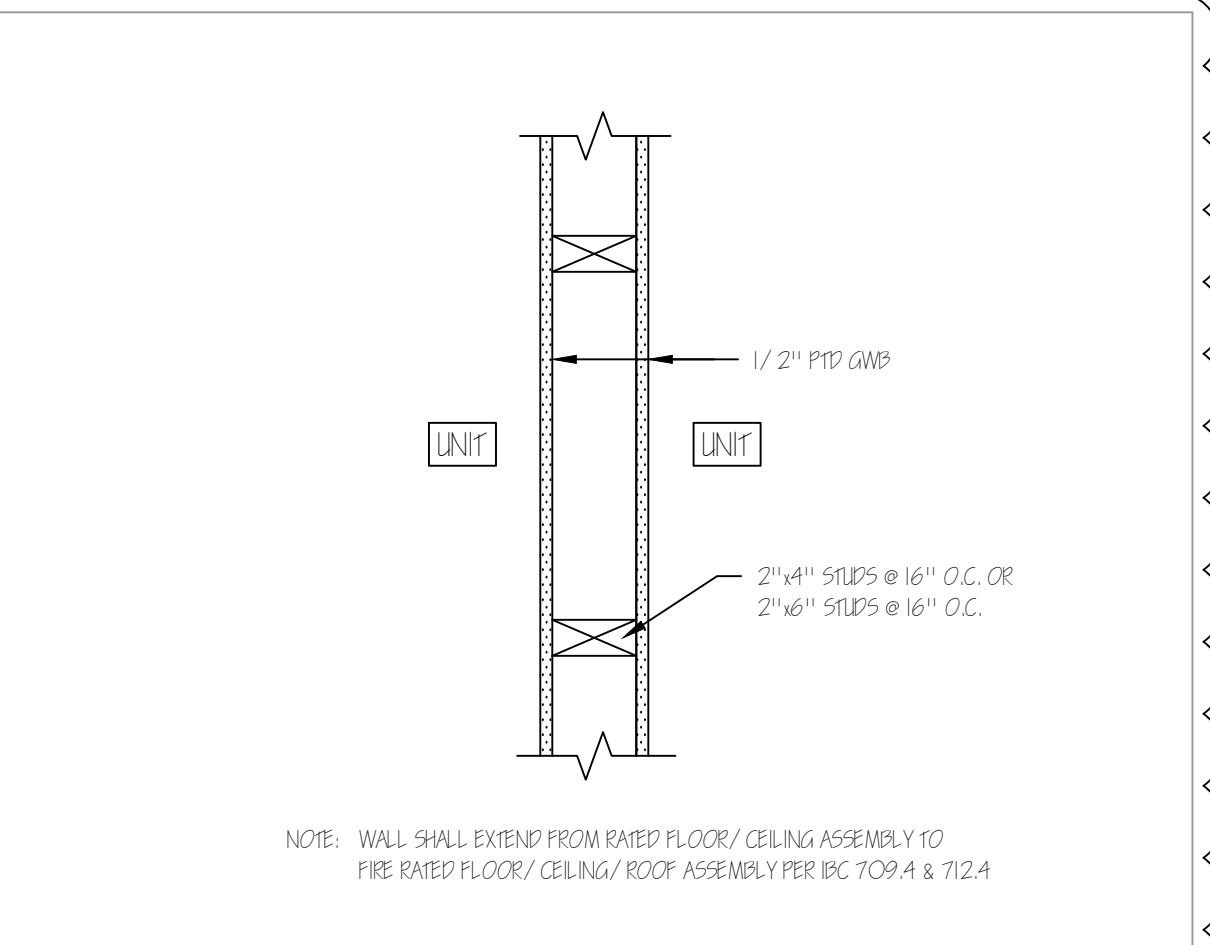
13 TYPICAL INTERIOR WALL (NON-RATED) 1 1/2"=1'-0"

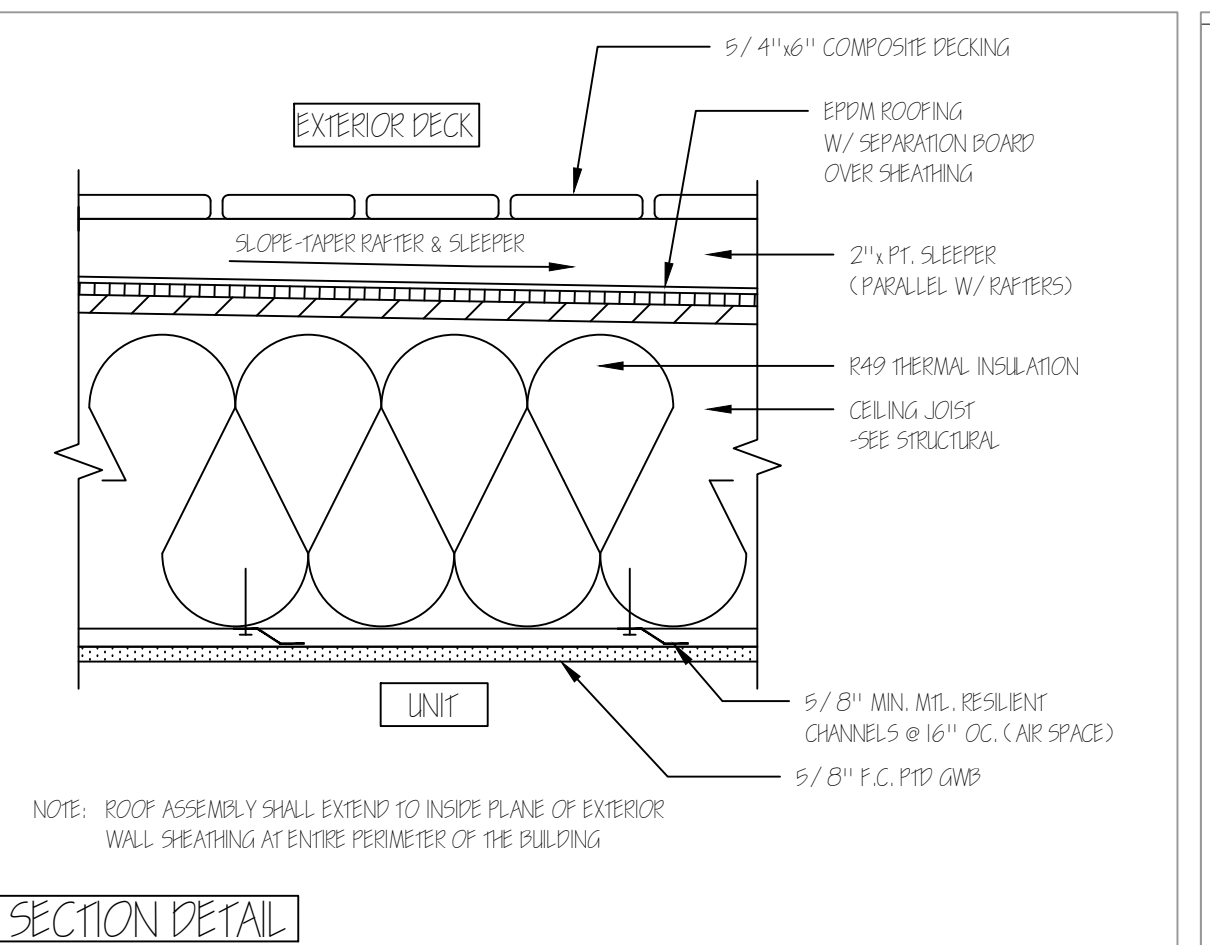
14 1 HR RATED CEILING/ ROOF/ DECK ASSEMBLY 1 1/2"=1'-0"

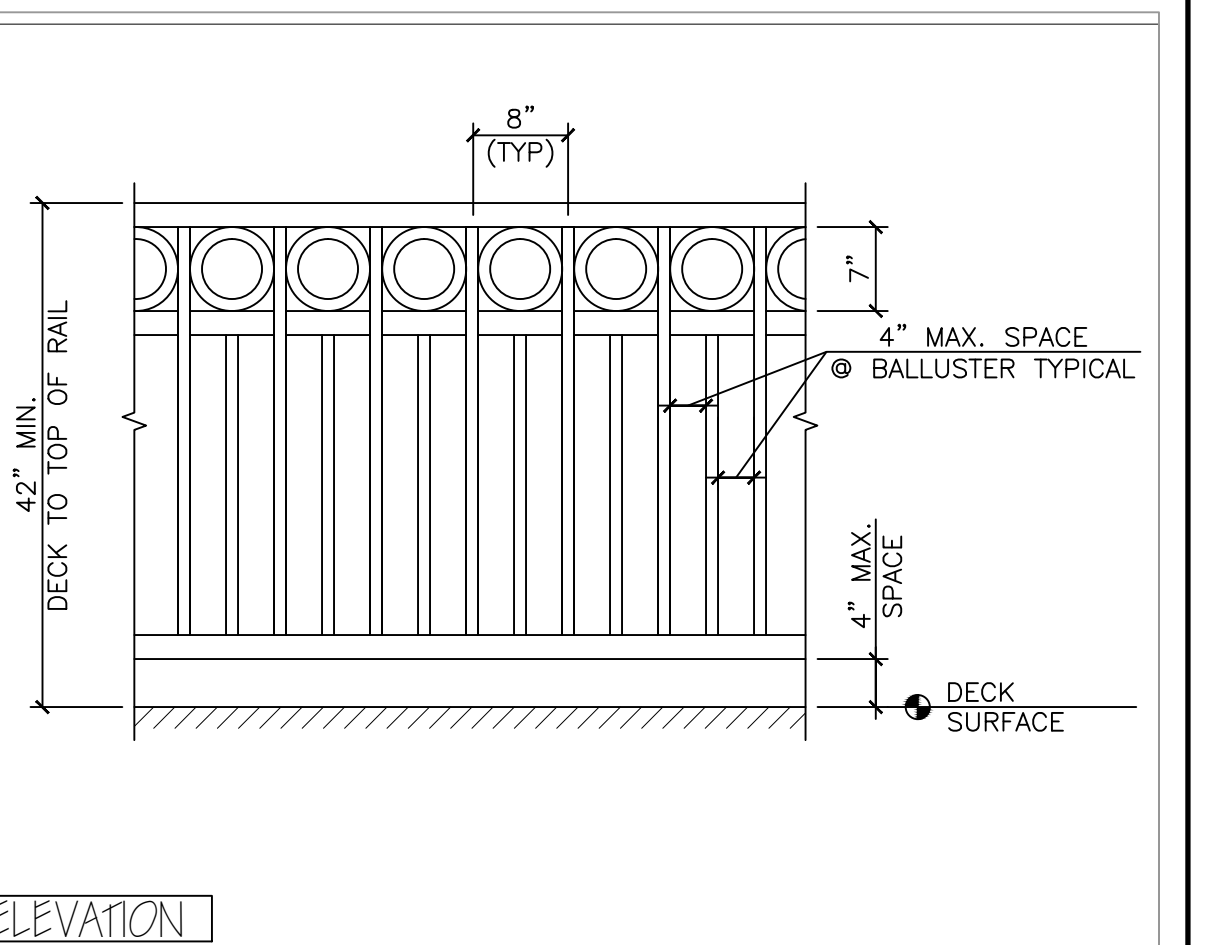
15 TYPICAL DECK GUARDRAIL 3/4"=1'-0"

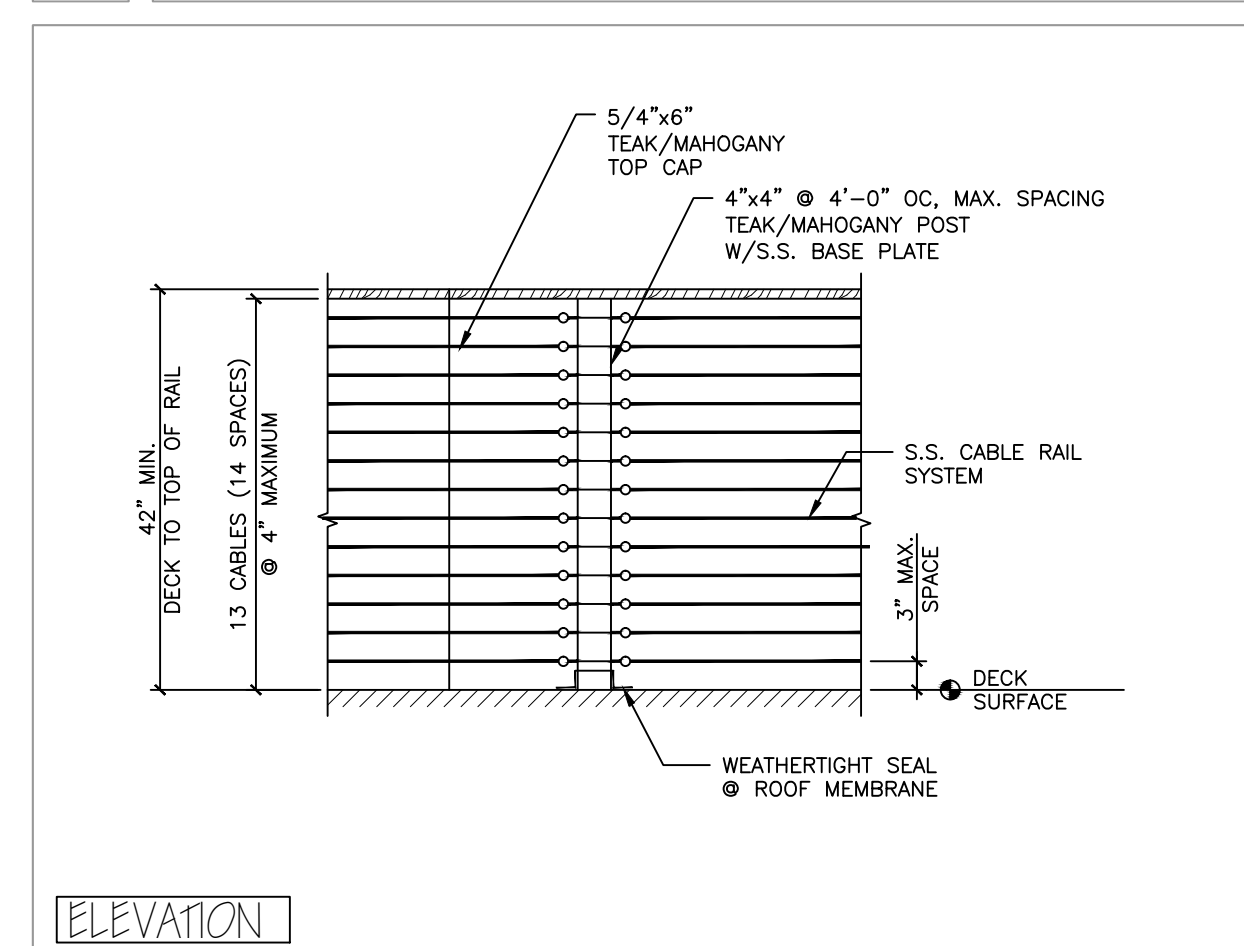
16 TYPICAL CABLERAIL DECK GUARDRAIL 3/4"=1'-0"

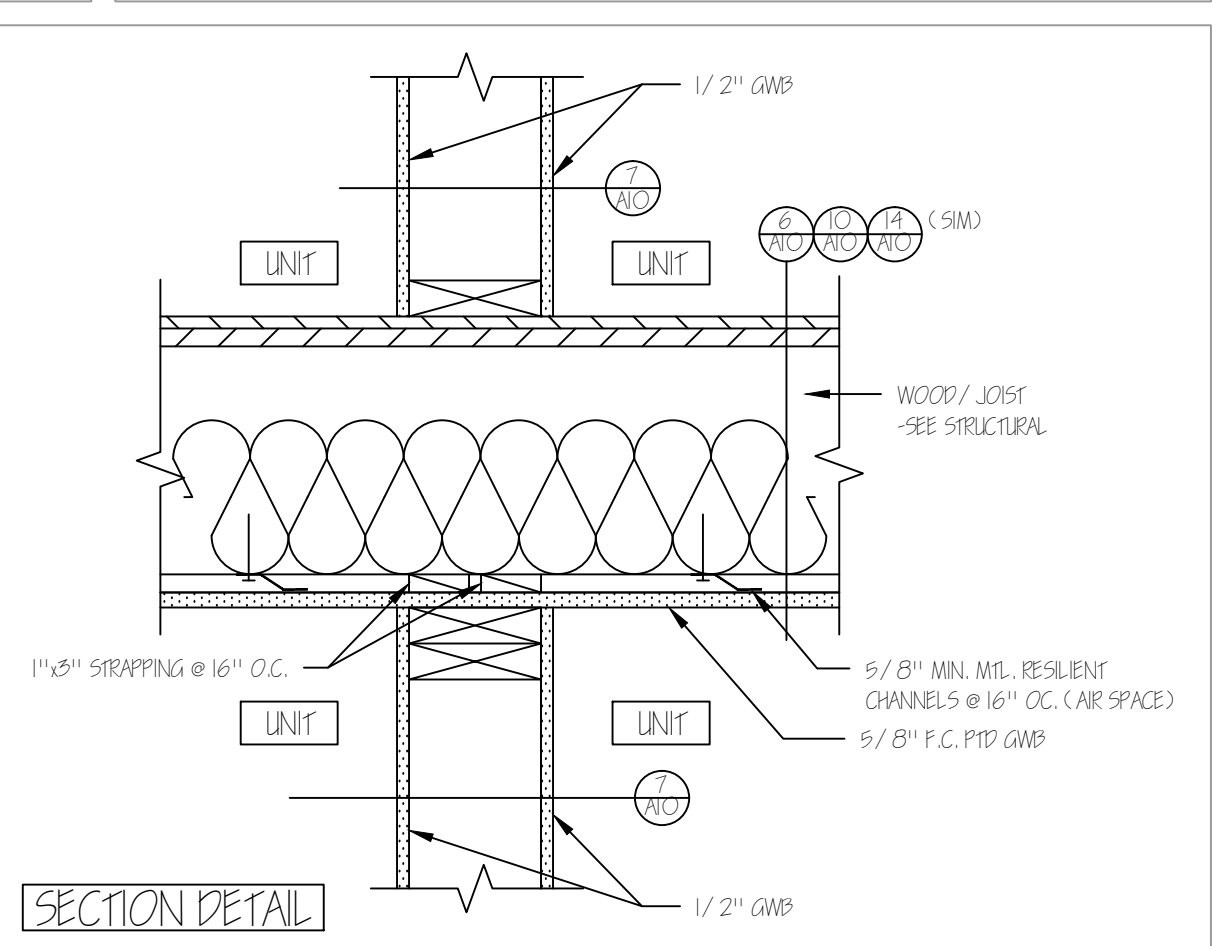
17 NON-RATED PARTITION @ 1 HR. FIRE RATED FLOOR/ CEILING ASSEMBLY 1 1/2"=1'-0"

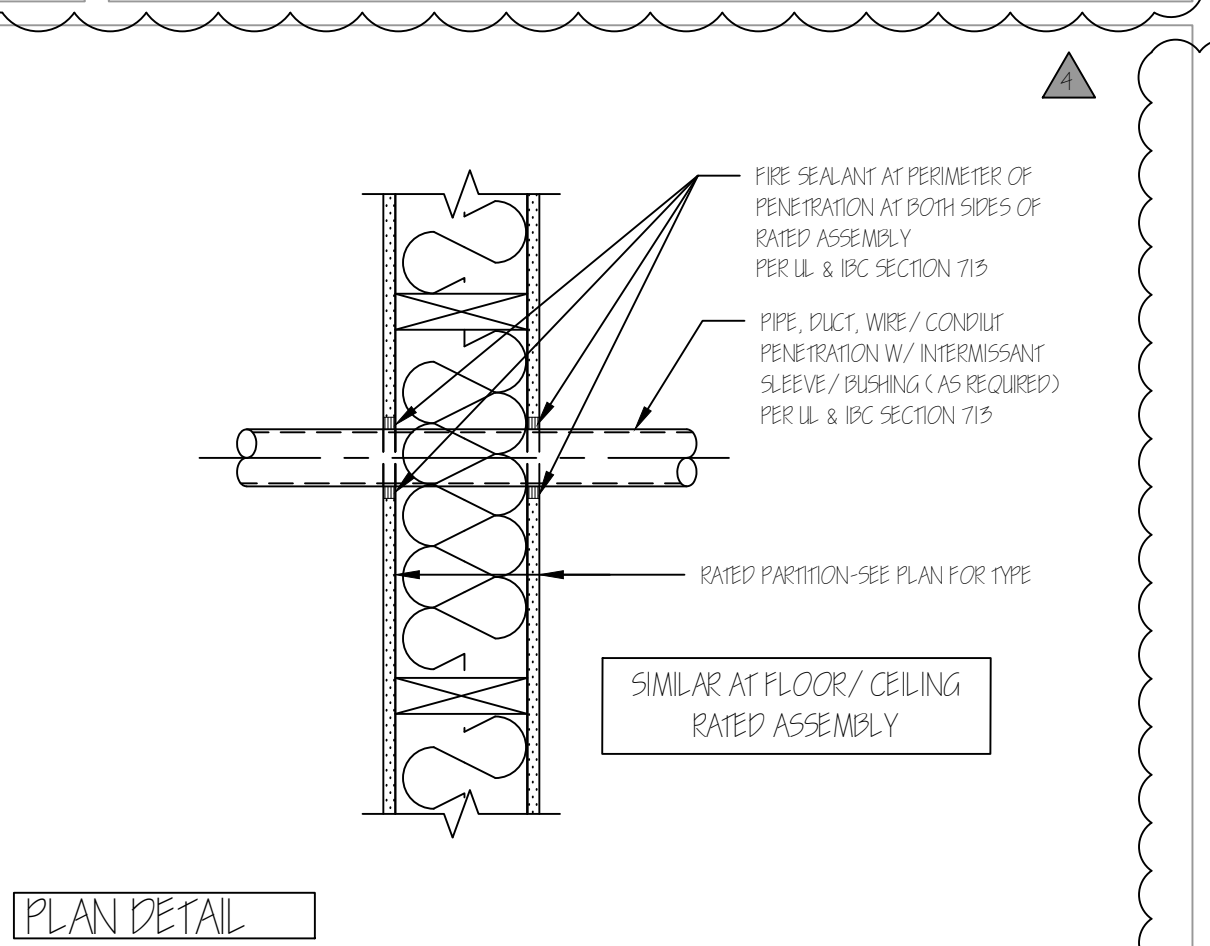
18 FIRE SEALANT @ PENETRATIONS 1 1/2"=1'-0"

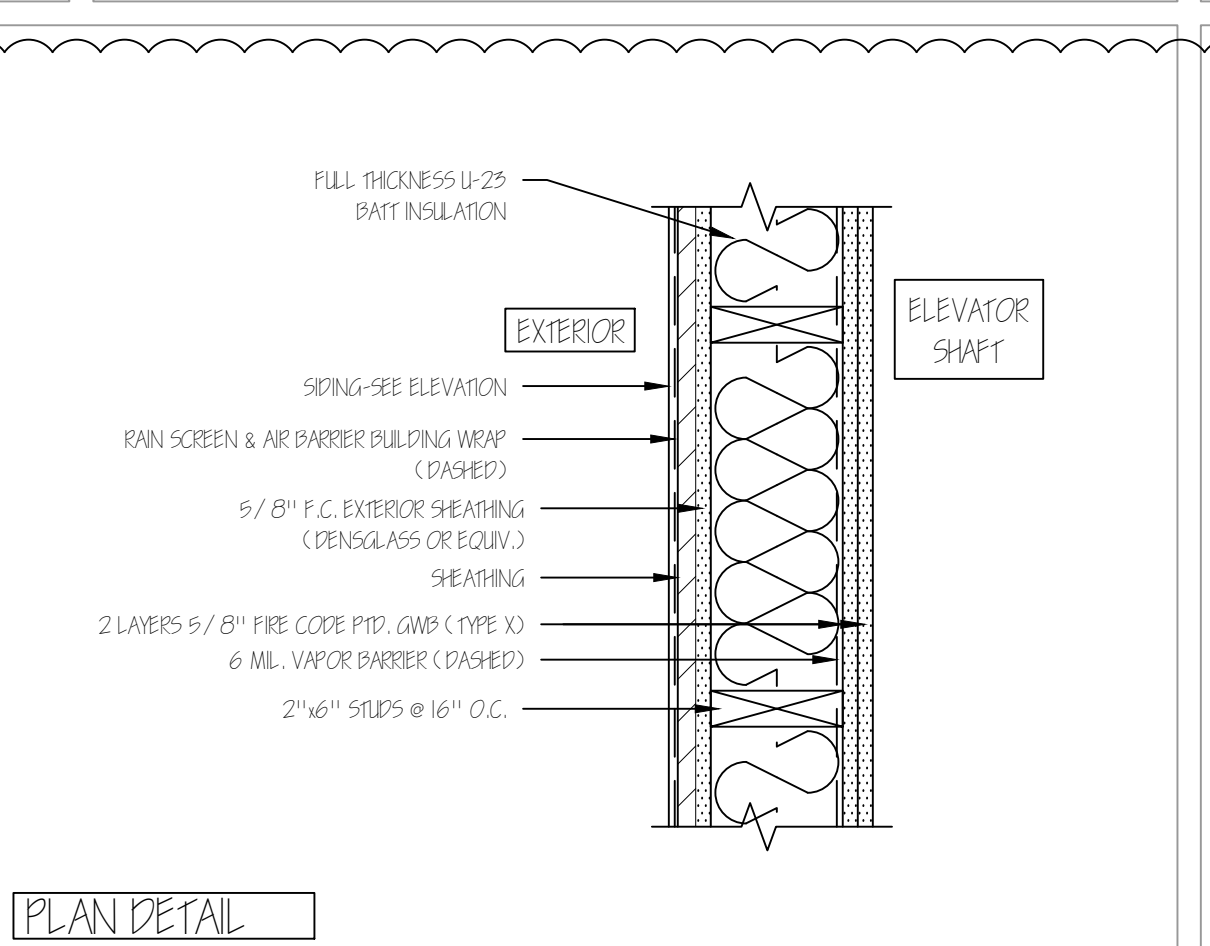
19 2 HR RATED EXTERIOR WALL @ ELEVATOR 1 1/2"=1'-0"

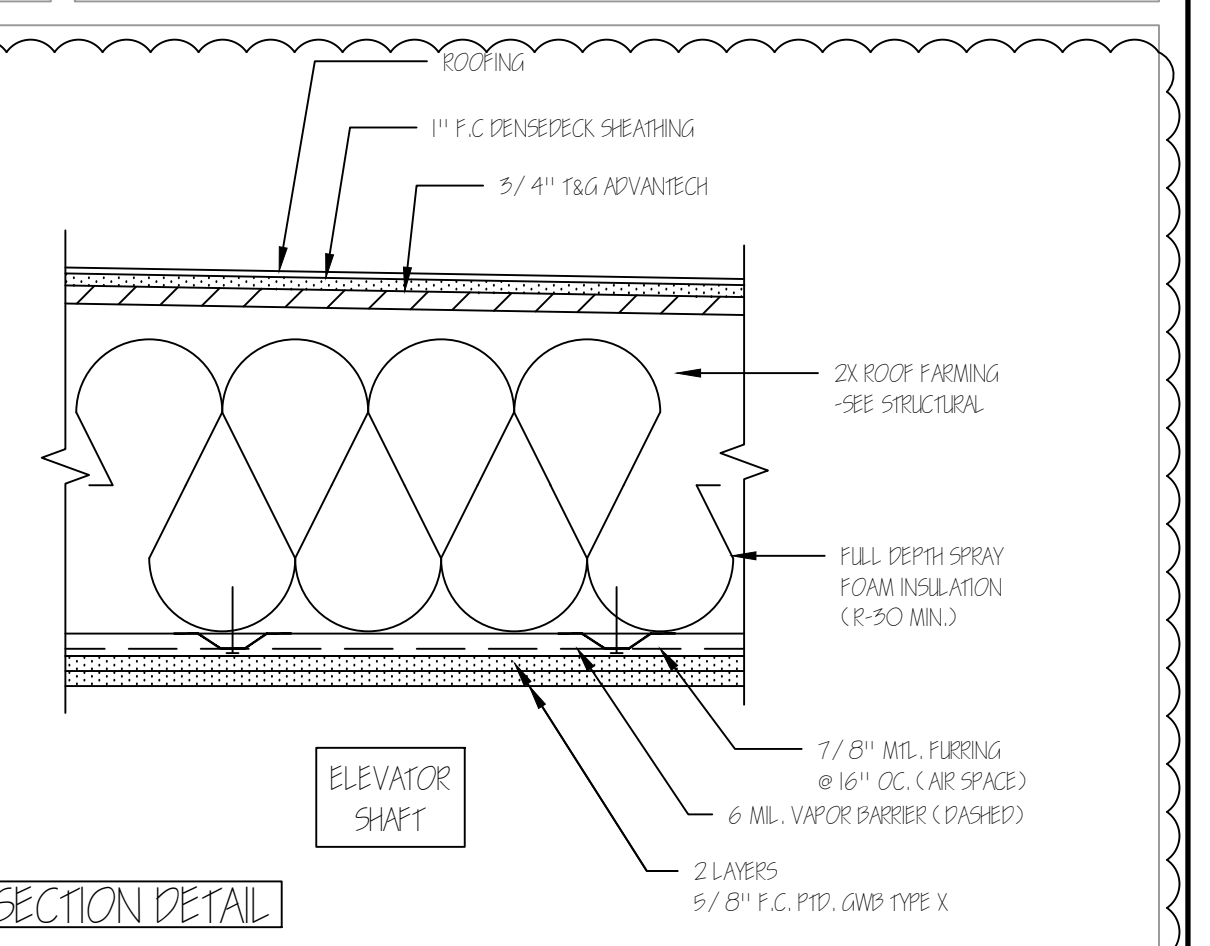
20 2 HR RATED CEILING/ ROOF @ ELEVATOR 1 1/2"=1'-0"
