**Research-Scale Fire Performance Evaluation  
of an Open Wood Floor Joist Assembly Coated  
with Albi Clad FP**

***ASTM E119-98: Standard Test Methods for  
Fire Tests of Building Construction and  
Materials\****

**Albi Manufacturing  
A Division of StanChem Inc.  
401 Berlin Street  
East Berlin, CT 06023**

**WFCi Report #04042(a)**

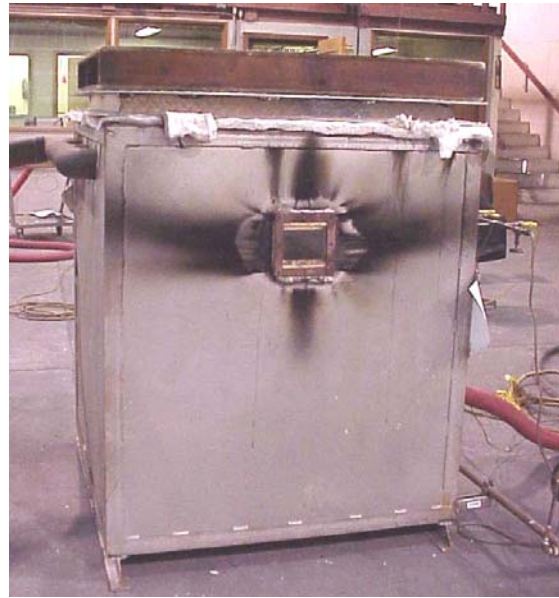
**FIGURE 1: HORIZONTAL FURNACE**

The furnace used in the test is a small-scale fire burning apparatus, fueled by natural gas (pictured at right.) The sample was mounted on to the top of the furnace horizontally. The exposed surface is subjected to the E119 time-temperature curve, while temperature measurements are taken from the unexposed surface, using a computerized data acquisition system.

The furnace valves are controlled based upon the average of the interior furnace temperature, which is determined from the internal thermocouples. Additional thermocouples are added to the unexposed surface of the specimen to monitor the specimen's temperature. Windows are provided in the sides of the furnace to allow viewing of the specimen's exposed surface and the taking of photographs during testing. Upon completion, or early termination of a test, the main gas supply valve is closed and the specimen is removed from the furnace, allowing for hose stream testing of specimen, if applicable, and allowing for post-testing observations.

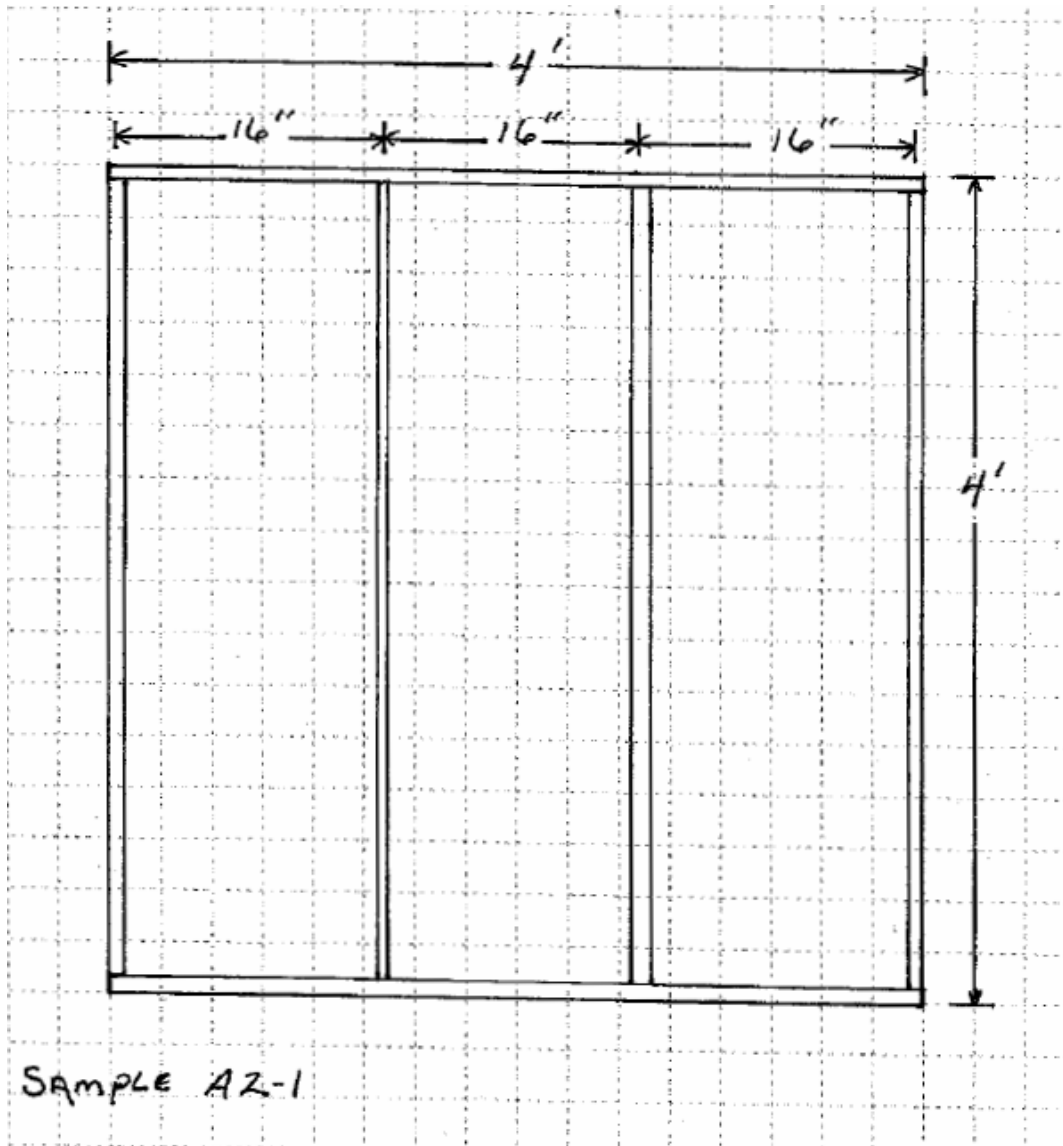
### Diagram 1: Sample Layout

The 4' X 4' wood floor joist assembly was constructed of rough cut (full dimensional) Douglas fire 2"X10"s to simulate a flooring section of an older building. The joists were spaced at 16" on center and the UL-labeled intumescent material, identified by the client as Albi Clad FP, was spray-applied to a wet film thickness of 40 mils (applied and measured by the client's representative) to the open joist area and bottom of floor decking on the exposed side. The floor decking consisted of 1"x4" fir tongue and groove subfloor covered by 5/8" CDX plywood decking.

The overall sample was identified by the client as **A2-1**.

The 4ft x 4ft floor joist assembly was constructed by the client's representative at the WFCi lab prior to testing. A description of the sample can be found on page seven of this report.

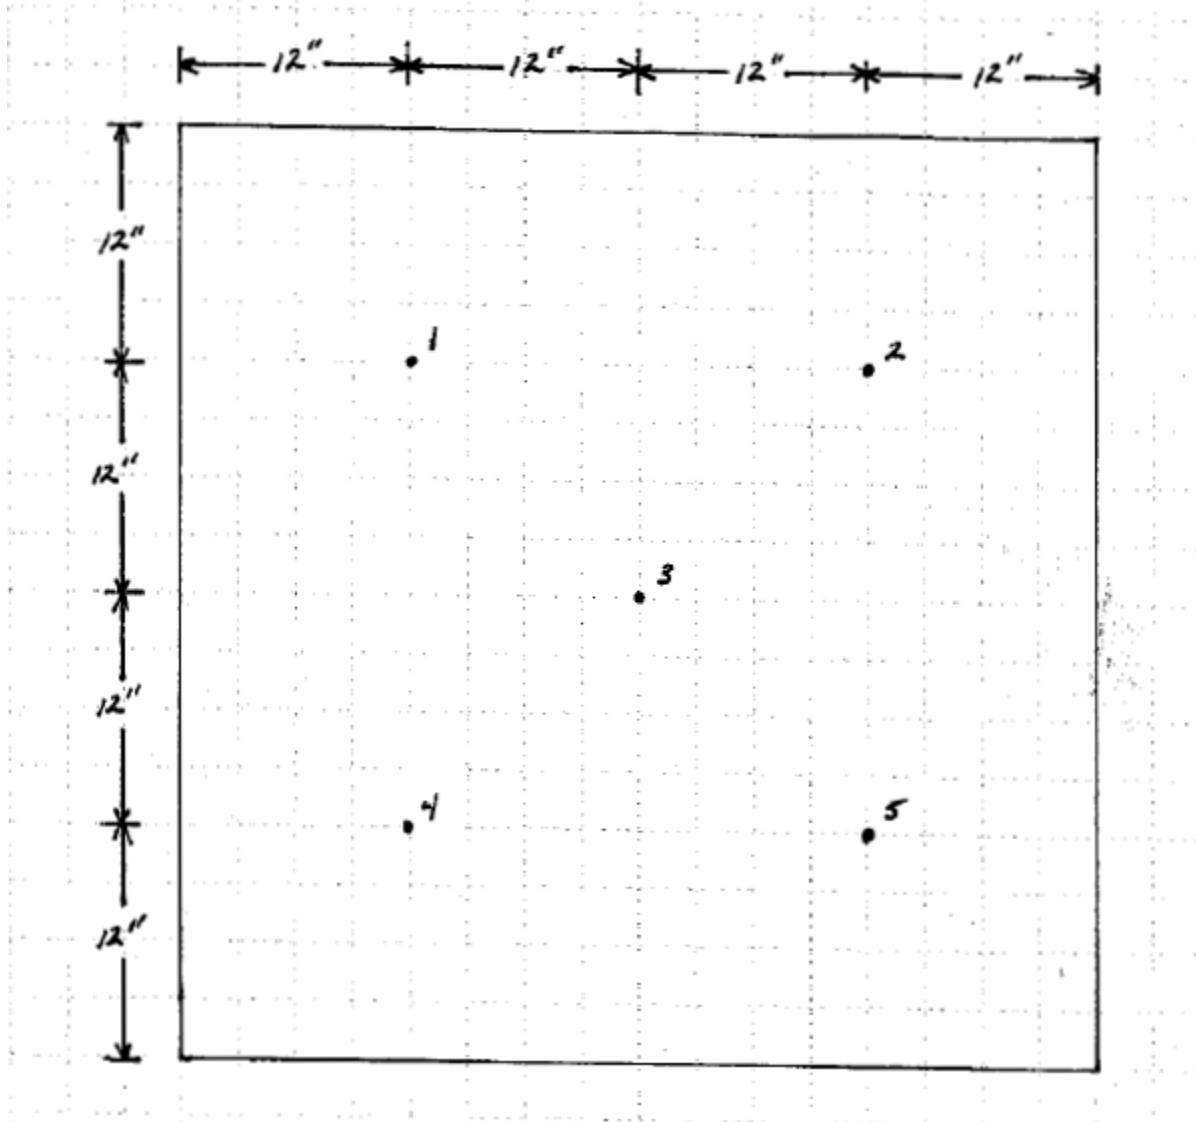
**Diagram 2: Thermocouple Layout**

The unexposed face of the floor construction was instrumented with 5 thermocouples to take temperature measurements throughout the test. These measurements appear in tabular form in the Test Data section of this report and in graphical form in Appendix A of this report.

Thermocouples 1-5 were located on the unexposed face of the wall construction. TC 3 was centered on the sample and TCs 1, 2, 4 and 5 were placed at quarter points on the upper left, upper right, lower left and lower right corners of the sample, respectively.

(See diagram on page 8 for locations)

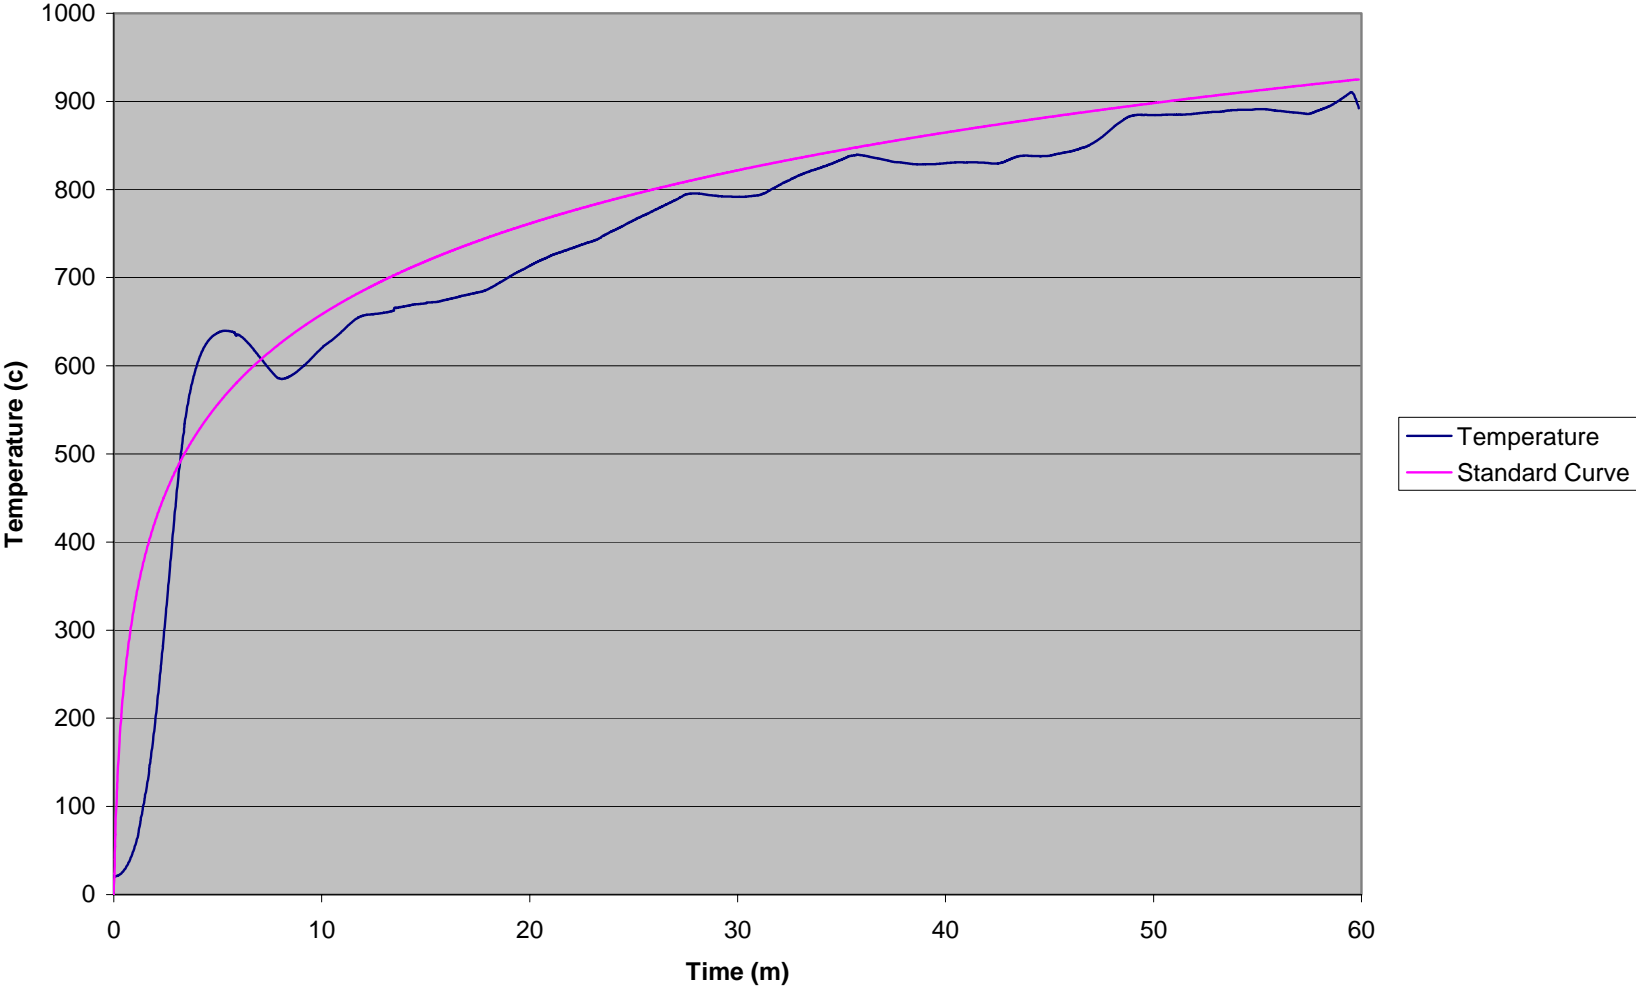
Chart 1: Furnace Temperature Vs. Standard Curve

Time	Total % of Standard Curve	Temperature (Celsius)	Standard Temperature
0:00:00	0	0	0
0:05:00	94.9	637.4	556.6
0:10:00	97.6	620.2	658.5
0:15:00	95.9	670.9	718.6
0:20:00	94.4	713.5	761.4
0:25:00	94.6	765.1	794.6
0:30:00	95.5	791.7	821.8
0:35:00	96.0	834.1	844.8
0:40:00	96.3	829.9	864.8
0:45:00	96.1	838.4	882.4
0:50:00	96.3	884.5	898.1
0:55:00	96.6	891.3	912.3
0:60:00	96.7	892.2	925.0

Furnace Temperature Vs. Standard Curve

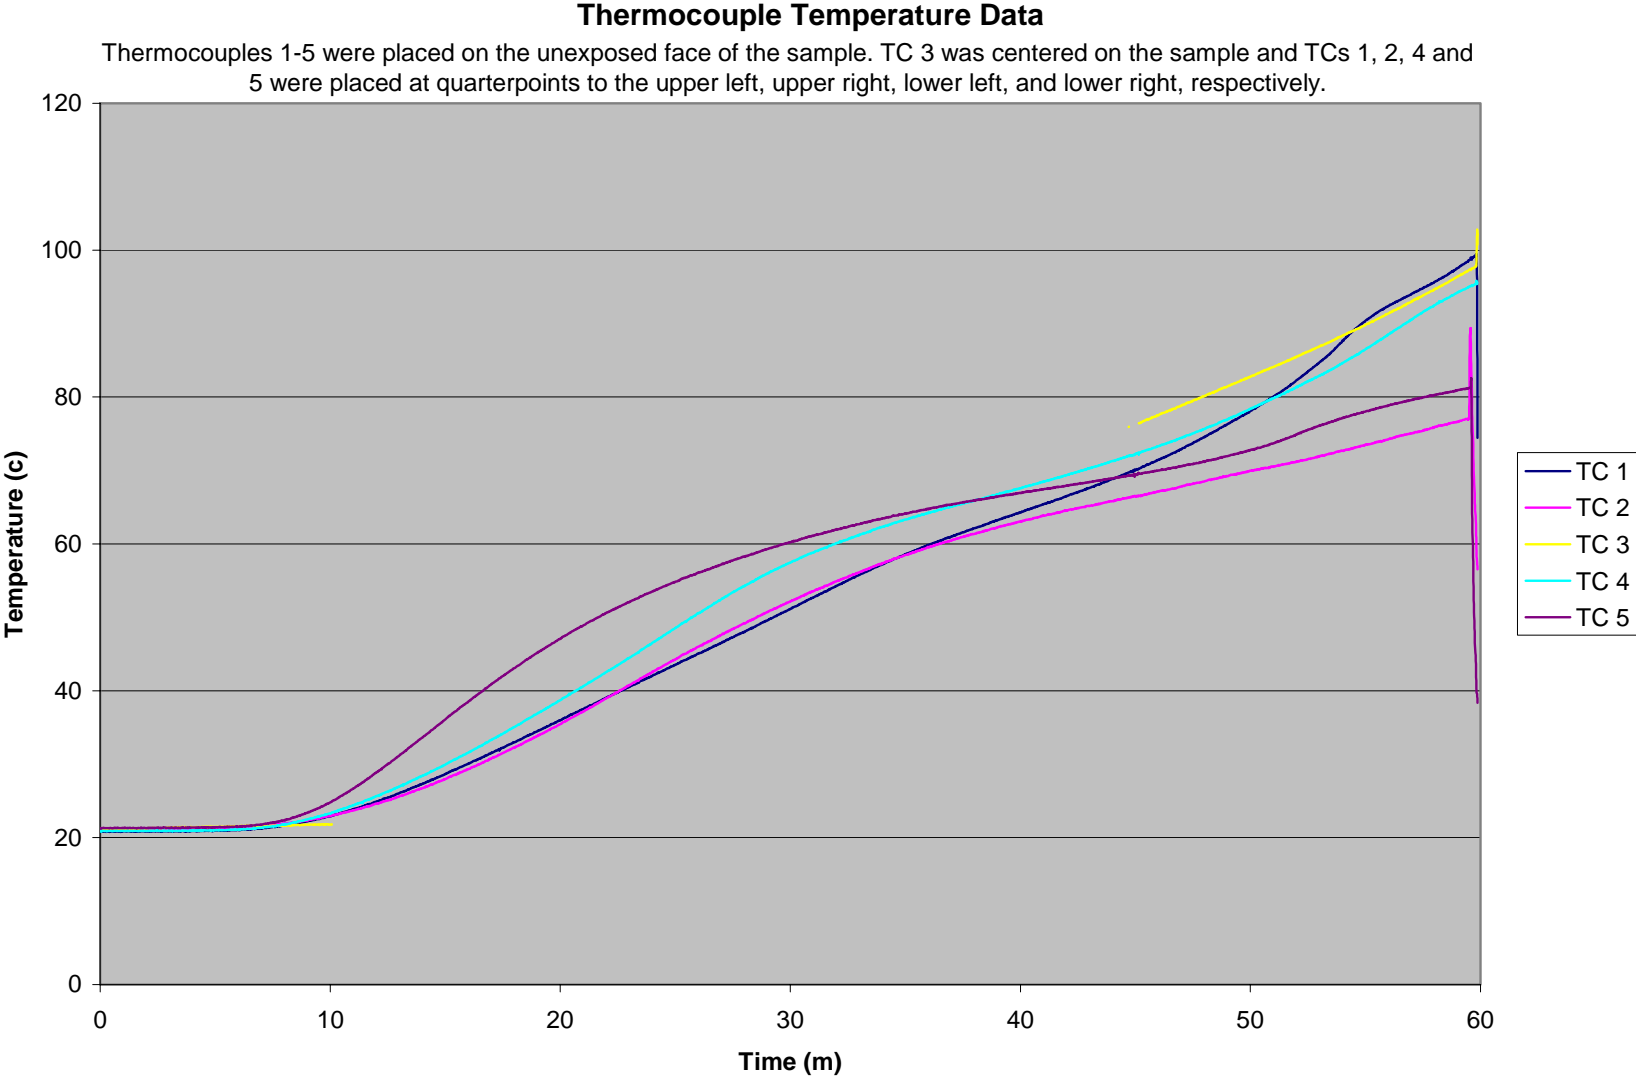
### Chart 2: Unexposed Face Thermocouple Temperatures

Time	Temperature (Celsius)				
	TC1	TC2	TC3	TC4	TC5
0:00:00	20.8	21.2	21.2	20.9	21.3
0:05:00	21.0	21.4	21.5	21.0	21.4
0:10:00	23.0	23.0	21.8	23.3	24.8
0:15:00	28.7	28.0	Malf.	30.0	36.1
0:20:00	36.0	35.5	Malf.	38.7	47.1
0:25:00	43.5	44.3	Malf.	48.6	54.8
0:30:00	51.1	52.2	Malf.	57.5	60.2
0:35:00	58.6	58.5	Malf.	63.3	64.1
0:40:00	64.3	63.1	Malf.	67.6	66.9
0:45:00	70.0	66.5	Malf.	72.2	69.4
0:50:00	78.1	70.0	82.8	78.4	72.8
0:55:00	90.4	73.5	89.9	86.5	78.0
0:60:00	74.4	56.5	100.8	95.6	38.4

The 4' X 4' wood floor joist assembly described in this report successfully met the temperature rise criteria for a 1 hour fire endurance period under conditions of this research-scale test. Temperatures on the unexposed side of the assembly remained below failure limits described above (with thermocouples 1, 3 and 4 peaking at around 100°C) and no flaming occurred on the unexposed side during the test. The load-bearing capability of this assembly was not assessed in this test.

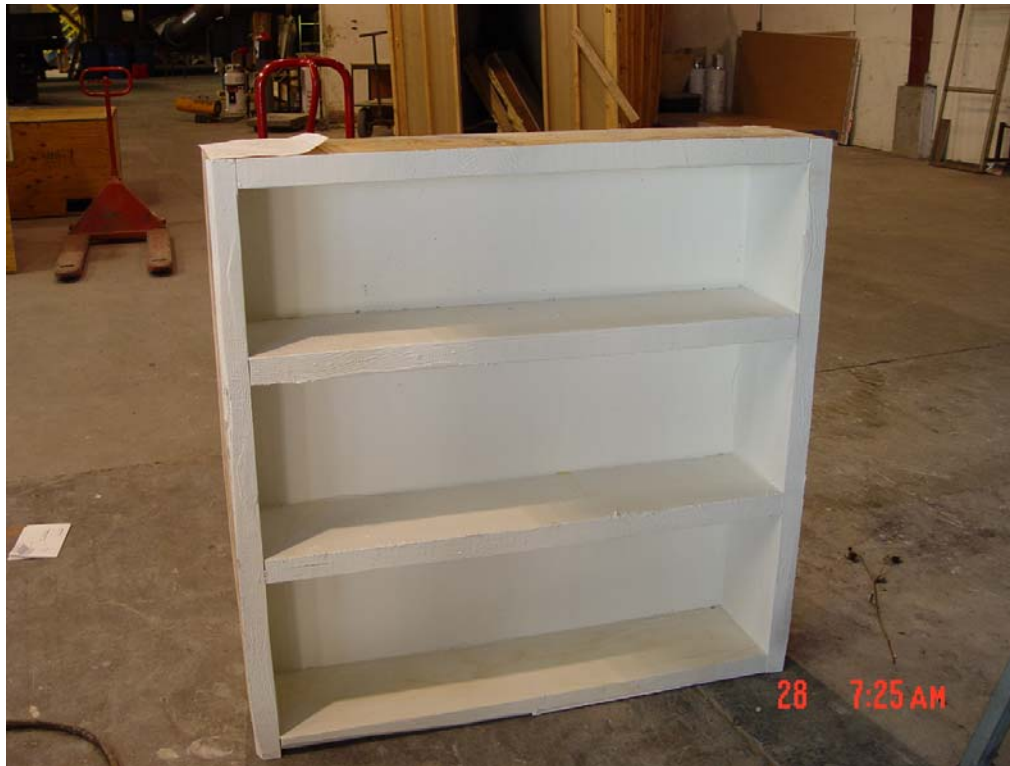
**Photograph 1: Exposed face of sample, pre-test**

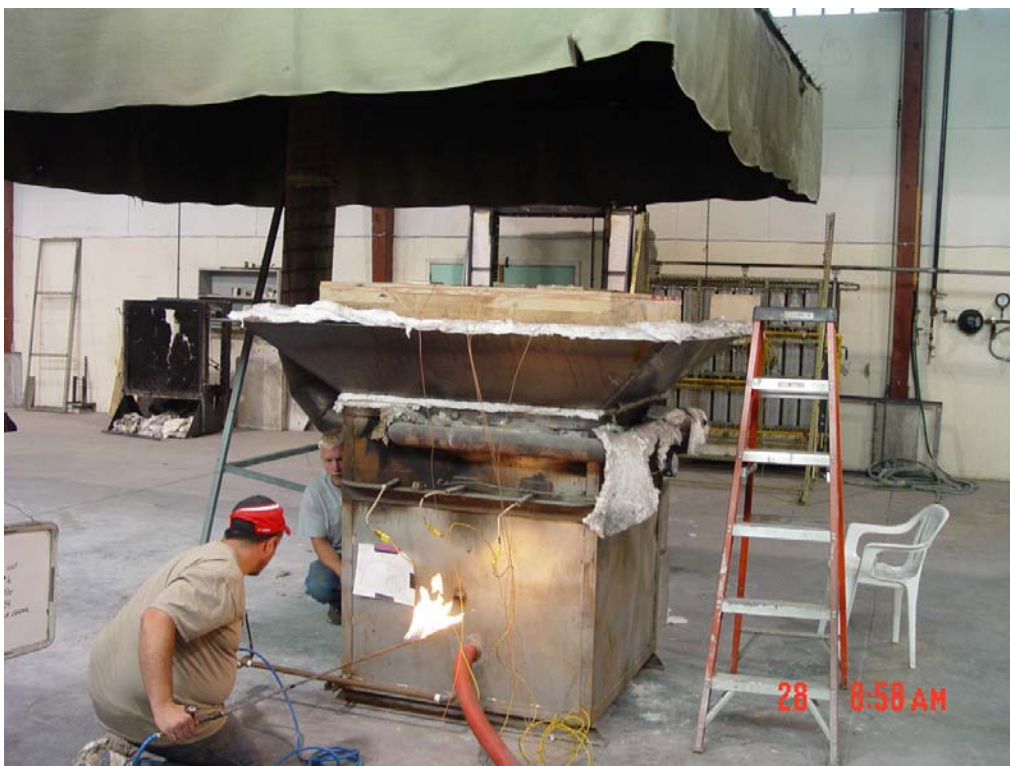
**Photograph 2: Sample mounted on horizontal furnace at start of test**

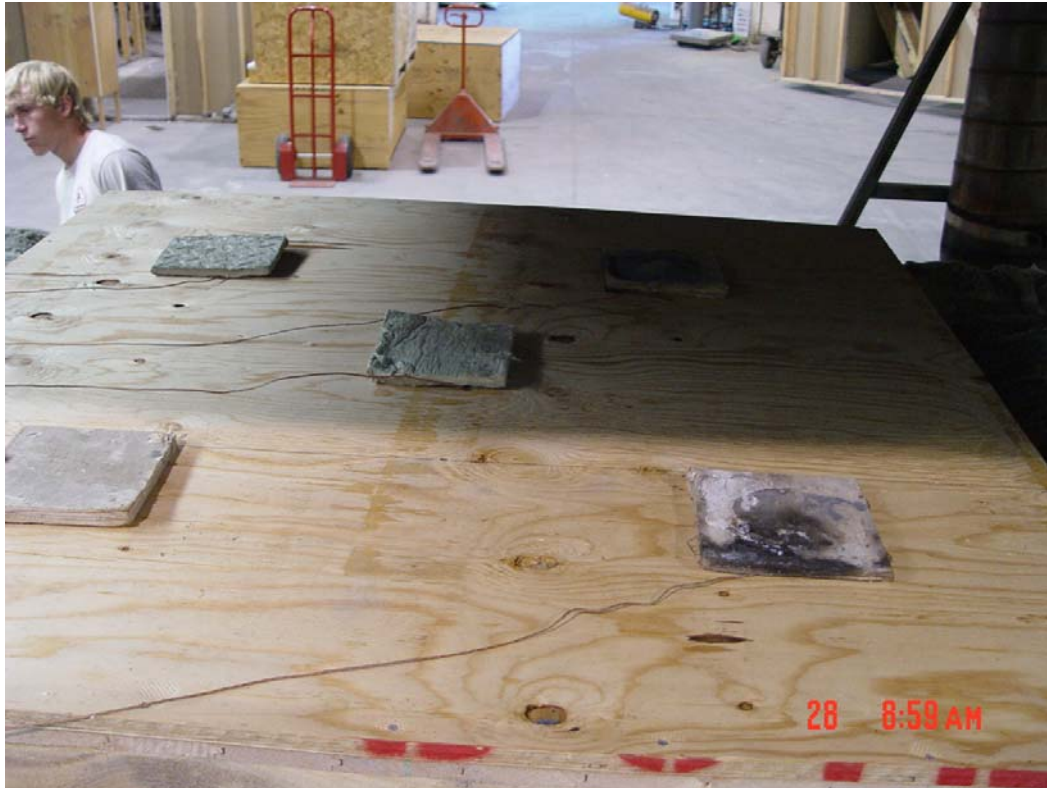
**Photograph 3: Unexposed sample face pre-test showing thermocouple placement**

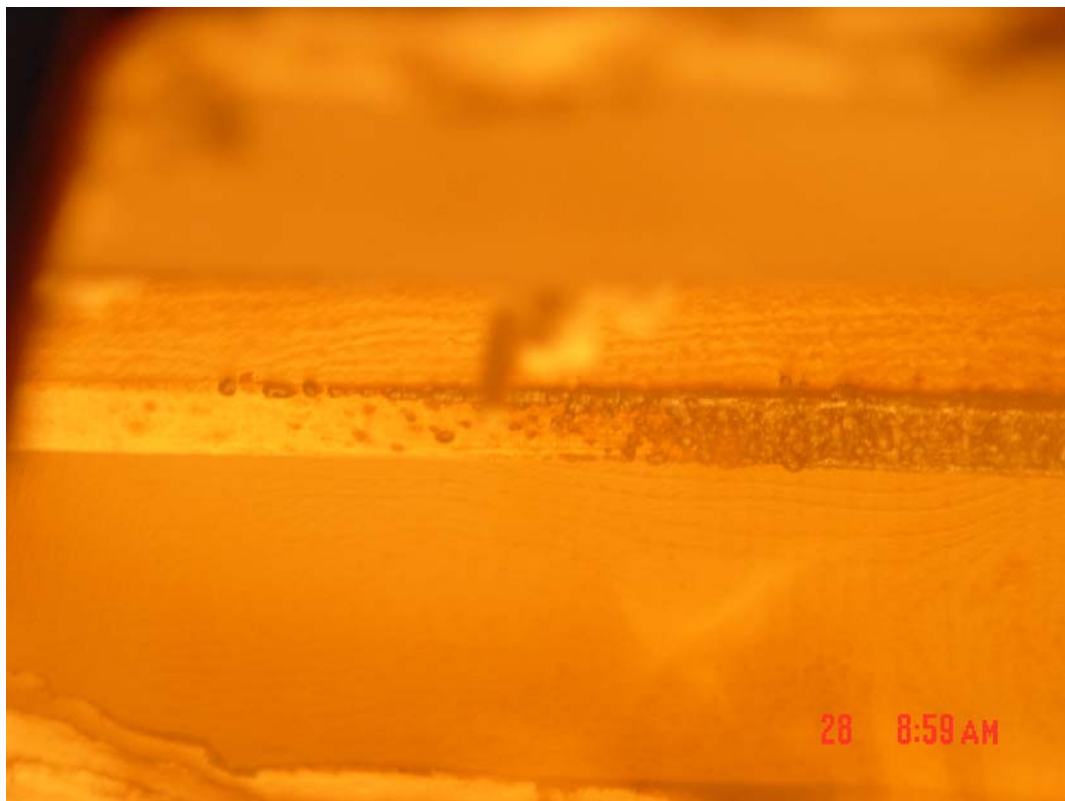
**Photograph 4: Coating intumescenting early in the test**

Test Time (h:mm:ss)	Event
0:00:00	Ignite Furnace, Start Test
0:00:47	Coating discoloring on joist edges
0:01:50	Joist edges black, joist face brown
0:02:30	Joist face black and intumescent

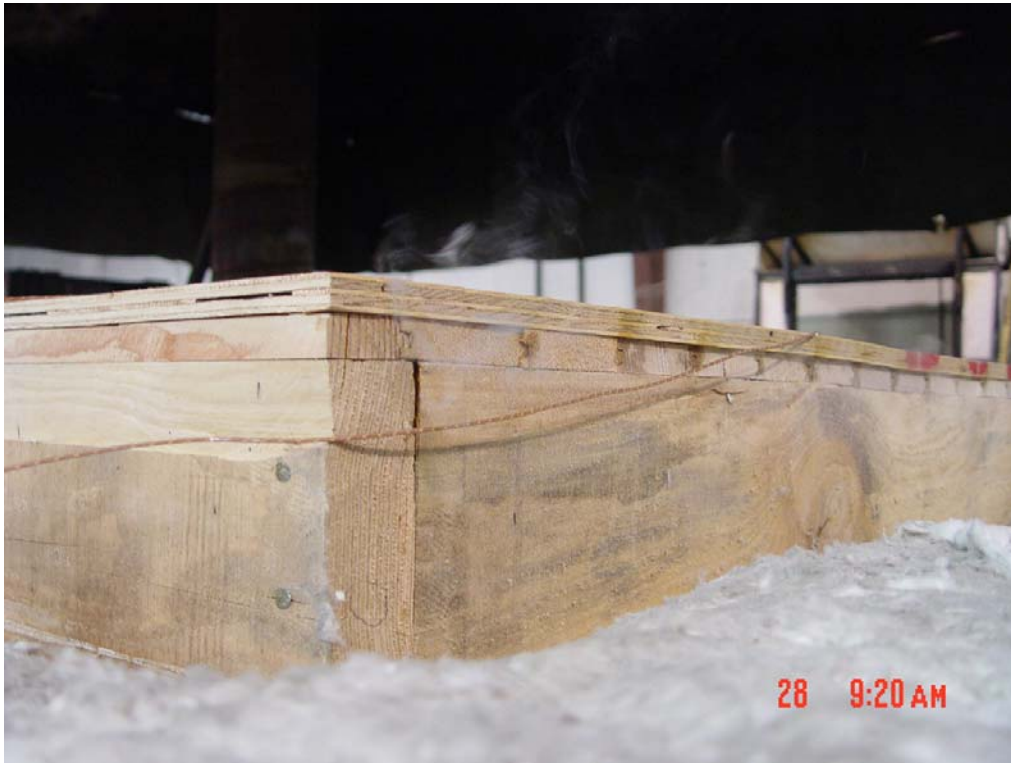
**Photograph 5: Light smoke leaking through the tongue and groove layer**

0:04:00	All surfaces are black and intumescent
0:11:55	Minor amount of smoke escaping from tongue and groove on left side
0:23:07	Cracks forming in the intumescent and flames attempting to attach at joist

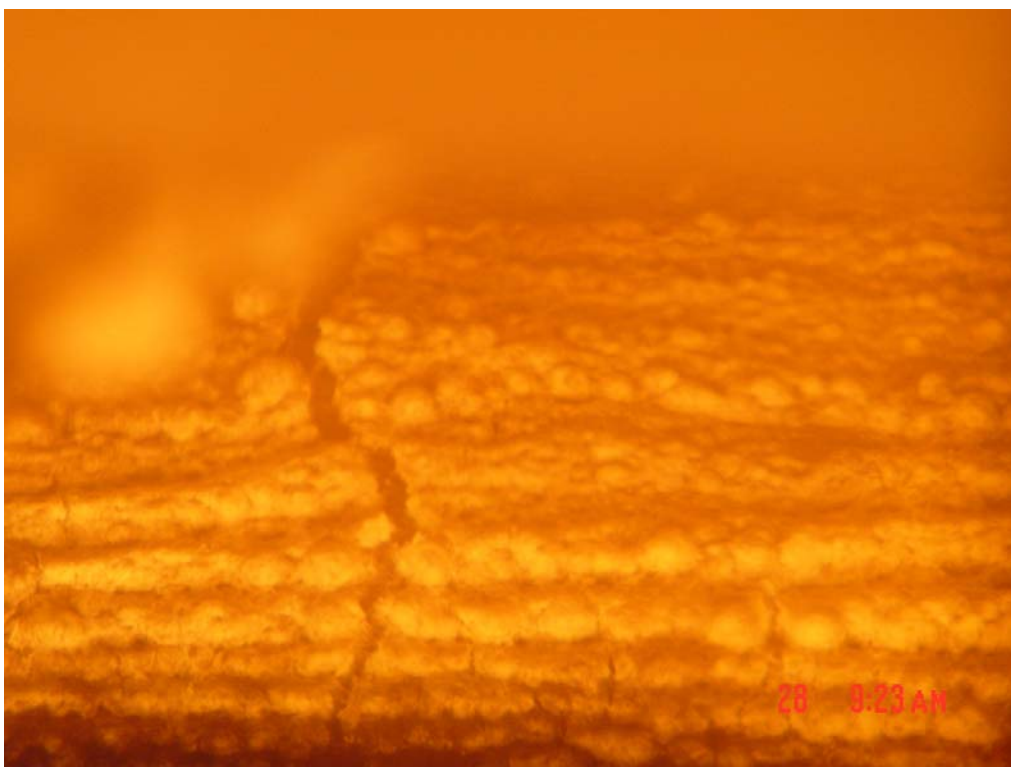
**Photograph 6: A crack forming in the intumescent coating during the test**

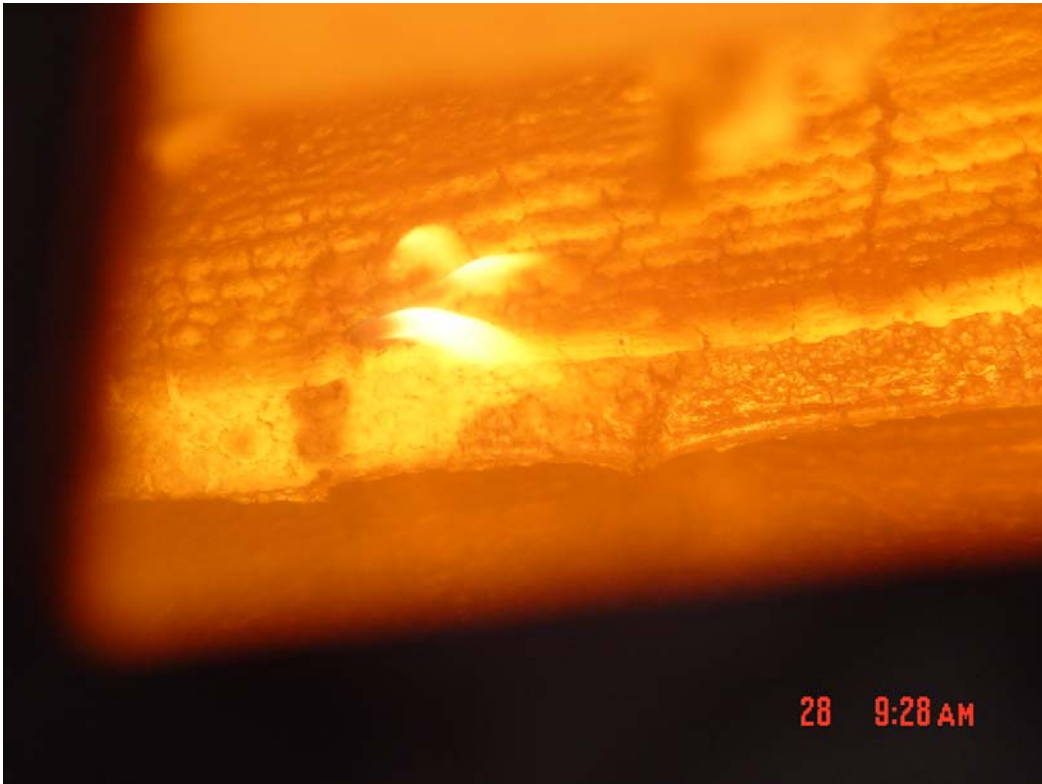
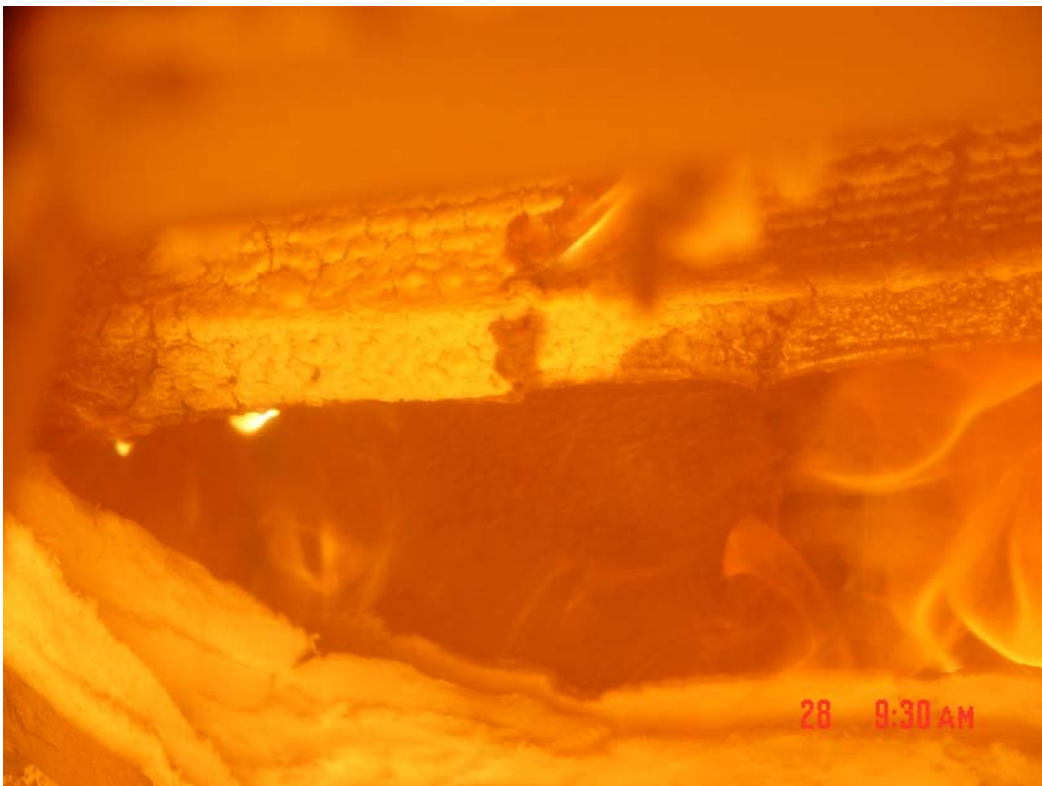
**Photograph 7: Flame attaching to the sample during the test**

**Photograph 8: Flame attaching to the sample during the test**

0:25:00	Intumescent coating turning white or ash color at flaming locations
0:27:43	Smoke escaping from all perimeters of unexposed side
0:31:23	Joists have attached flames

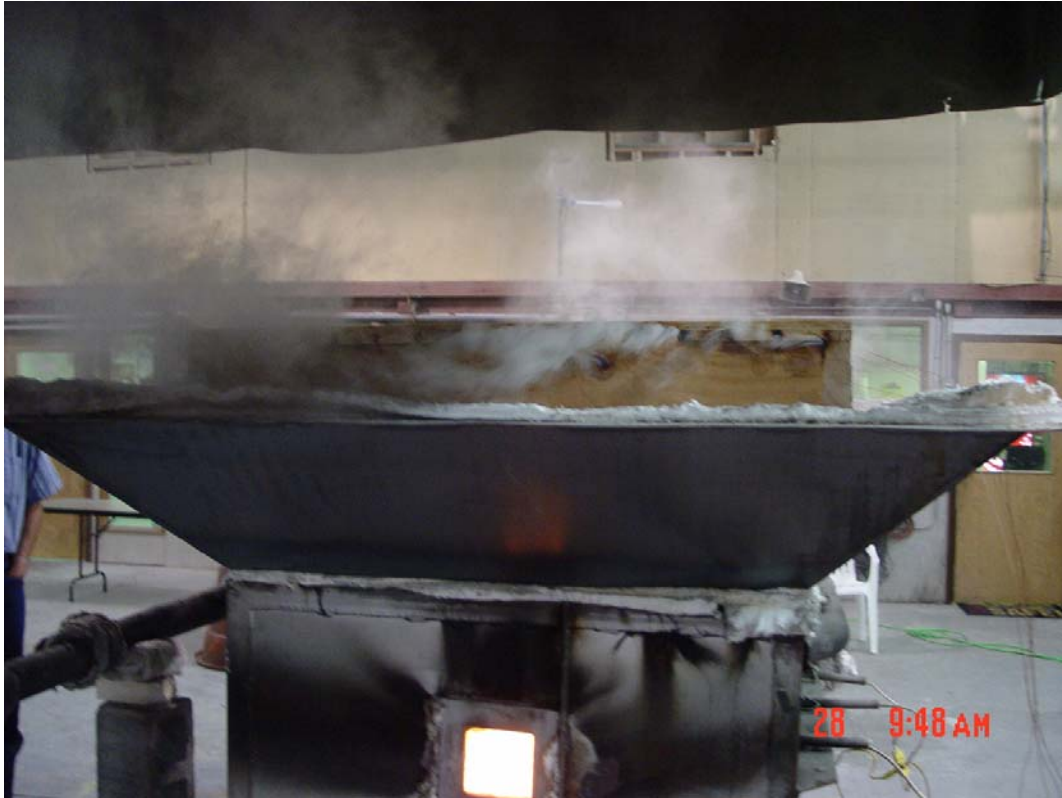
**Photograph 9: Smoke rising from the sample during the test**

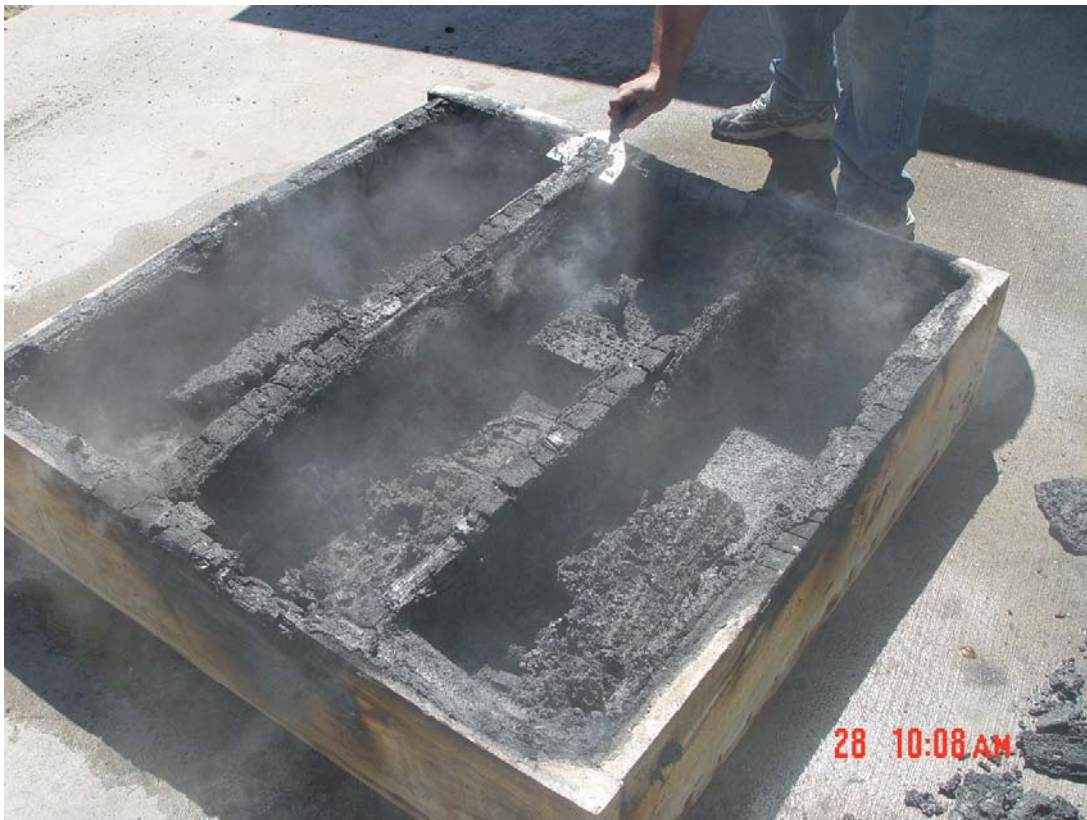
**Photograph 10: Sample post-test**

0:55:25	No change
0:57:55	Flames to exterior of sample at top between sample and furnace seal, flames smothered with Kao-wool
1:00:00	Stop Test
Post Test	Cavity intumescent thickness is approximately 2-15/16". Thickness on joist face is approximately 1-1/8", thickness on joist edge is unknown, all burned off

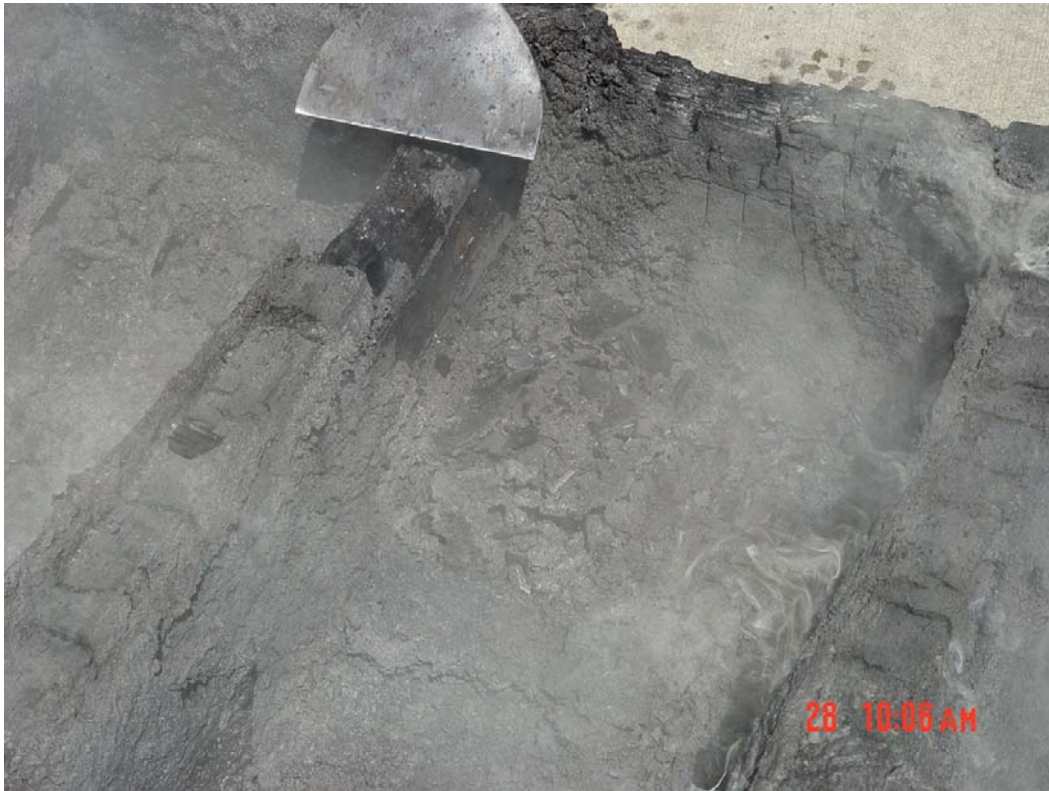
**Photograph 11: Intumescent being scraped away to show char depth**

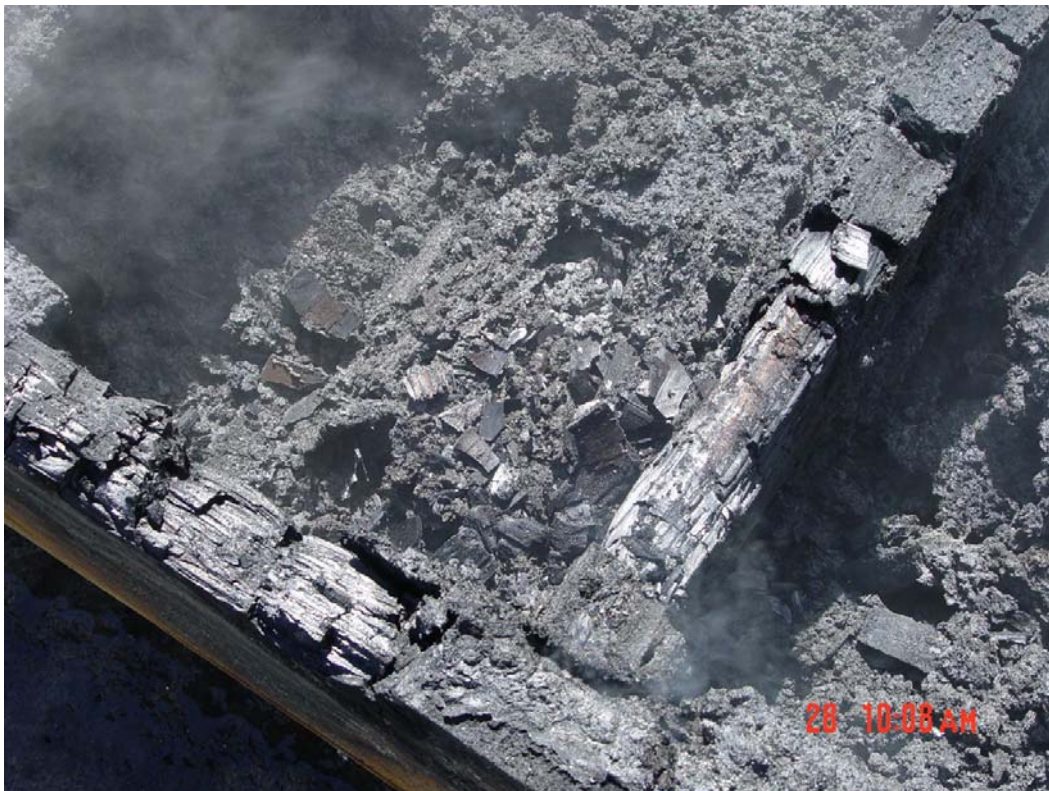
**Photograph 12: Exposed sample with coating scraped away**

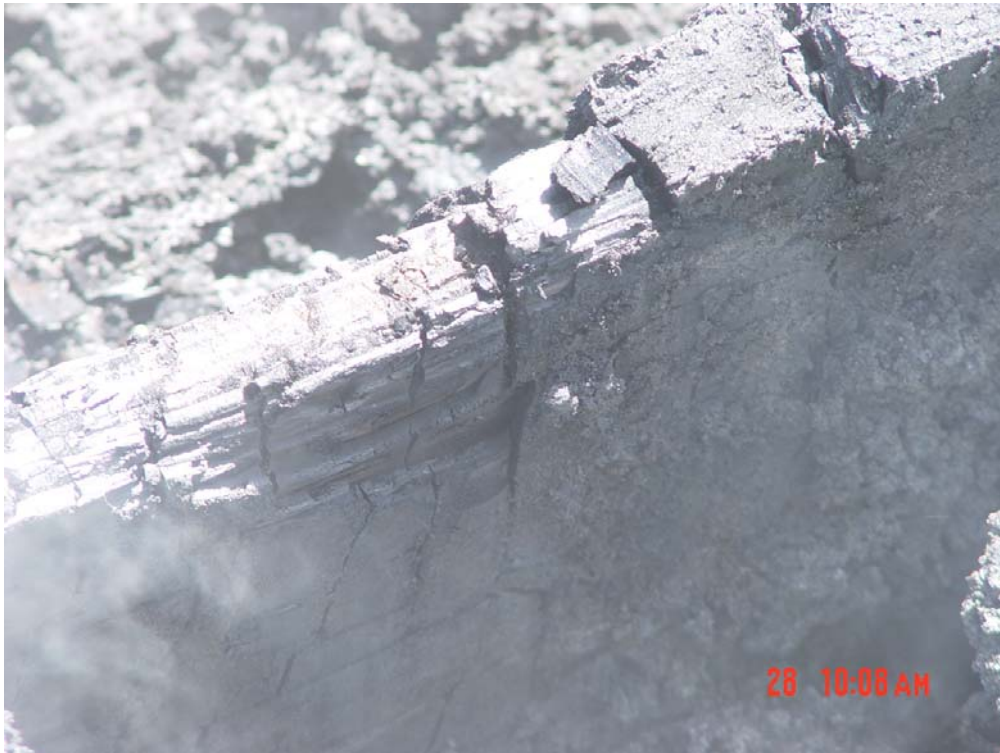
**Photograph 13: Close-up of an exposed joist with the intumescent scraped off**

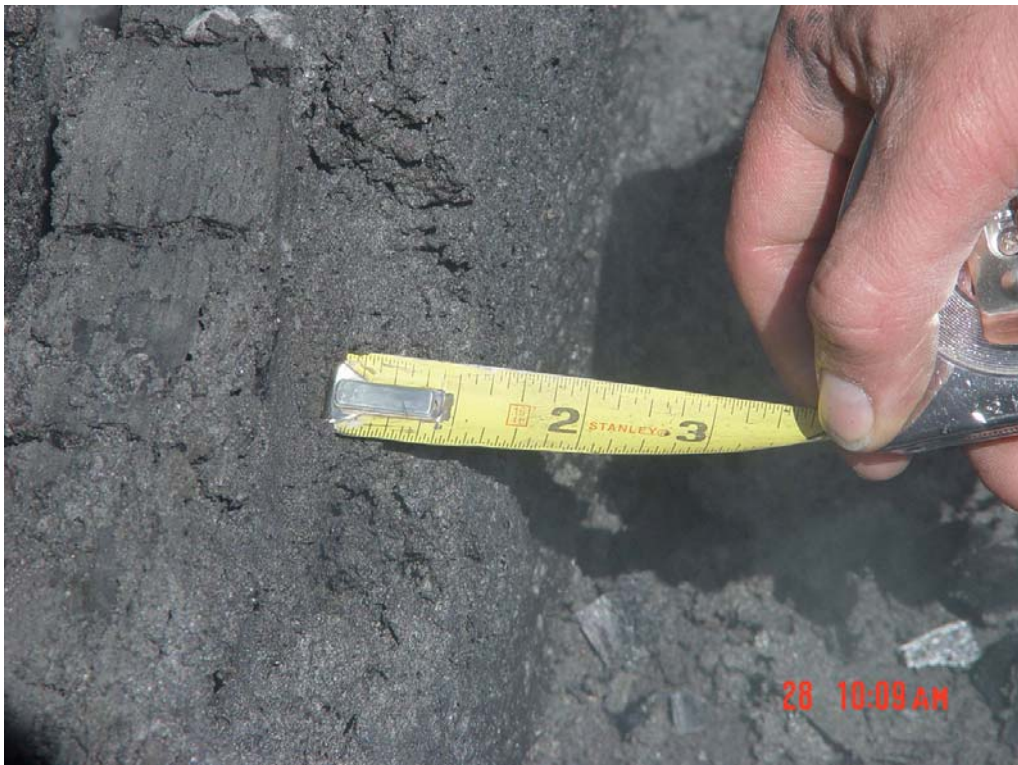
**Photograph 14: Measuring the intumescent depth on the side of a joist**
