FIRE TEST REPORT: 1-Hour Floor/Ceiling Assembly with 2 x 6 Wood Joists, 16" O.C.,
3/4" TruFlor O.S.B., 6" Fiberglass Insulation, 1/2" Regular
Gypsum Wallboard Ceiling Coated With 25-mil Thick Intumescent
Coating, ForceField Fireguard E-84.

MODEL, NAME & NUMBER: ForceField FireGuard E-84 Intumescent Coating,

STANDARDS TESTED TO: ASTM E-119-10a Floor/Ceiling; NFPA 251; UL 263, Small Scale
Test; CAN/ULC-S-101-07 With No Load Capacity.

REPORT NO: GL60911

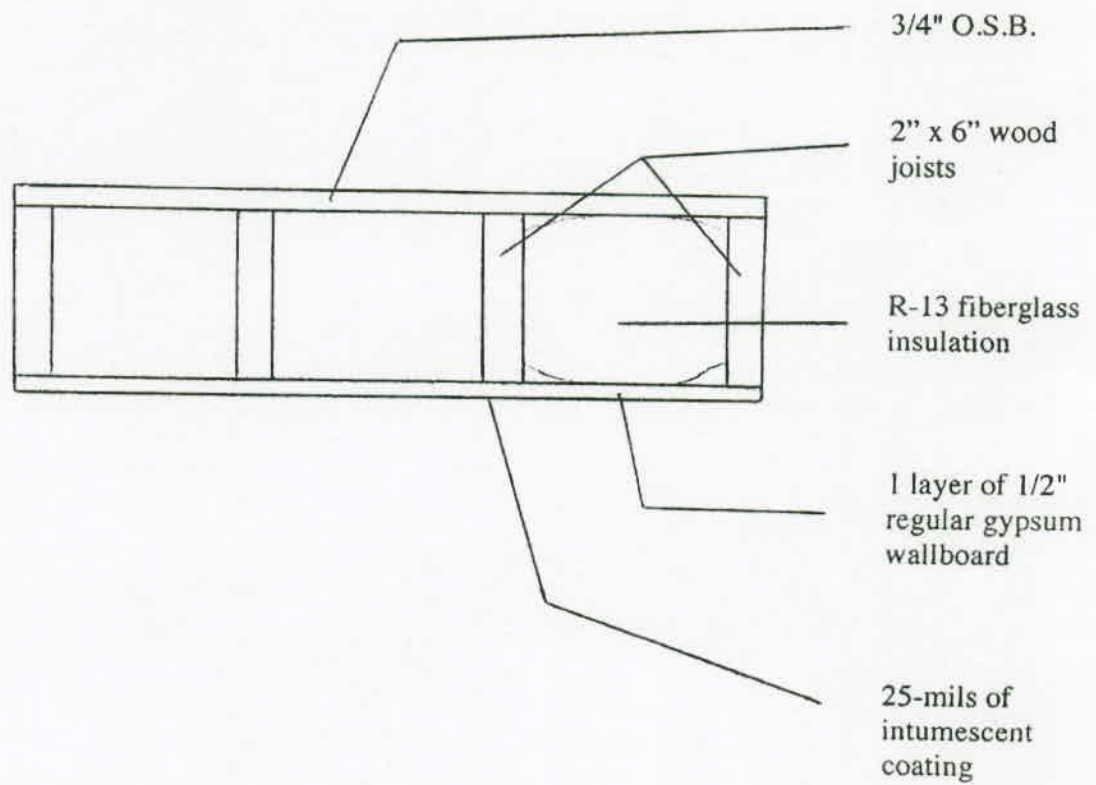
Assembly Drawing

Cross Sectional View

- a. Wood floor joists and headers—2" x 6", spaced 16" O.C.;
- b. floor--3/4" TruFlor oriented strand board (O.S.B.);
- c. 1 layer of 1/2" regular gypsum wallboard;
- d. 6" thick R-13 fiberglass insulation between the joists;
- e. 25-mil thickness of ForceField Fireguard E-84 Intumescent Coating.

- 2.2a Wood joists were spaced 16" on center with a rim header, nailed together with 10d common nails.
- 2.2b The O.S.B was placed on top of the joists on the unexposed side and was fastened with 1-5/8" screws. The test assembly was 4 feet x 4 feet.
- 2.2c 6" thick R-13 fiberglass insulation was installed between the joists.
- 2.2d 1 layer of 1/2" regular gypsum wallboard was attached to the joists and headers with 1-5/8" screws 8" O.C.
- 2.2e 25-mil thick coating of intumescent coating on the face of the 1/2" regular gypsum wallboard.

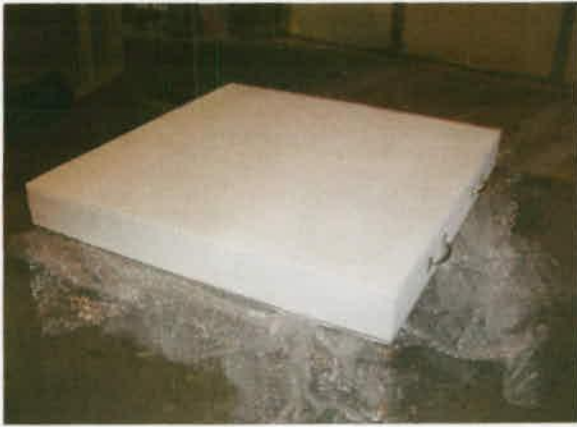
Before test: test sample ceiling, side to be exposed

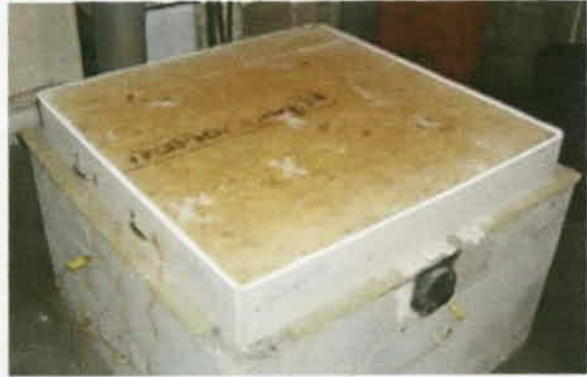
unexposed side, floor

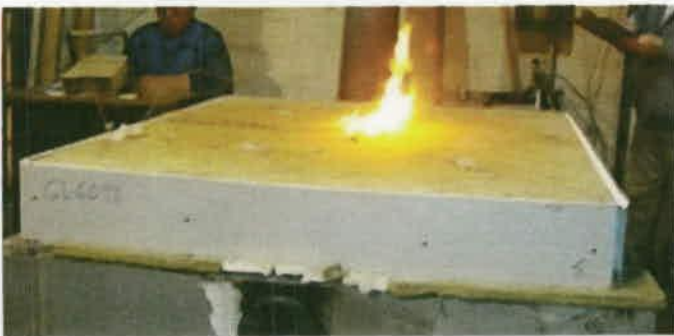
After test: unexposed side; 01:01

<u>Test Time Minutes</u>	<u>Observation- FireGuard E-84</u> <u>thickness of coating: 25 mil</u>
0:00	Test start time of day 8:54 am, gas on
0:03	Intumescing, bubbling and charring
0:07	Entire surface intumesced
0:15	No change
0:20	No change
0:25	No change
0:30	Piece of intumescent coating fell off at #7-10 T/C area
0:32	Crackling and popping sounds
0:34	Pieces of intumescent coating fell off at #8 and #6 T/C area
0:37	Pieces of intumescent coating fell off at #9 and #6 T/C area
0:43	Crackling sounds
0:48	T/C #8 steam-vapor
0:55	Steam vapor and crackling sounds
0:58	Unexposed surface- char-brown marks on near #8 T/C
0:59	Unexposed surface- embers near #8 T/C
0:59:40	Unexposed surface- Flaming, test terminated.

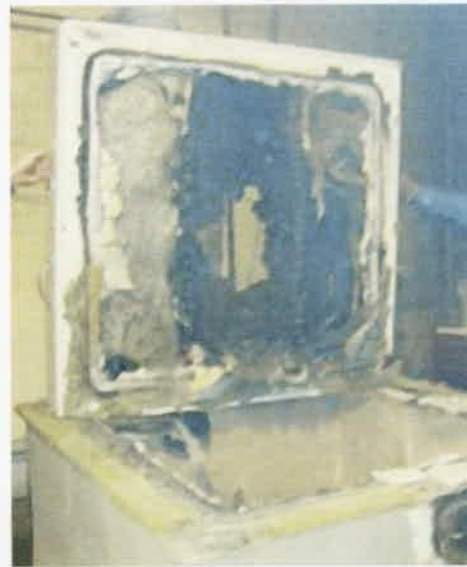
After test: exposed side
