Carriage House Rear Wall: View of in-place wall reinforcement, showing depth of footing below bottom of timber beam.

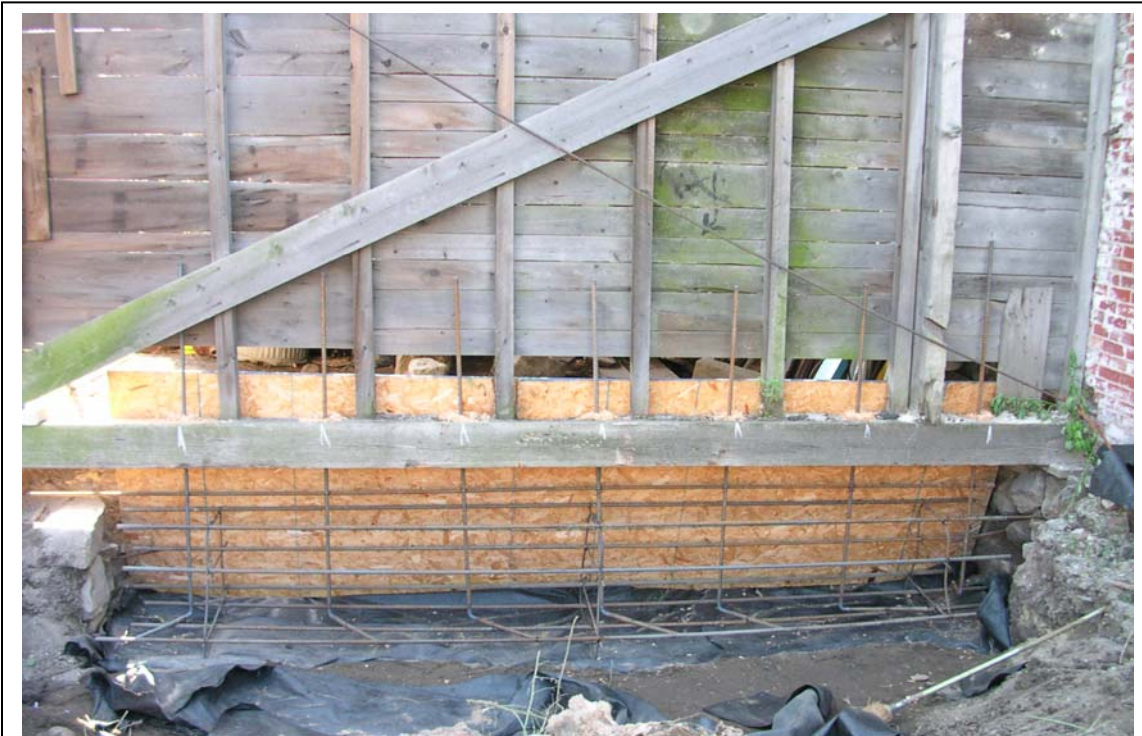
PHOTO
1004.2
1004 008.jpg

Carriage House Rear Wall: Filter fabric and crushed stone in place, prior to installing rear form and placing concrete.

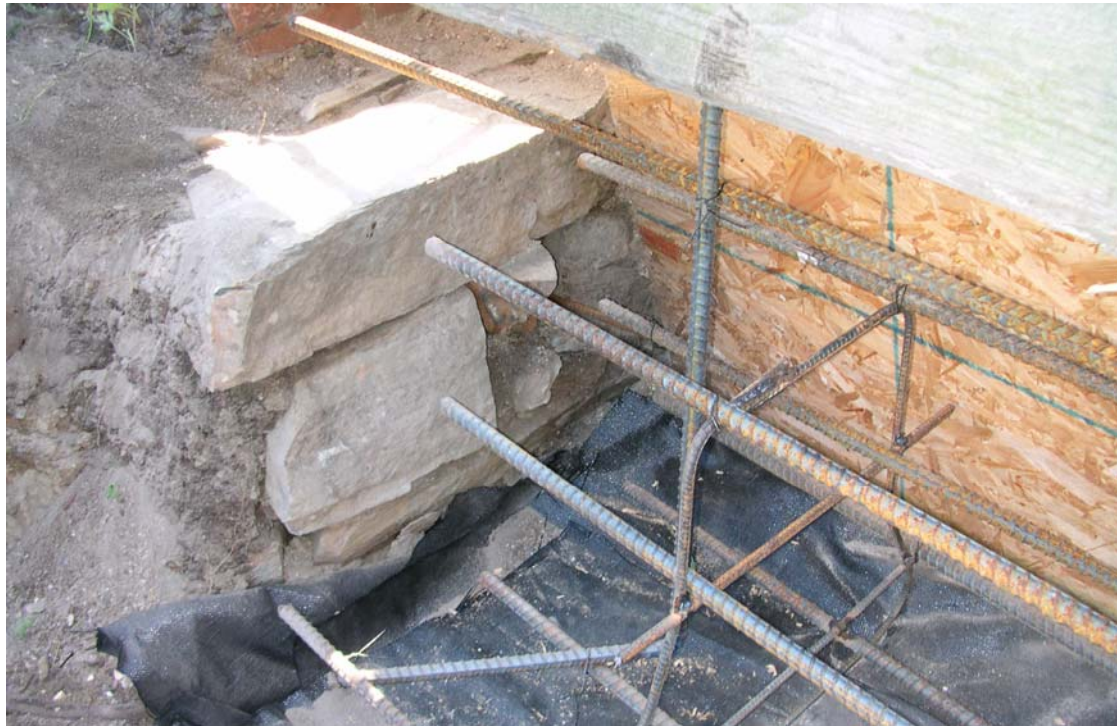
**PHOTO
1004.3**
1004 009.jpg

Carriage House Rear Wall: Archway end of wall foundation, prior to cleaning and installing dowels into rubble voids.

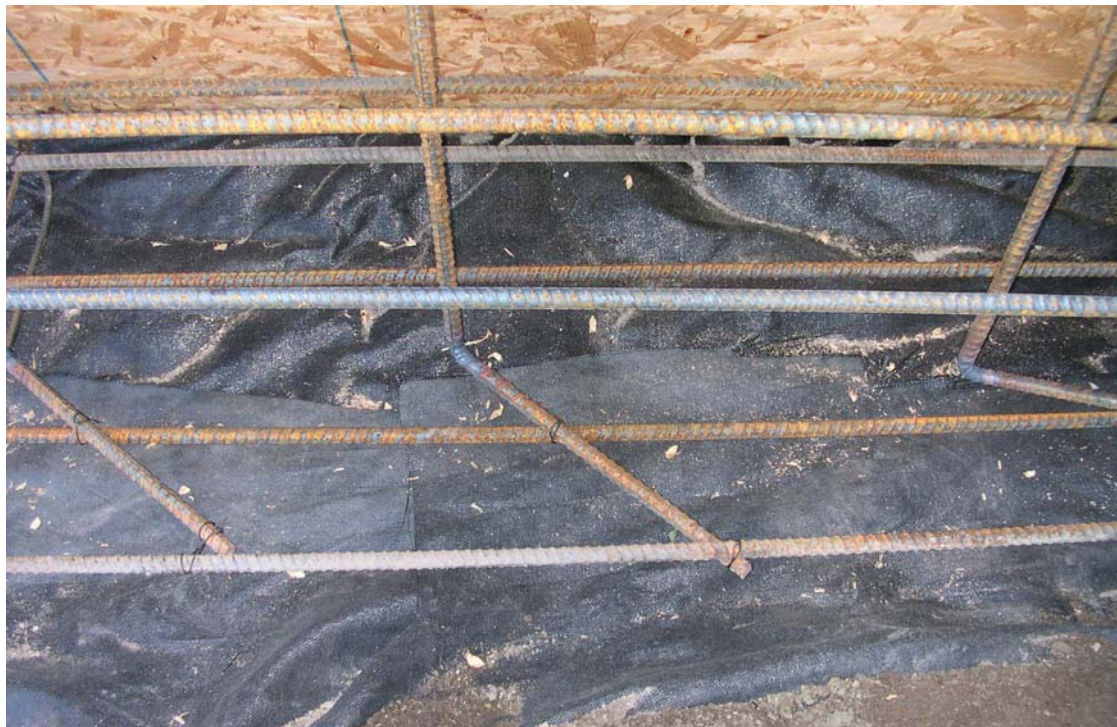
**PHOTO
1004.4**
1004 003.jpg

Carriage House Rear Wall: Photo showing bottom reinforcing steel.
