WEEKLY FIELD REPORT

Project OCEAN GATEWAY PARKING GARAGE
Location PORTLAND, MAINE
Client RIVERWALK, LLC.
Contractor LEDGEWOOD CONSTRUCTION (CM)
M.C. HALL, INC. (DEMOLITION)

Report No. 1
Period From 9 April 2007
To 20 April 2007
Page 1 of 2
File No. 30322-030

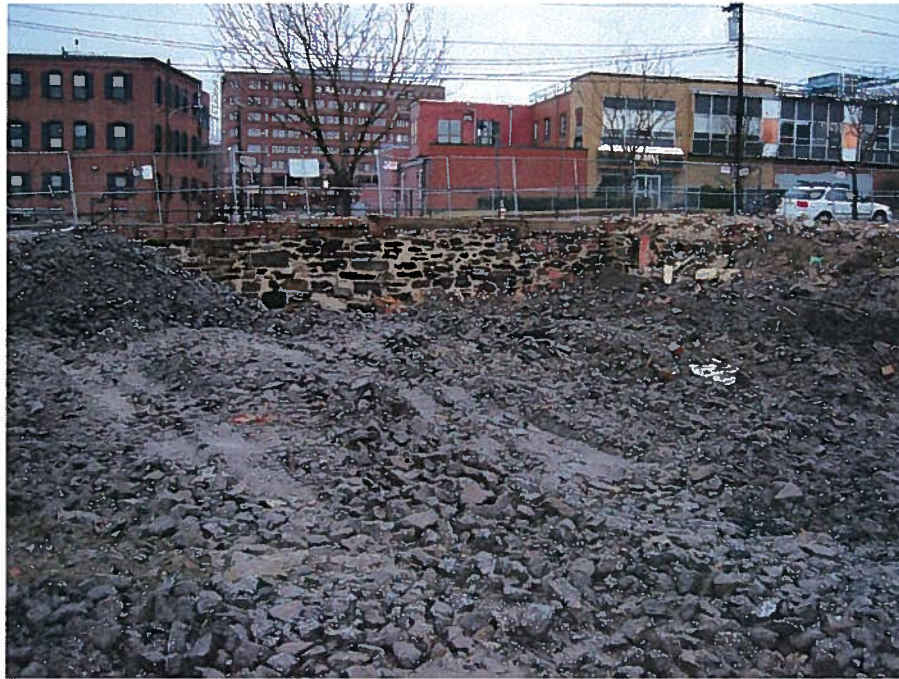
Photograph 1. Space formerly occupied by The Breakaway Tavern, looking south at India Street and the Jordan's Meats property. The basement foundation wall is visible with partial filling of the "below grade" space (4/18/07).

1. Demolished the eastern portion of the former Breakaway Tavern building (see attached photographs) including the lower level foundation walls and ground floor slab. This portion of the building was a three-story structure with a full basement level. The top of the ground floor slab was at approximately El. 24 to El. 24.5 with the basement level slab at approximately El. 14.5 to El. 15 (based on an optical survey performed by Haley & Aldrich). The above-grade portion of the building was previously demolished and hauled offsite exposing brick and mortar foundation walls and a concrete floor slab in the "below grade" portion of the building. The existing foundation walls along India Street and Fore Street (see Figure 1 and attached photographs) were left in place in order to provide support to the adjacent sidewalk during the removal of the basement floor slab and spread footing foundations. The remaining two foundation walls (north and west walls; see attached Figure 1) were removed and hauled off site. The basement floor slab and floor slab for the "at-grade" portion of the building was approximately 3 to 4-in. thick and consisted of mesh reinforced concrete. The basement portion of the building was backfilled with imported sand/gravel. The fill was end-dumped and was not placed and compacted in engineered lifts.

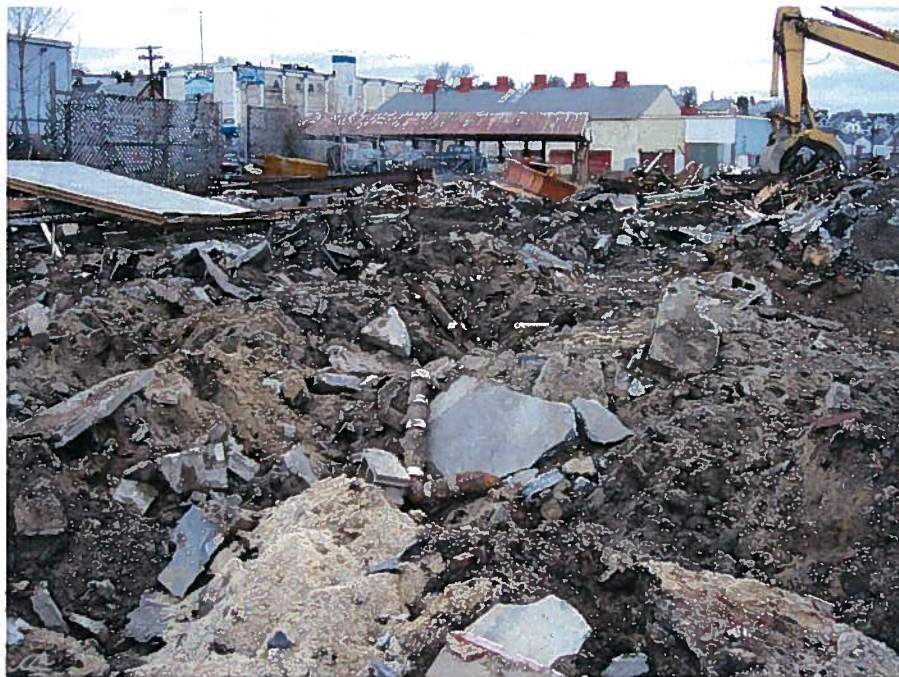
Photograph 2. Space formerly occupied by The Breakaway Tavern, looking north at the Shipyard Brewery with the Micucci property to the left. The "at-grade" portion of the structure and floor slab has been demolished (4/10/07).

1. Demolished the western portion of the former Breakaway Tavern building, abutting the Micucci Property (see attached photographs), including the "at grade" ground floor slab and concrete footings. This portion of the building was a single-story structure with a lightly reinforced slab-on-grade with top of slab at approximately El. 24 to El. 24.5 (based on an optical survey performed by Haley & Aldrich). The demolition debris was temporarily stockpiled north of the building and periodically loaded into 18-wheel trucks and hauled to an off site disposal facility.

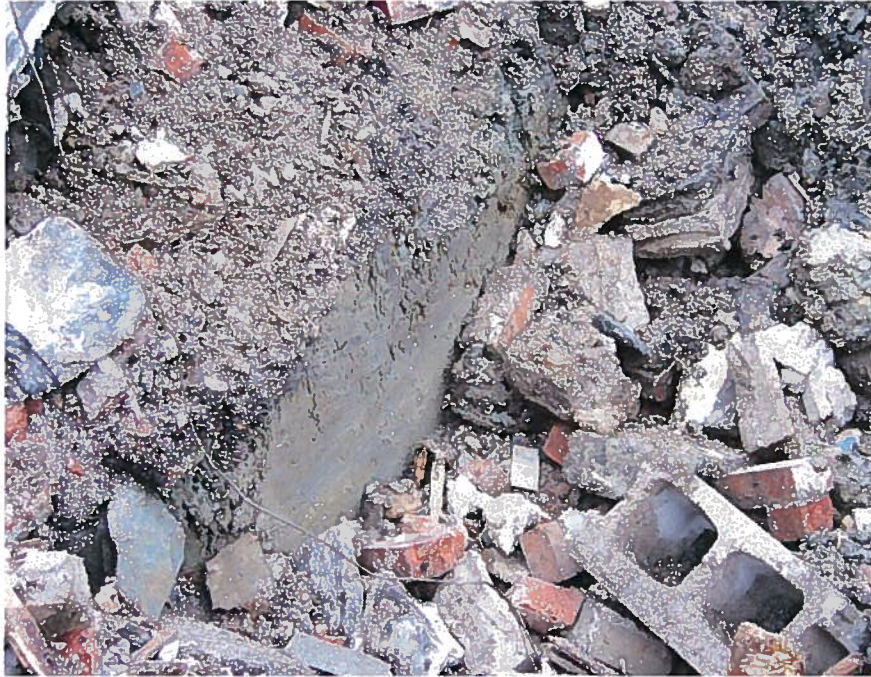
Photograph 3. Test Hole No. 1, looking north with naturally deposited marine clay visible on the left sidewall (4/18/07).

1. Field Representative spoke with Mark Hall (MCH) regarding the removal of the footings, foundation walls and basement level concrete floor slab. Mr. Hall indicated that the floor slab had been removed and consisted of a 3 to 4-in. thick concrete slab with wire mesh reinforcing. Field Representative inquired about the presence and removal of additional foundations. Mr. Hall stated that no other foundation units were encountered during demolition of the basement level and that one of his workers indicated that bedrock was encountered directly beneath the basement floor slab. Field Representative informed Mr. Hall that one test boring (HA05-4) was drilled adjacent to the northeast corner of the building to a depth of 72 ft below ground surface (BGS) without encountering bedrock. Field Representative requested Mr. Hall excavate two test pits through the previously placed backfill in order to investigate the presence of shallow bedrock within the limits of The Breakaway Tavern. Two test pits, designated Test Pit No. 1 and Test Pit No. 2, were excavated on 18 April at the approximate locations shown on Figure 1 using a CAT 345B excavator. The test pits were excavated to a depth of approximately 4 ft below the basement floor level and exposed naturally deposited, olive gray marine clay at both locations (see attached photographs). Bedrock was not encountered in either test pit. The test pits were backfilled with uncompacted sand/gravel imported to the site.

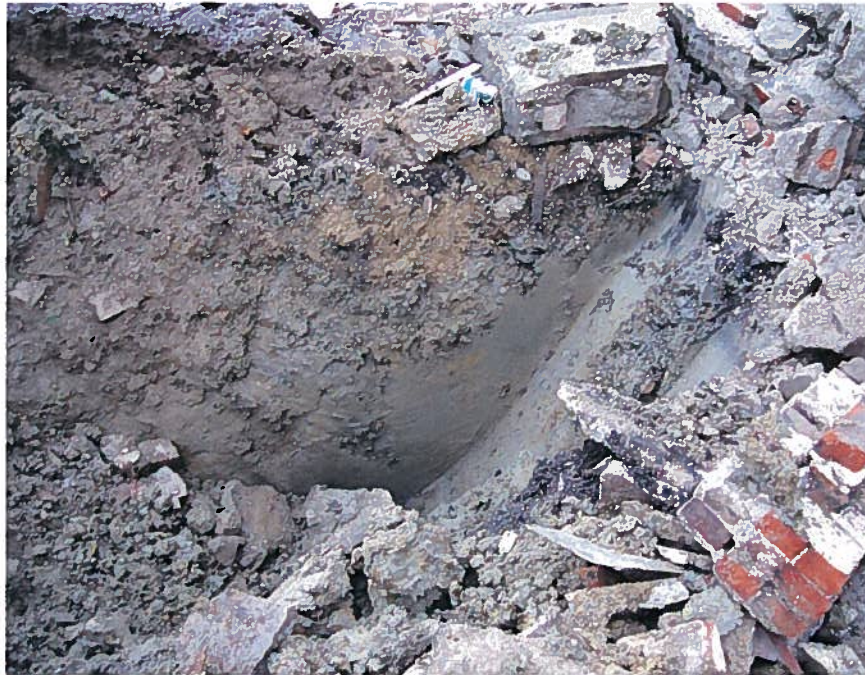
Photograph 4. Test Hole No. 2, looking east with naturally deposited marine clay visible on the front and right sidewalls (4/18/07).
