<b>Project</b>	OCEAN GATEWAY PARKING GARAGE	<b>Report No.</b>	2
<b>Location</b>	PORTLAND, MAINE	<b>Period From</b>	28 May 2007
		<b>To</b>	01 June 2007
<b>Client</b>	RIVERWALK, LLC.	<b>Page</b>	1 of 4
<b>Contractor</b>	LEDGEWOOD CONSTRUCTION (CM) SHAW BROTHERS CONSTRUCTION (EARTHWORK) G. DONALDSON CONSTRUCTION (PILE DRIVING)	<b>File No.</b>	30322-030

**WEEKLY FIELD REPORT**

SITE PLAN (SHEET NO. C202)  
WEEKLY FIELD REPORT NO.: 2

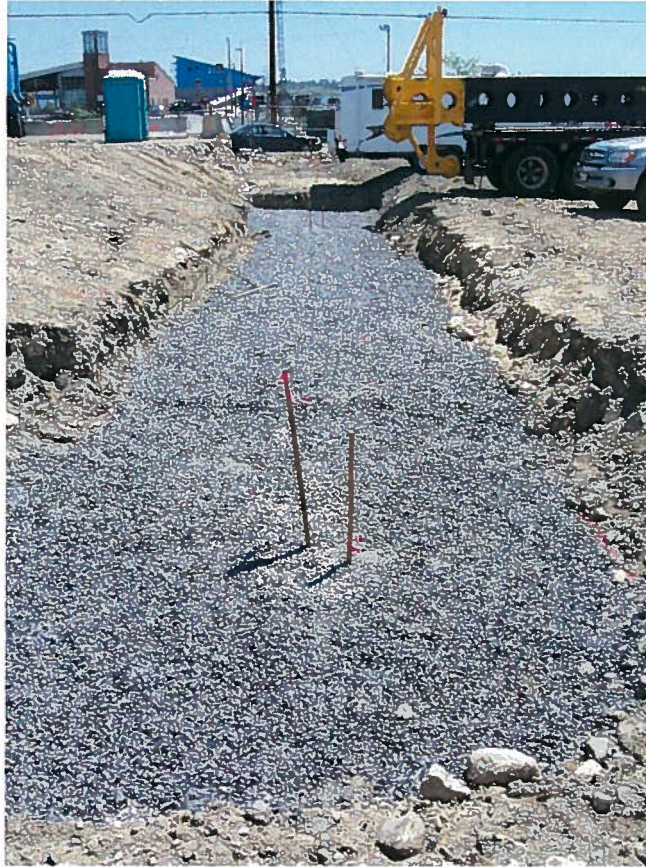
*Photograph 1. Crushed stone placed over prepared subgrade along column line H, looking east (5/29/07).*

3. FRAC Tank previously delivered to the site was placed north of column line H (See Figure 1).
4. Shaw Bros. previously excavated for the pile caps and grade beams along column line H and the pile cap at column G-1. The areas were excavated to bottom of pile cap/grade beam elevations as shown on the foundation plan (see Figure 2 and photographs). The excavation was performed using a CAT 320C excavator outfitted with a smooth bucket attachment. The material generally consisted of granular fill (sand, gravel, cobbles, and concrete and brick fragments). The material was loaded into dump trucks and was used as fill in the landscape area west of column line 1, adjacent to Middle Street. The excavations were advanced approximately 2-in. below the proposed bottom of pile cap/grade beam level. An approximate 2-in. thick lift of 1½-in. crushed stone was placed on the exposed subgrade surface to minimize disturbance during placement of concrete forms and reinforcing steel.

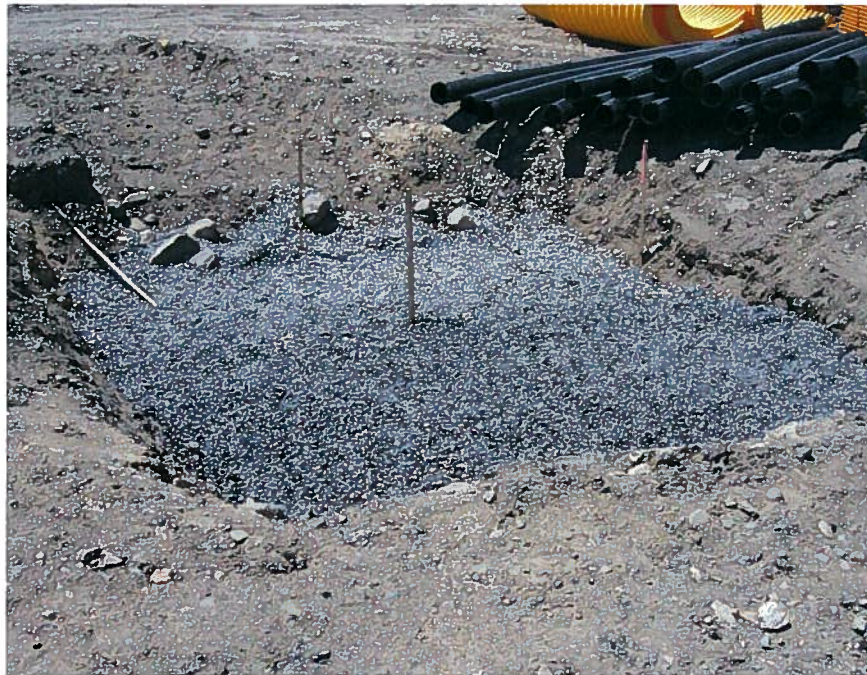
*Photograph 2. Crushed stone placed over prepared subgrade at column G-1, looking south (5/29/07).*

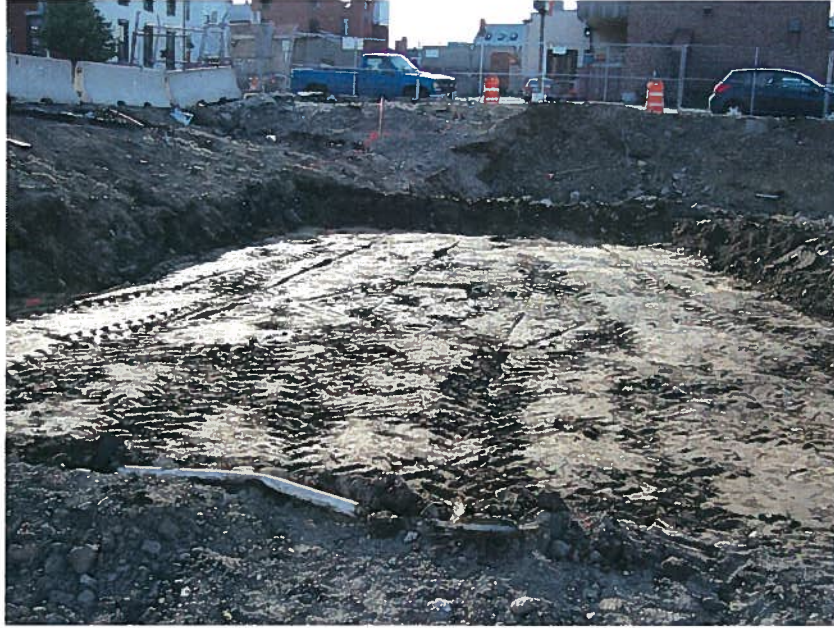
*Photograph 3. Prepared subgrade beneath subsurface stormwater chamber, looking west (5/29/07).*

5. Shaw Bros. excavated to subgrade level (El. 19) for the subsurface stormwater detention structure within the limits of the entrance roadway off of Middle Street, west of column line 1, with a CAT 320C excavator outfitted with a smooth bucket attachment (see Figure 1 and photographs). The material generally consisted of granular fill (sand, gravel, brick and concrete fragments) and was temporarily stockpiled adjacent to the excavation. Water was observed seeping into the south side (adjacent to the Micucci property) of the excavation. The exposed subgrade (predominantly granular fill) was proof rolled with two passes of an Ingersoll-Rand smooth drum vibratory roller. The area was proof rolled with the vibrator turned off in order to prevent disturbance of a small amount of marine clay exposed in the northwest corner of the excavation.

5. Field Representative monitored excavation and subgrade preparation for the subsurface stormwater detention structure. The elevation of the bottom of the excavation was El. 19. The subgrade consisted of granular fill (sand, gravel, cobbles, and concrete and brick fragments with a small amount of marine clay). The exposed subgrade was proof rolled with two passes of an Ingersoll-Rand smooth drum vibratory roller. The area was proof rolled with the vibrator turned off in order to prevent disturbance of a small amount of marine clay exposed in the northwest corner of the excavation. The subgrade soil appeared firm and undisturbed prior to placement of the separation geosynthetic fabric and crushed stone.

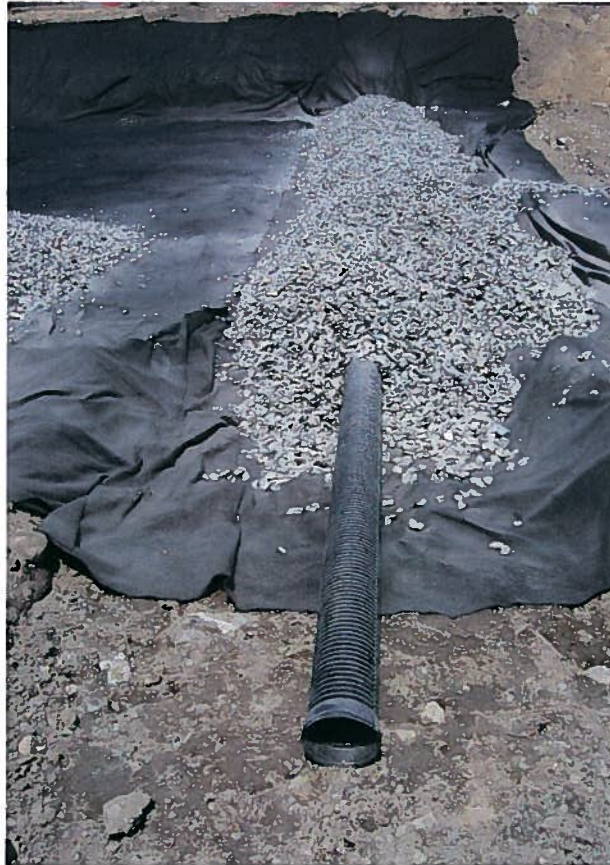
*Photograph 4. 6-in. diameter perforated plastic underdrain pipe installed (invert at El. 19) beneath the subsurface stormwater chamber, looking west (5/30/07).*

5. Shaw Bros. installed a 6-in. diameter perforated PVC underdrain (invert at El. 19) within the limits of the subsurface stormwater detention structure. The underdrain was installed west of column line 1, running perpendicular to Middle Street (see Figure 1 and photographs).

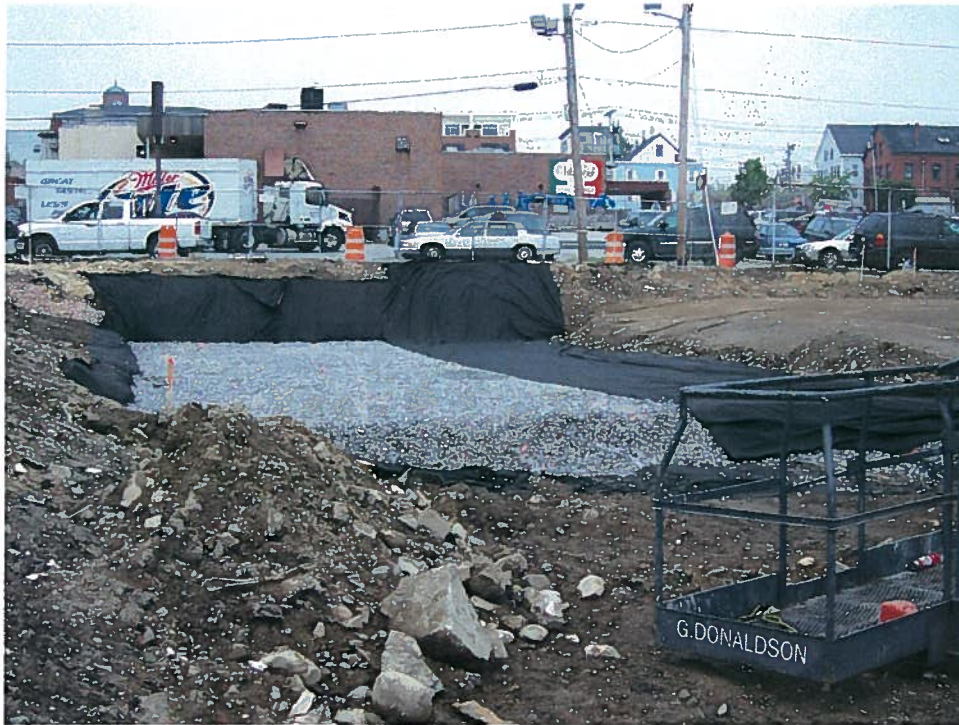
*Photograph 5. Completed crushed stone layer (top at El. 20) beneath the proposed subsurface stormwater detention structure, looking west (5/30/07).*

6. Shaw Bros. began placing layer of 1½-in. crushed stone on top of separation geosynthetic fabric and PVC underdrain up to El. 20 (within the limits of the subsurface stormwater detention structure) with a CAT 320C excavator and hand tools (see photographs).

1. Shaw Bros. continued placing concrete jersey barriers along Fore Street.
2. Shaw Bros. completed placing layer of 1½-in. crushed stone on top of separation geosynthetic fabric and PVC underdrain up to El. 20 (within the limits of the subsurface stormwater detention structure) with a CAT 320C excavator (see photographs). The layer was compacted with two passes of a self-propelled vibratory plate compactor.

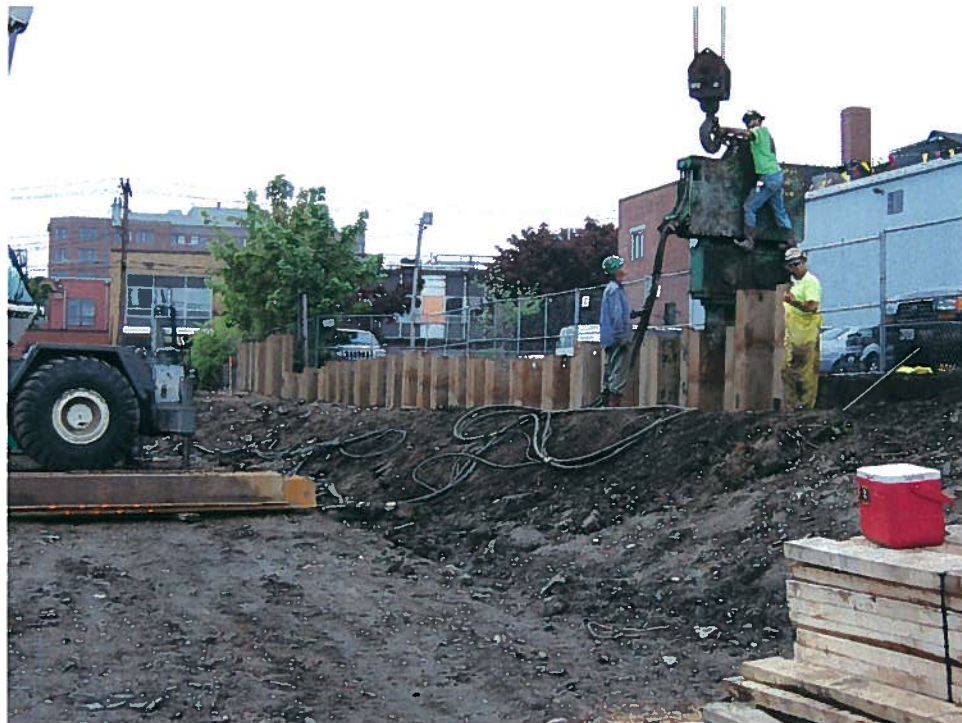
*Photograph 6. Installation of steel sheeting for the support of excavation system parallel to column line 1, adjacent to the Micucci property, looking south (5/31/07).*

3. G. Donaldson began installation steel sheeting for the support of excavation system parallel to column line 1, adjacent to the Micucci property (see Figure 2 and photographs). The sheeting was installed using an ICE 22 hydraulic vibratory driver/extractor and a Terex HC-133 service crane. The sheets were installed beginning approximately 25 to 30 ft south of column line A-1 and 6 to 7 ft west (towards the Micucci property). Steel sheets were approximately 25 ft long and were installed to an approximate tip elevation of El. 2 (11 ft below the proposed bottom of excavation for pile caps/grade beams).

1. G. Donaldson continued the installation of steel sheeting for the support of excavation system along column line 1, adjacent to the Micucci property as described under Item No. 3 on Thursday, May 31 (see Figure 2 and photographs).
2. Delivery of 5 HP14x102 and 16 HP 12x53 steel H-piles measuring approximately 60 ft in length. The steel H-piles were stockpiled in the central portion of the site generally along column line 1.9/2.1, between column line B and column line D.
3. Shaw Bros. removed brick sidewalk along Fore Street with a CAT 320C excavator. Bricks were loaded into dump trucks and hauled off site. All granite curbing was left in place.
