Client: S.W. Cole Engineering, Inc.**Project:** 169 Newbury Street**SWCE Project #:** 16-0910**Date:** November 8, 2016**Subject:** Inspection of Field Weld**Report:** 001

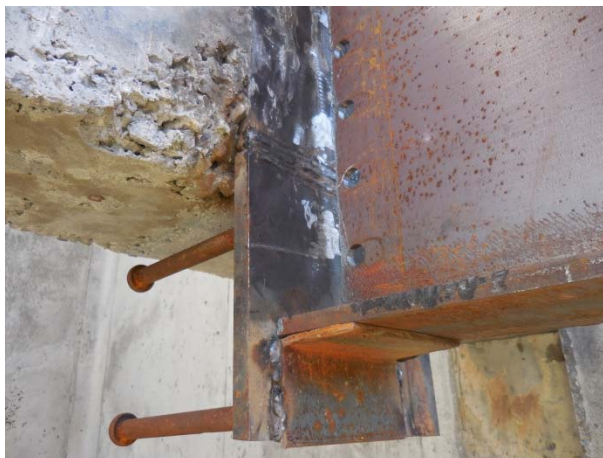
The weld in question was a spliced section to extend an embedded plate at first floor location D.3/5 (reference RFI #39). There was no field sketch available. We were advised that a complete penetration weld was required (see photograph below).

The weld was visually acceptable per AWS D1.1 visual acceptance criteria.

Ultrasonic testing indicated a through thickness weld of approximately .750" had been obtained. No internal defects were apparent.

Please note that this was an open root joint and therefore per AWS D1.1 could not be considered a complete penetration weld as there was no backing used and no access for backgouging.

The weld appears to meet the intent of the EOR. The superintendent and erector were advised of our observations.
