# Final Report of Special Inspections

Project: *Widgery Wharf Building 1*  
Location: *Union Wharf, Portland, ME*  
Owner: *Proprietors of Union Wharf*  
Owner's Address: *36 Union Wharf, Portland, ME*

Subject: Pile Installation Summary  
Office Building  
Widgery Wharf  
Portland, Maine

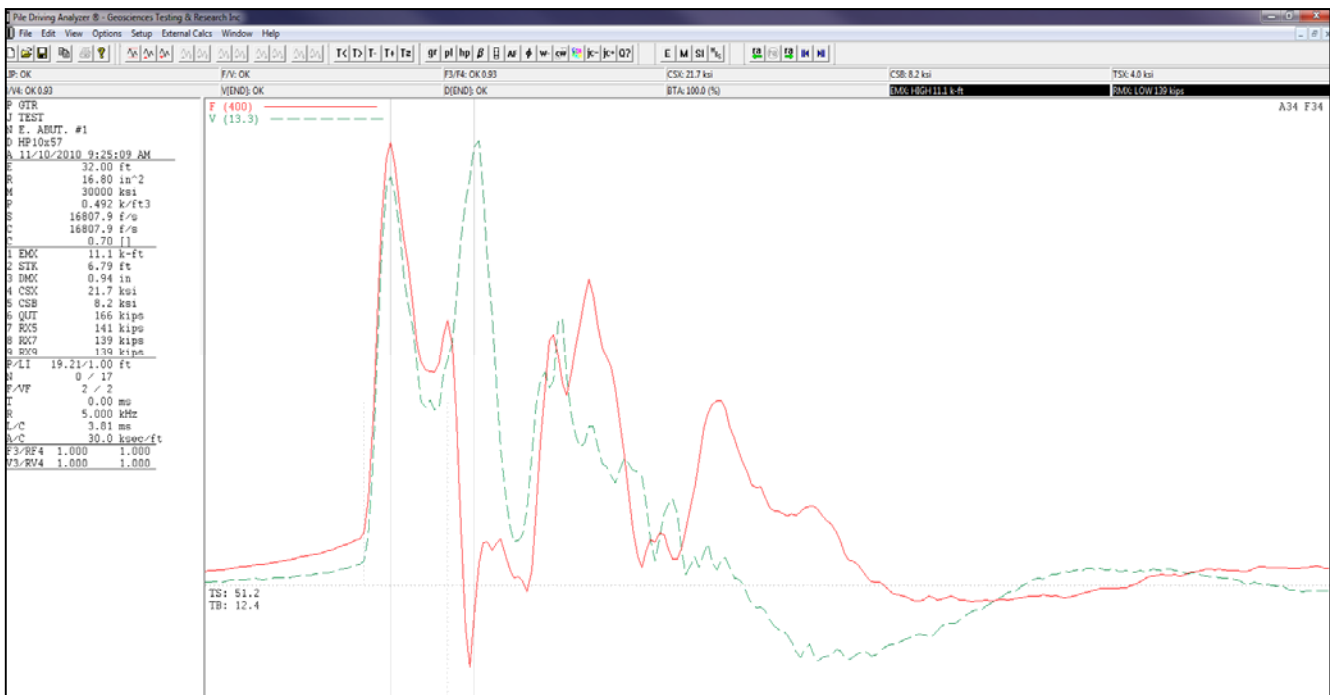
Figure 1. Data collection during pile driving in the (PDI - PDA<sup>®</sup> -Win Program).

Dynamic pile testing was performed using a Pile Driving Analyzer (PDA<sup>®</sup>), such as the PAK<sup>®</sup>, PAL<sup>®</sup>, or PAX<sup>®</sup> systems, manufactured by Pile Dynamics, Inc. (PDI) of Cleveland, Ohio. These systems are computers fitted with data acquisition and signal conditioning components. The instrumentation consists of two strain gages and two accelerometer transducers attached a minimum of 1.5 pile diameters below the pile top. During impact, the strain and acceleration signals are recorded and processed for each hammer blow. The strain signal is converted to a force record and the acceleration signal is converted to a velocity record. The PDA<sup>®</sup> saves selected hammer blows containing this information to disk and determines the transferred energy, compressive/tensile stresses, displacement, pile integrity, and the estimated pile bearing capacity using the Case Method. This information can be viewed on the computer screen during driving. A screen shot of data collection in the PDA<sup>®</sup> Windows (PDA-W<sup>®</sup>) Program is provided in Figure 1. Selected blows can be further processed to predict the static pile capacity using signal matching programs.

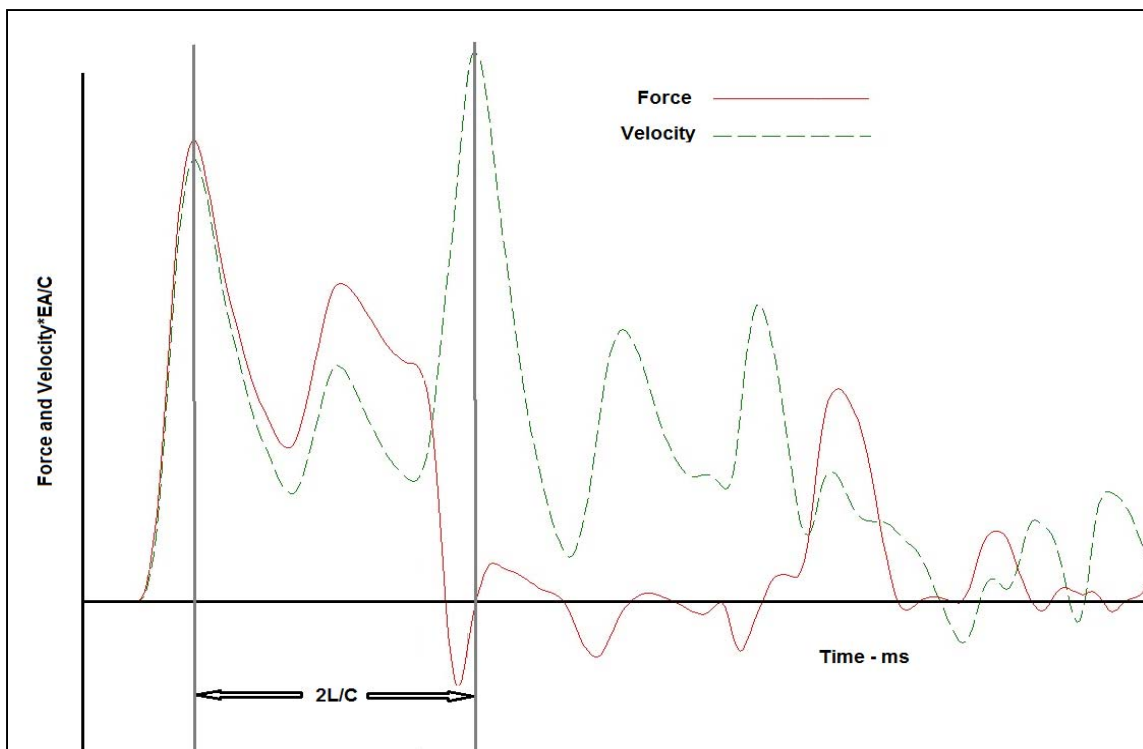
Figure 3. Typical Force and Velocity traces for a pipe pile driven into soft clay (high velocity and low force at tip -  $2L/C$ ).

As long as there is no change in the pile impedance and there are no external forces (i.e. friction), the force and velocity are proportional (equal). Reflections at the tip can be explained by two classical boundary conditions. Free end conditions (analogous to easy driving through soft clay) require zero force and no velocity restrictions at the tip, resulting in a compression wave returning as a tension wave and an increase in velocity (theoretically doubling). Figure 3 graphically presents a typical reflection from a pipe pile during penetration into soft clay. Fixed end conditions (analogous to hard driving into bedrock) require zero velocity and no force restrictions at the tip, resulting in a compression wave being reflected with a greater magnitude than the incident wave (theoretically doubling) and the tip velocity at theoretically zero. Figure 4 graphically presents a typical reflection from an H-pile driven to bedrock. The time the wave takes to travel down to the tip and reflect back to the transducers is twice the pile length divided by the wave speed of the pile material ( $2L/C$ ).

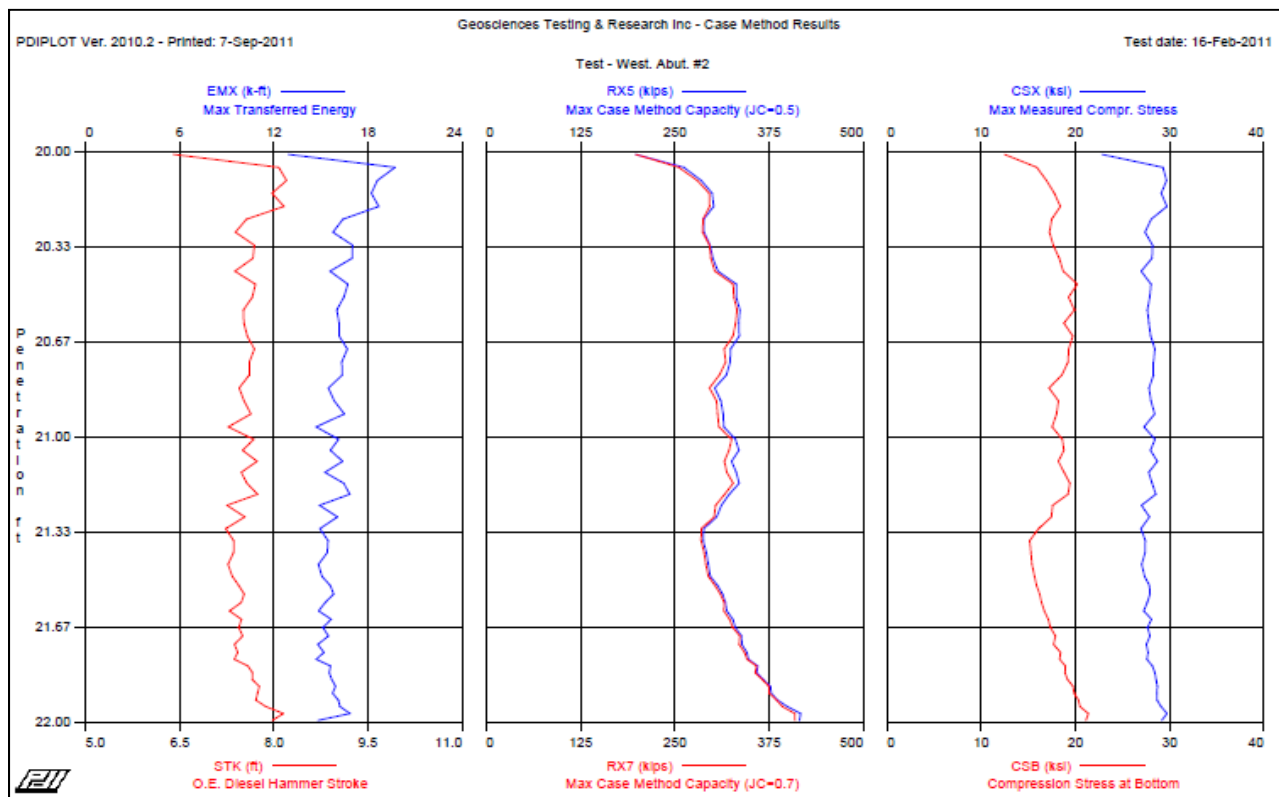
Figure 5. Typical Dynamic Testing summary Output (PDI Plot® Program)

After data collection, the most pertinent output quantities from the dynamic pile testing can be summarized in a graphical manner. The data can be also presented in tabular format, averaging the results based on penetration depth or blow number as specified by the user. Figure 5 shows typical graphical output. Each of the three plots presents two quantities sharing the vertical (penetration) axis.

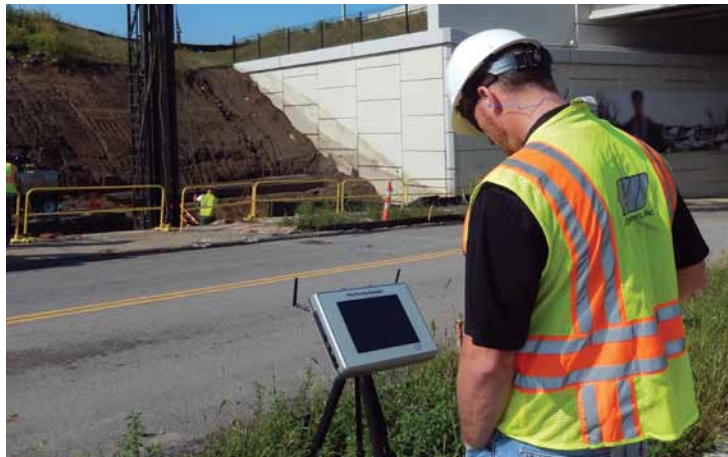
*PDA-8G in the field*

*The Pile Driving Analyzer model 8G is designed with the field engineer in mind. Its screen, with a higher resolution LCD than previous generations of PDAs, displays measured signals and calculated results in real time, and allows more options to be viewed simultaneously.*

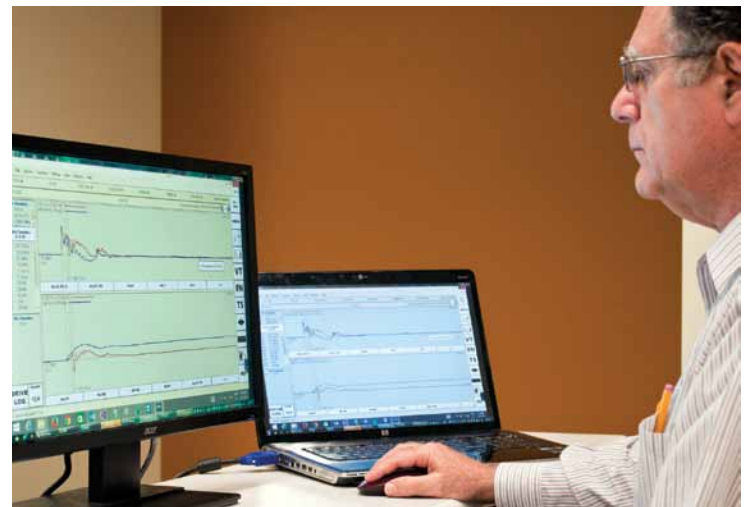
- No cables from the accelerometers and strain transducers to the PDA.
  - Fast signal transmission of up to 100 m (330 ft) through WiFi
- The PDA-8G may also be used with cabled (traditional) accelerometers and strain transducers.*

*Receiving test data with SiteLink.*

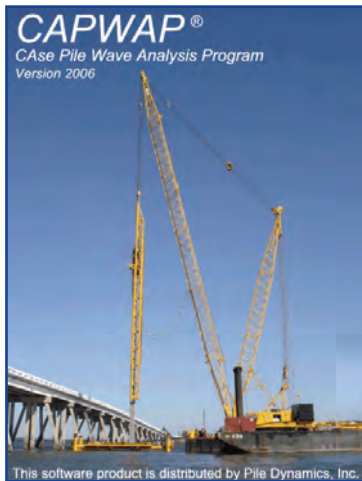
**CAPWAP – CAse Pile Wave Analysis Program** – determines static soil resistance and simulates a static load test.

CAPWAP calculates:

- Static shaft resistance, magnitude and distribution
- Static end bearing
- Stresses at any point along the shaft
- Energy transferred from the ram to the foundation

from force and velocity data measured by the **Pile Driving Analyzer®** on a foundation impacted by a ram.

Based on these results, CAPWAP simulates a static load test and predicts the instantaneous load settlement behavior of the tested foundation.

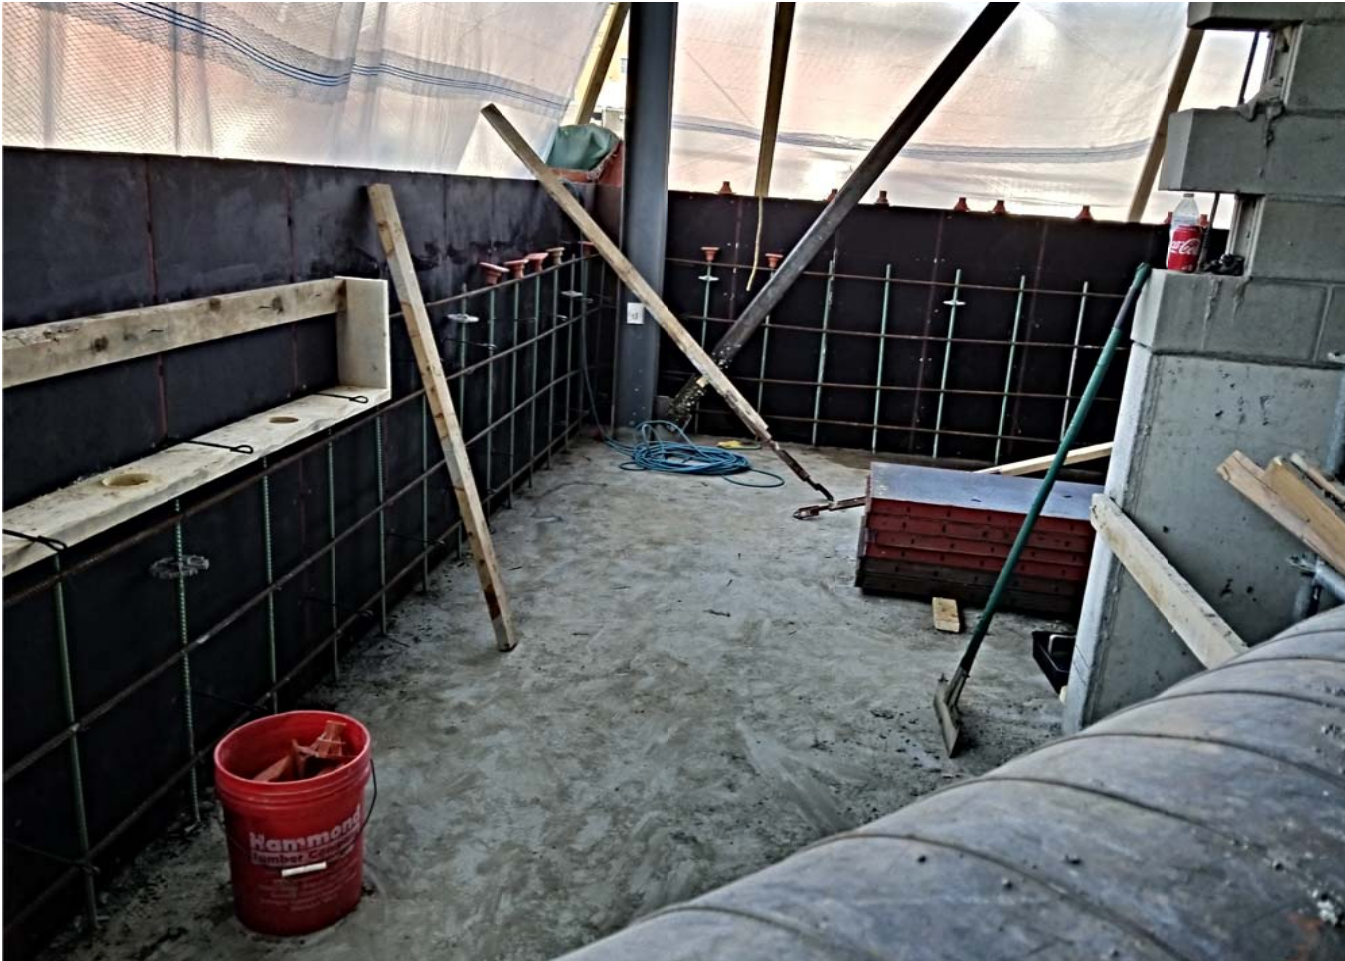
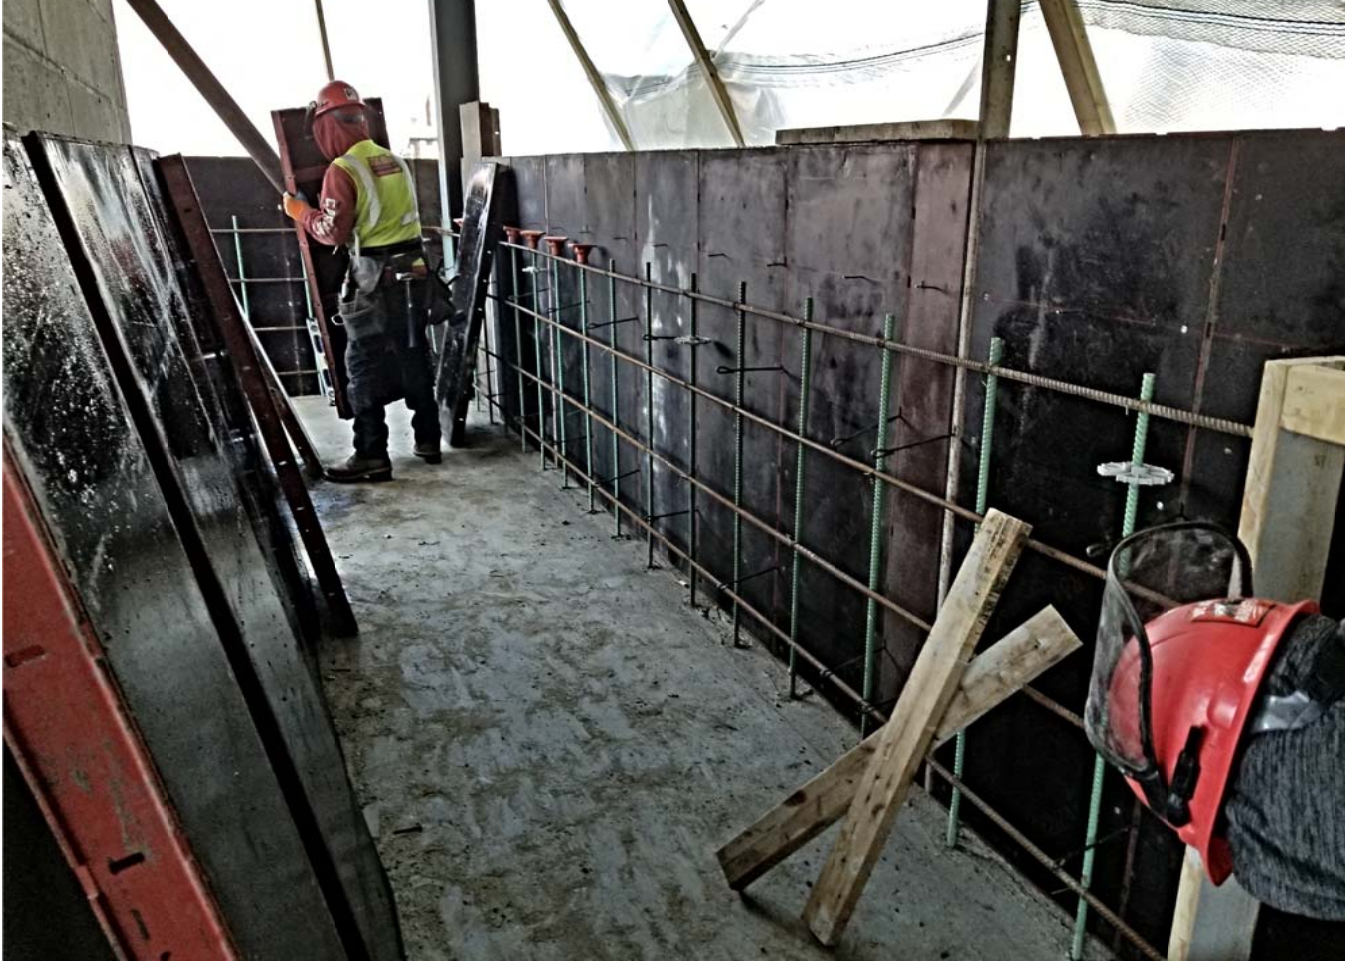
S.W. Cole was onsite as requested by Ducas Construction for reinforcement observations of concrete stem wall. Reinforcement observed appeared consistent with the above referenced documents featuring #5 epoxy coated vertical dowels embedded in slab at 15" o.c. spacing and horizontal #5 bars adhering to ASTM A615 grade 60 at 12" o.c. spacing.

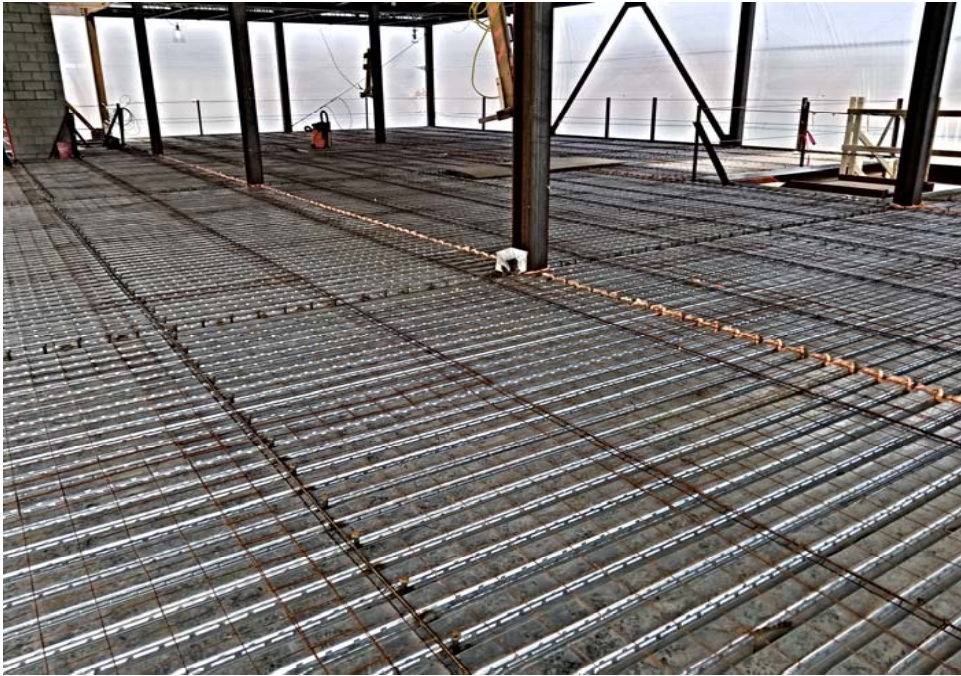
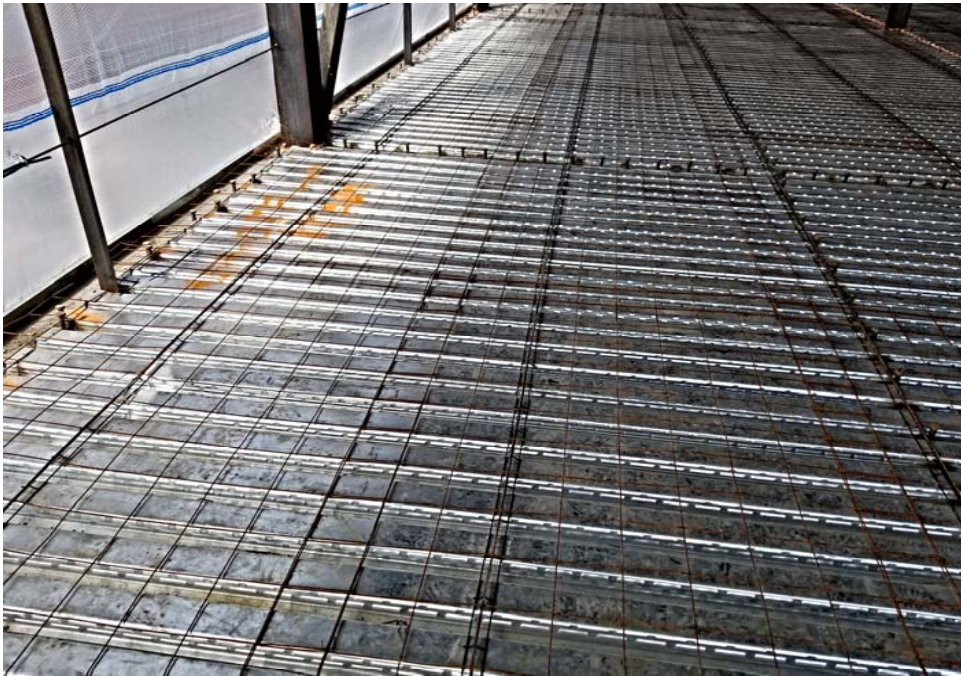
S.W. Cole was onsite as requested by Ducas Construction for reinforcement observations of 4<sup>th</sup> floor slab on deck. Reinforcement observed appeared consistent with the above referenced documents featuring 6x6 W.W.F. W1.4xW1.4 with 1" chairs at 4' o.c.
