# Solar Glare Hazard Analysis Report

Analysis name	Fore St Garage
PV array axis tracking	none
Orientation of array (deg)	150.0
Tilt of solar panels (deg)	5.0
Rated power (kW)	193.63
Vary reflectivity	True
PV surface material	Smooth glass with ARC

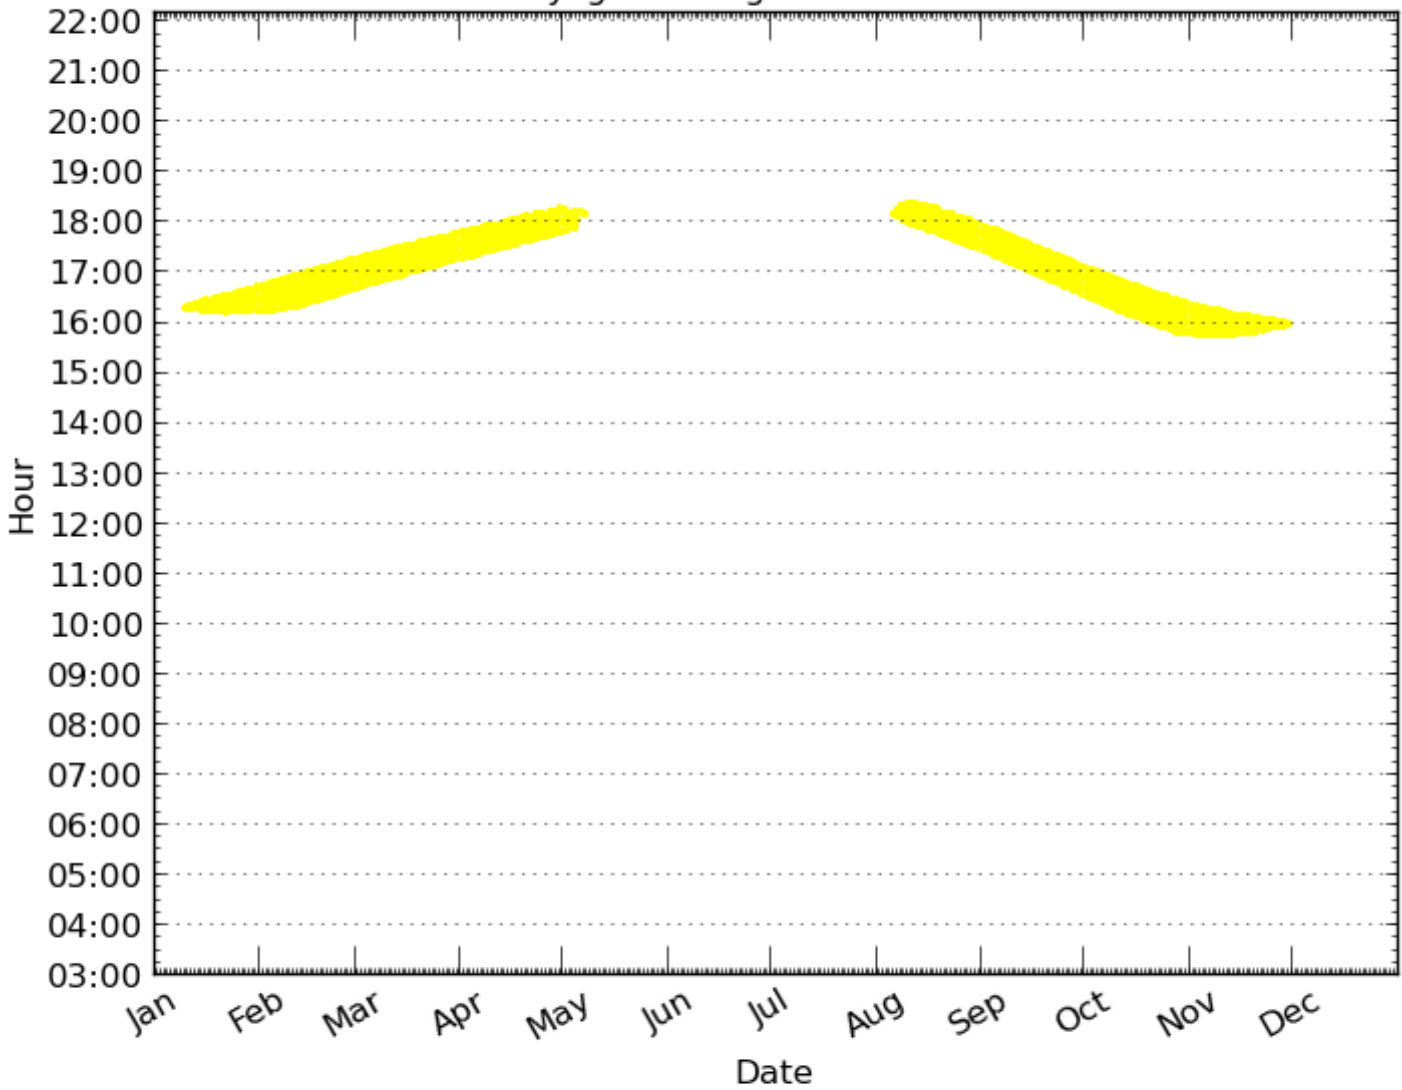
## Glare Occurrence Plot

All times are in standard time. For Daylight Savings Time add one hour.

1-minute time interval.  
All times are in standard time.  
For Daylight Savings Time add one hour.
