Solar Glare Hazard Analysis Report

Analysis name	Fore St Garage
PV array axis tracking	none
Orientation of array (deg)	150.0
Tilt of solar panels (deg)	5.0
Rated power (kW)	193.63
Vary reflectivity	True
PV surface material	Smooth glass with ARC

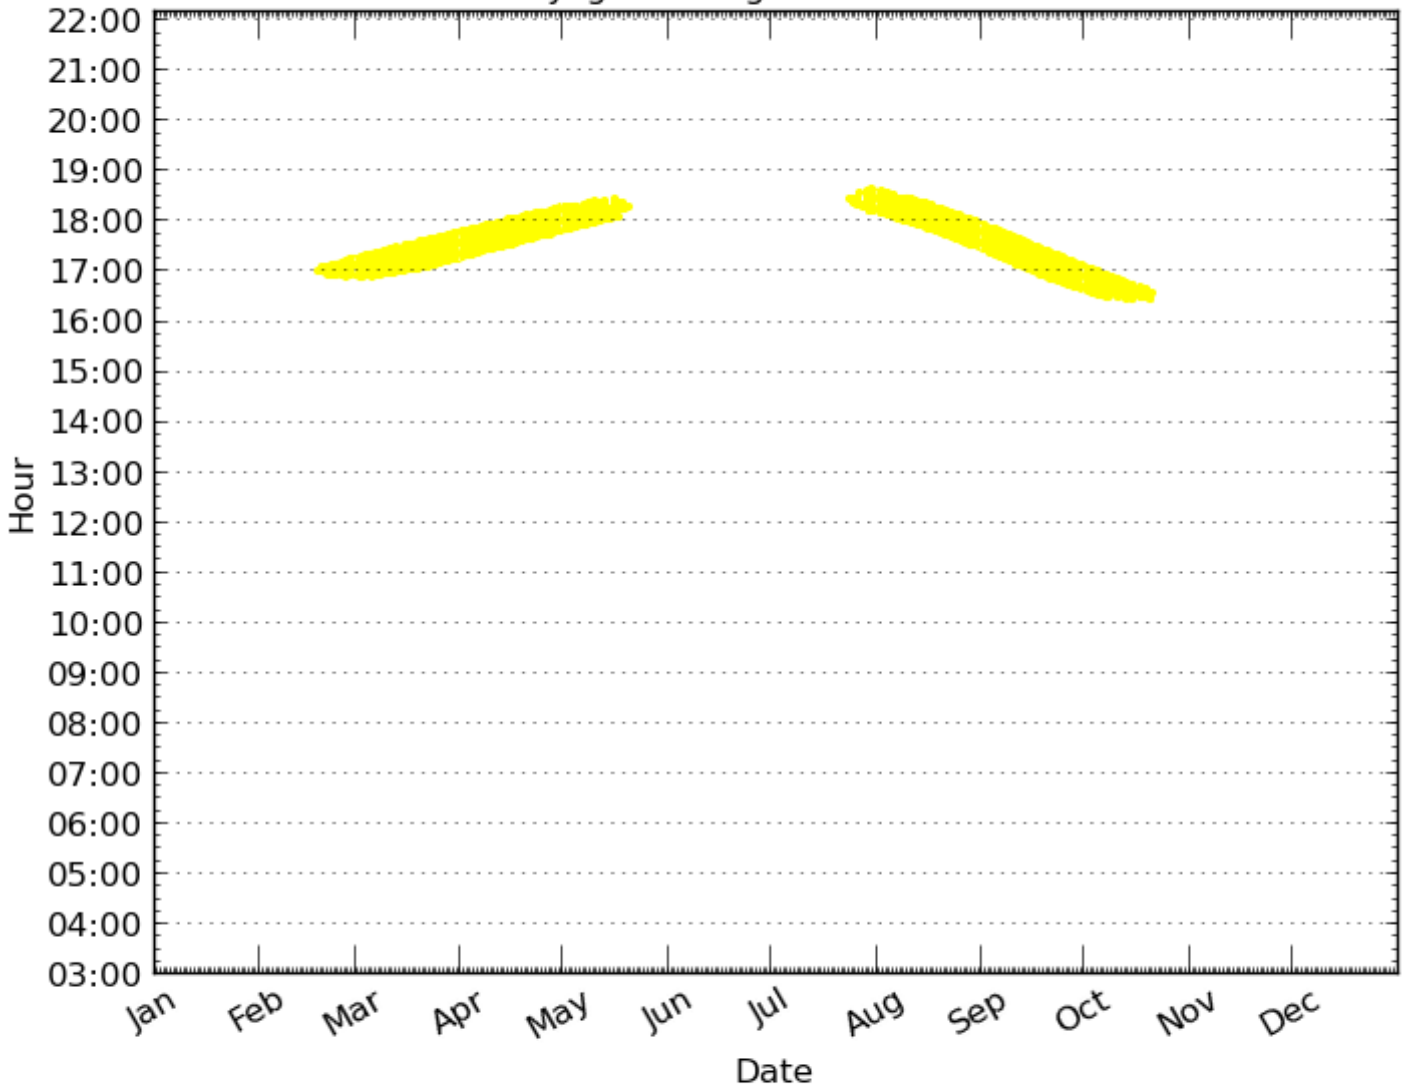
Glare Occurrence Plot

All times are in standard time. For Daylight Savings Time add one hour.

1-minute time interval.
All times are in standard time.
For Daylight Savings Time add one hour.
