**UST CLOSURE SITE ASSESSMENT REPORT SUMMARY COVER SHEET**

<b>St.Germain Client:</b> Skillful Vending	<b>ME Facility/Tank Registration #:</b> 21566
<b>Facility Name:</b> Skillful Vending	<b>St.Germain Rep.:</b> Brian Bachmann
<b>Location:</b> 58 Alder Street Portland, Maine	<b>Facility Owner:</b> Skillful Vending
<b>Date of Tank Closure:</b> 8/28/2009	<b>Tank Contractor:</b> CHES, Inc.
<b>St.Germain Project Number:</b> 3147.1	<b>Evidence of Discharge:</b> Yes
<b>Purpose of Site Assessment:</b> Document the removal of one gasoline underground storage tank (UST), one fuel oil UST, and associated piping.

**UST CLOSURE SITE ASSESSMENT STANDARD REPORT**

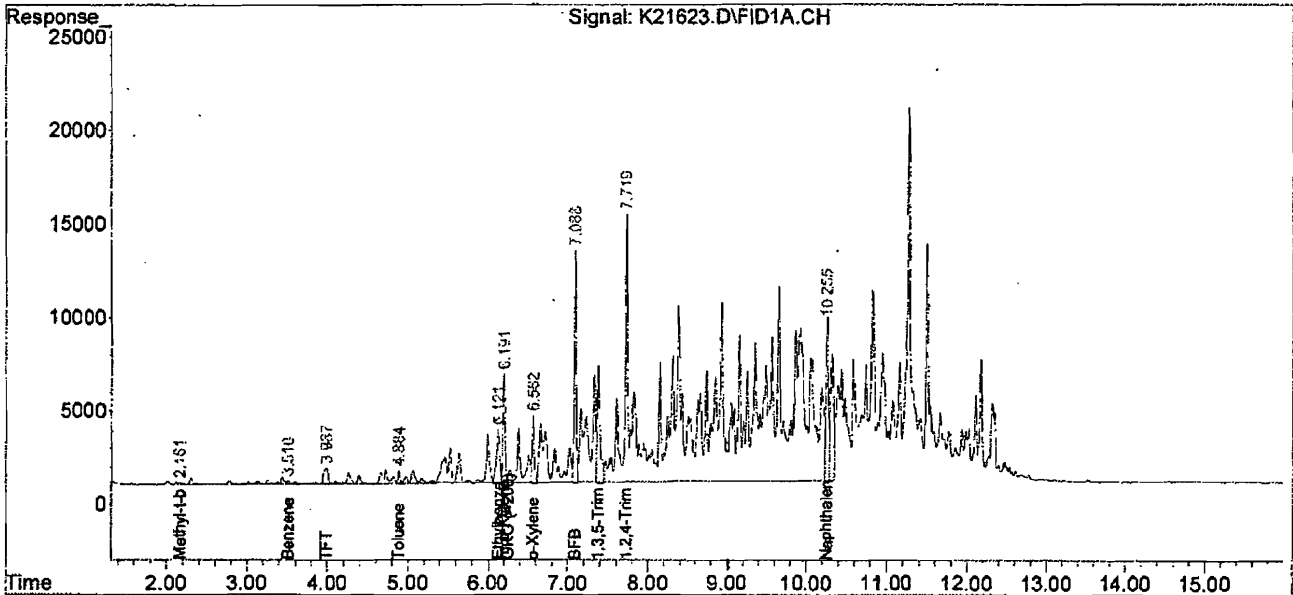
Quantitation Report (QT Reviewed)

Compound	Result	Units	Quantitation Limit
GRO	1360000	µg/kg	33690
