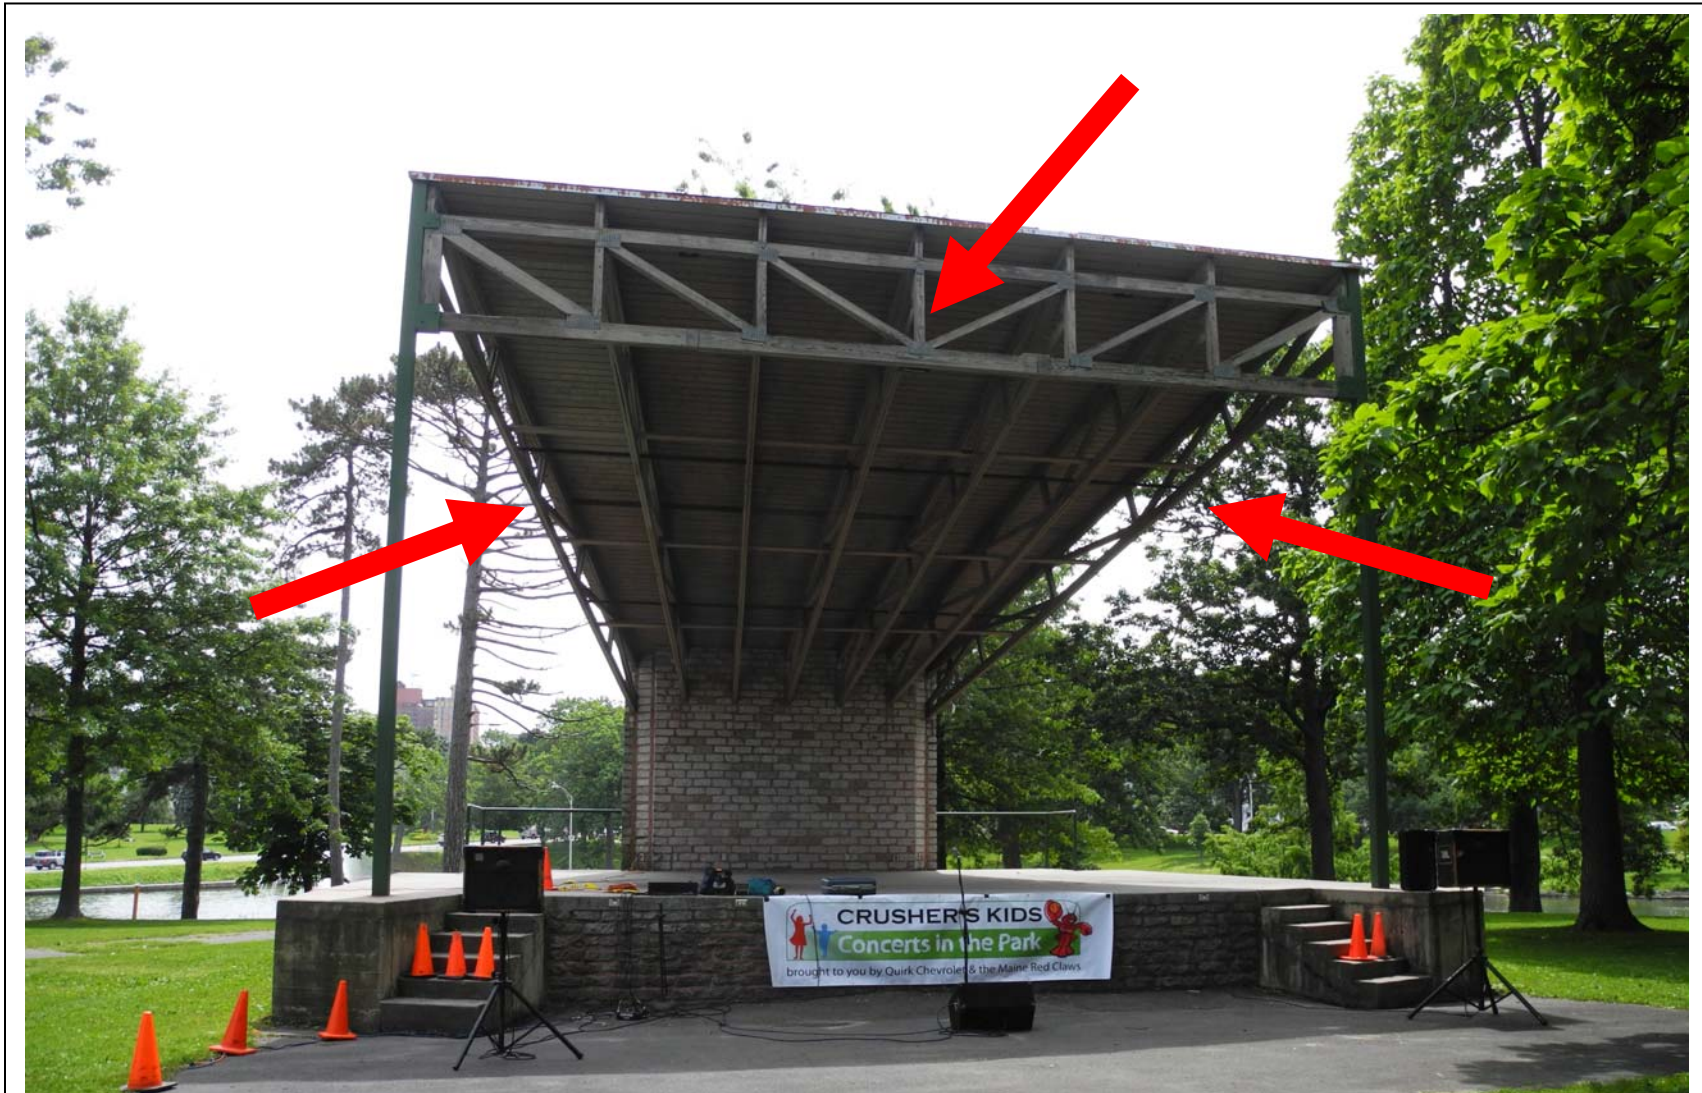
PHOTO
1
0941.jpg

Deering Oaks Bandstand: Front View. Anticipated work scope includes temporary shoring and replacement of three perimeter trusses (arrows) as well as front drip edge replacement and side edge drip edge and shingle replacement.

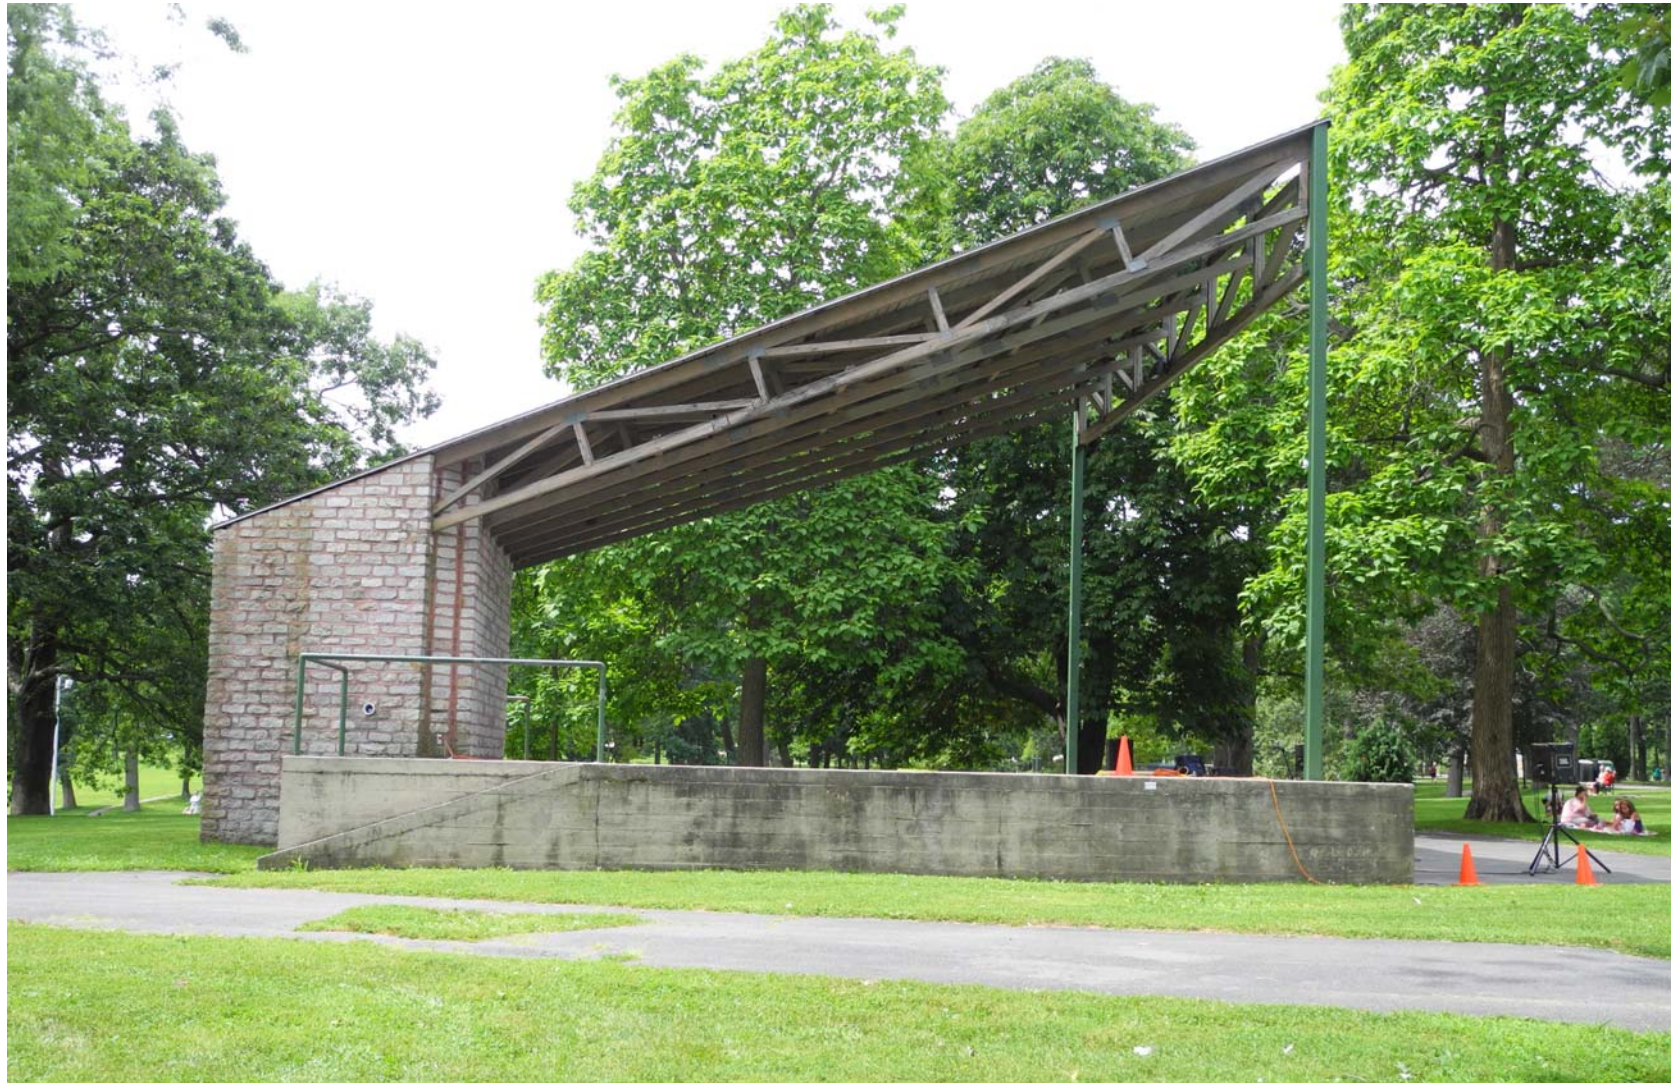
PHOTO
#2
2843.jpg

Deering Oaks Bandstand: Left Elevation: Replace exterior truss and matching truss on right elevation.

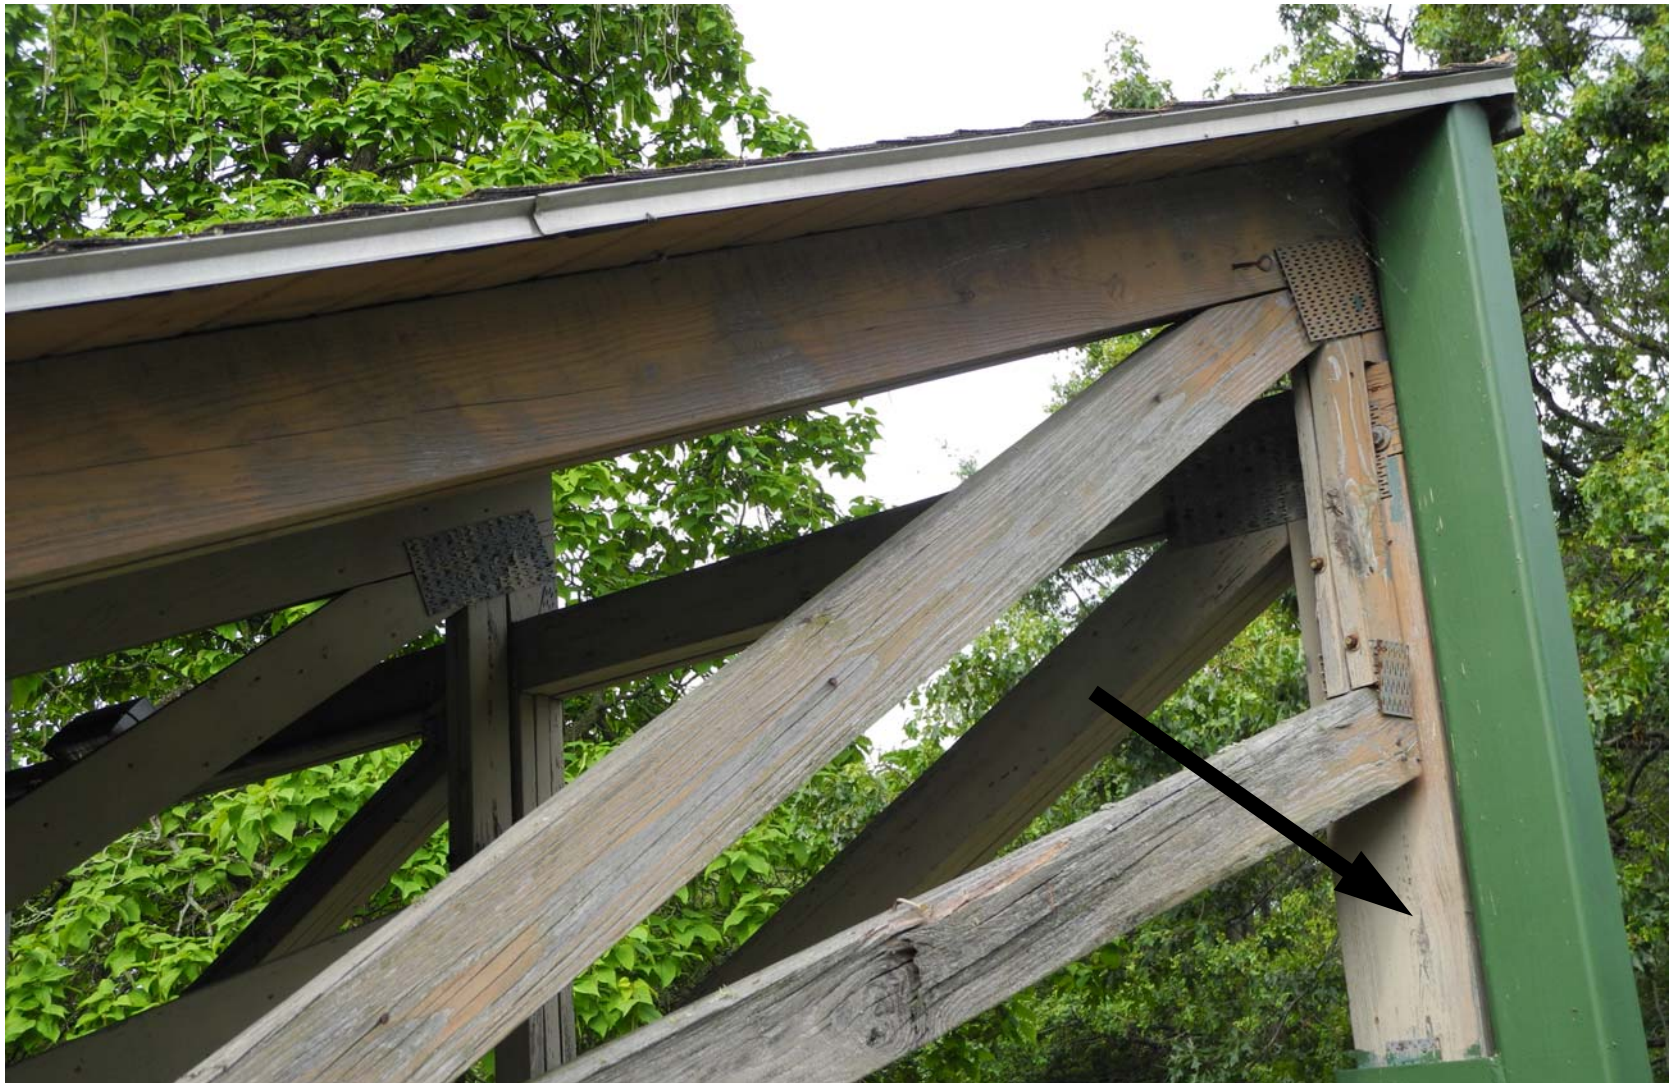
PHOTO
#3
06093.jpg

End Truss Connection at Girder Truss: Arrow shows end of Front Girder Truss. See Photo #4 for downward view of girder truss bottom chord bearing location.

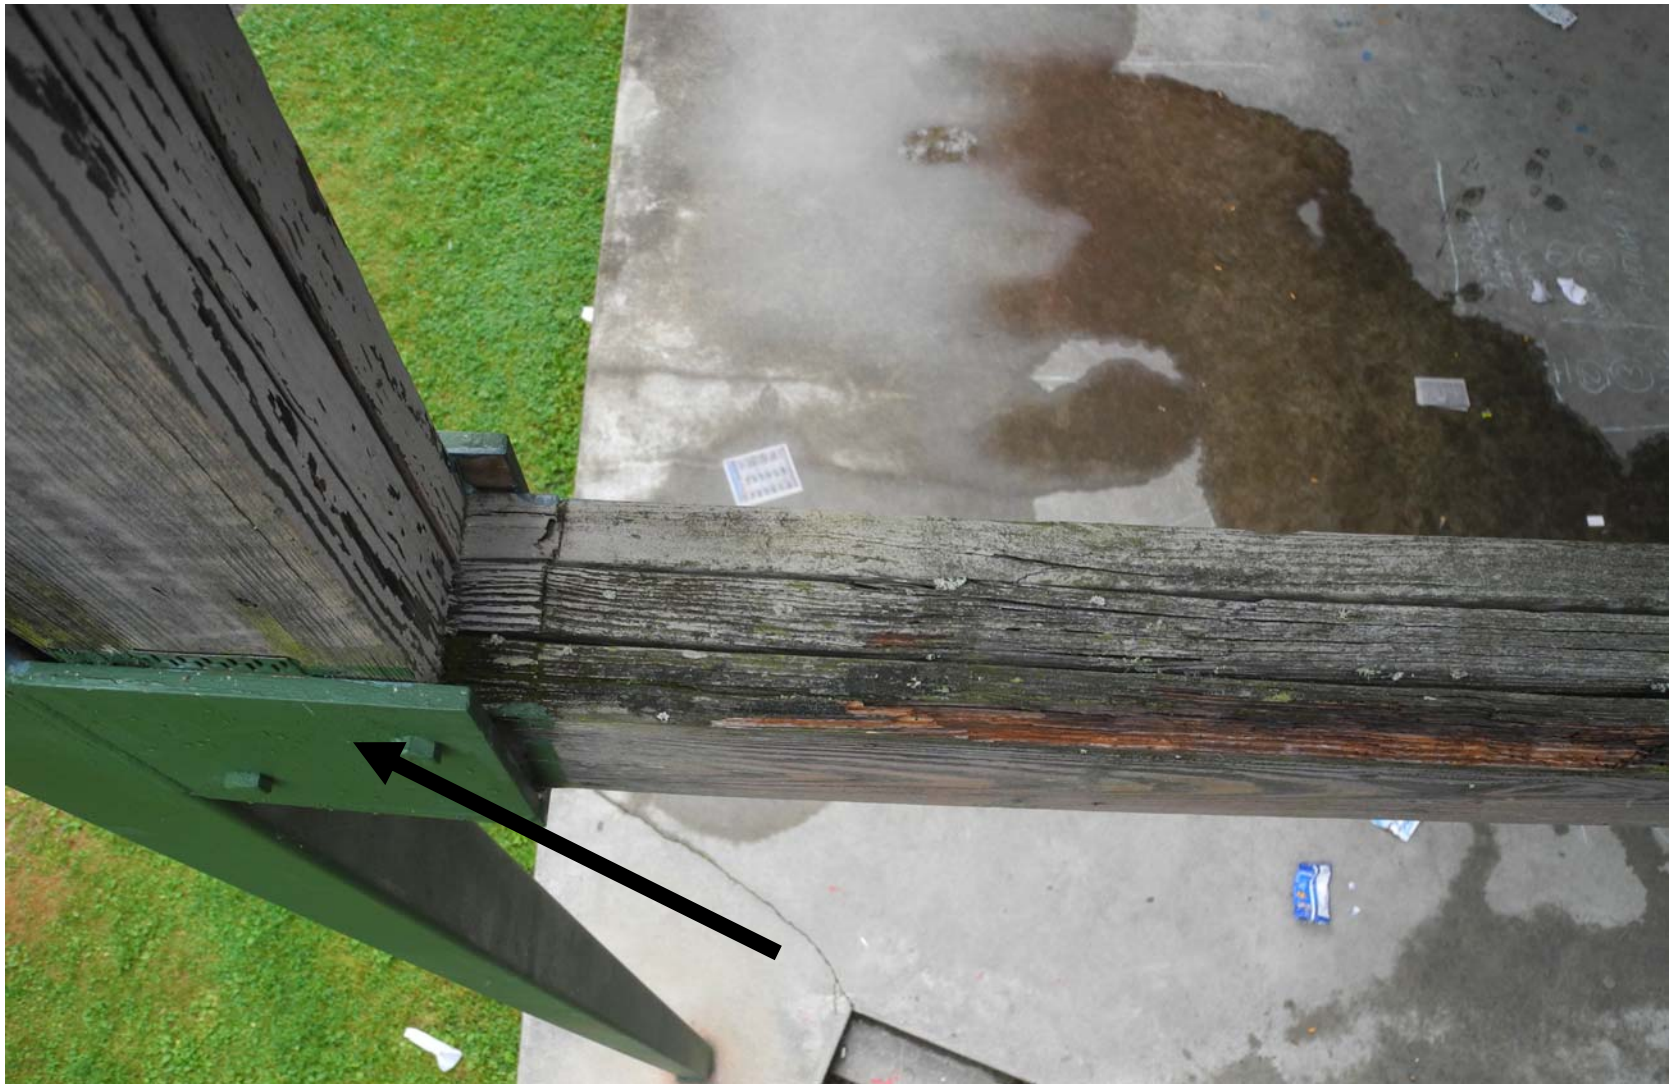
PHOTO
#4
0990.jpg

Girder Truss End: Downward view of bootom chord bearing seat: It will be necessary to cut or burn away front plate at top and bottom of truss (arrow) to allow new girder truss to slide into place.
