JOB: 15-17 SHERMAN ST. PORTLAND, ME

OCTOBER 2, 2017

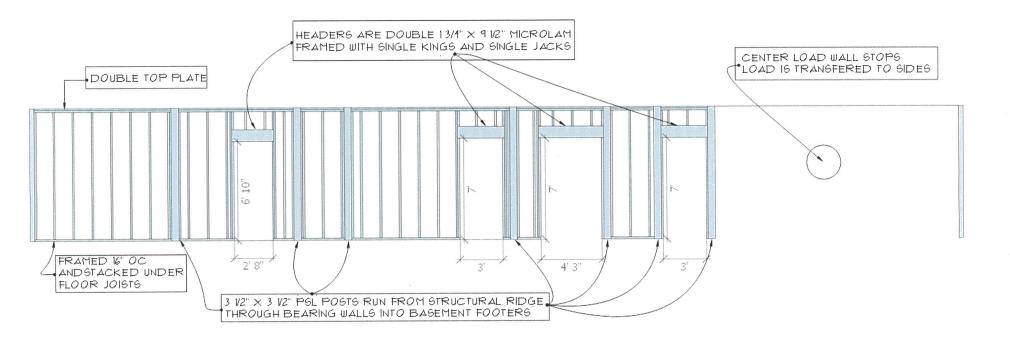
CENTRAL BEARING WALL

-LOAD BEARING CENTRAL WALL FALLS ON PRE EXISTING 10" X 10" SUPPORT BEAM IN BASEMENT
