Field Report #4

Project: Gateway PG – High St Façade Repairs Phase 1
Project #: WO 3521
Date/Time: November 3, 2015, 11:00 a.m.
Observers Adam Sampson (BSE)

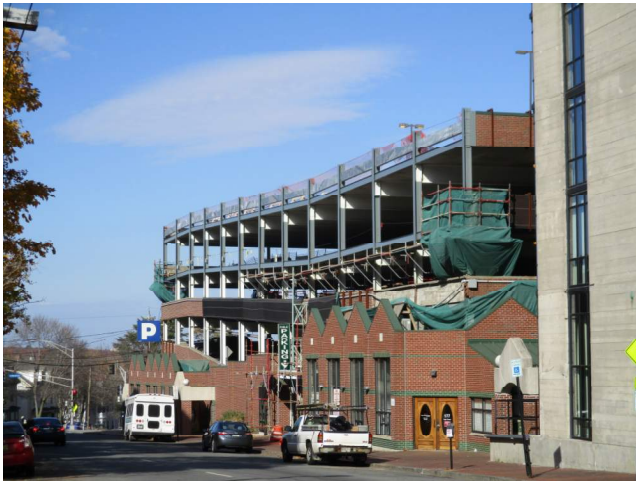
1. Knowles Industrial Services (KISC) has removed all the brick and CMU façade and begun removing the staging from level 3. (See photo below).

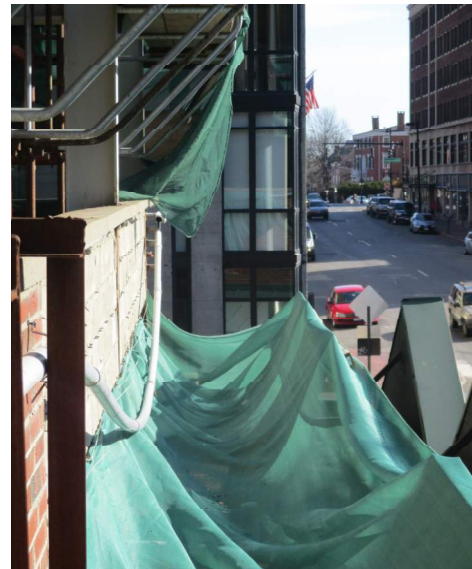
2. A section of the data cable running along the second level façade between Column lines 1 and 3 has become unsupported. This should be re-supported immediately to insure no damage is done to the cable. (See photo above).
3. At the roof level any scratches, dings or exposed steel on the column extensions and HSS bumpers needs to be cleaned, primed and painted or cold galvanized, respectively. (See photos below).

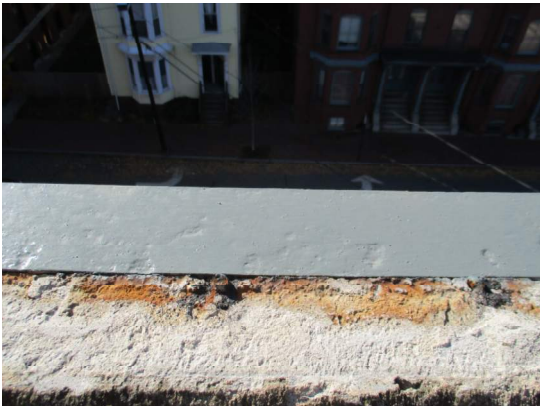
4. Rebar exposed at the concrete curb on the roof level should be ground flush with the concrete. The concrete curb is to be repaired and coated. (See photo below).

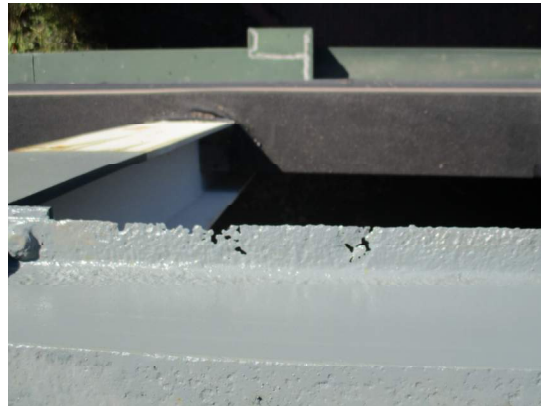
5. In general the third level steel beams along the High street façade are in fair condition with the exception of a few spots with section loss at the beam flange. The section loss of the beam flange is more of an aesthetic concern rather than structural issue. (See photo above).
6. The pedestrian cables and fencing were observed onsite. (See photo below).

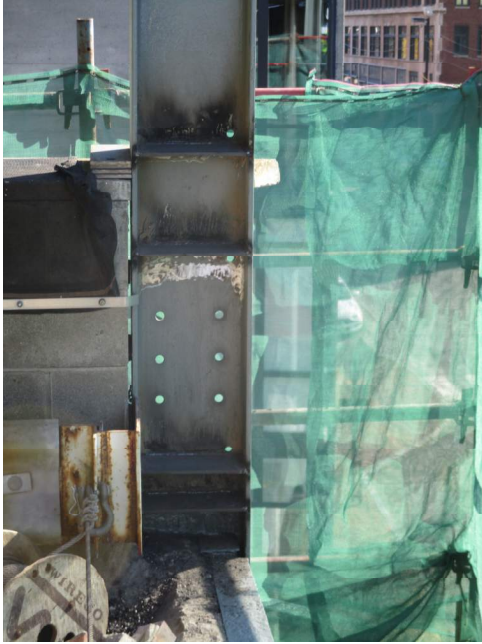
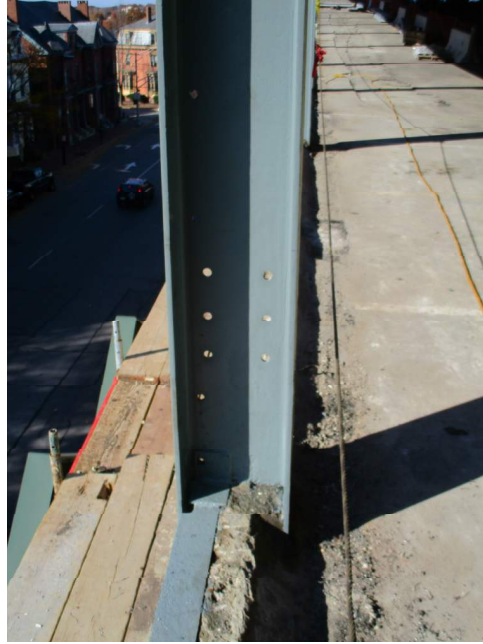
- Smith Custom Fabrication (SCF) has begun installing stiffener plates at column lines 1 and 13. SCF has field drilled all bolt and cable holes except the bottom pedestrian cable hole between column lines 6 and 10. All bolt holes need to be painted prior to installation of bolts or cables. At a few locations bolt/cable holes were not painted. (See photos below).

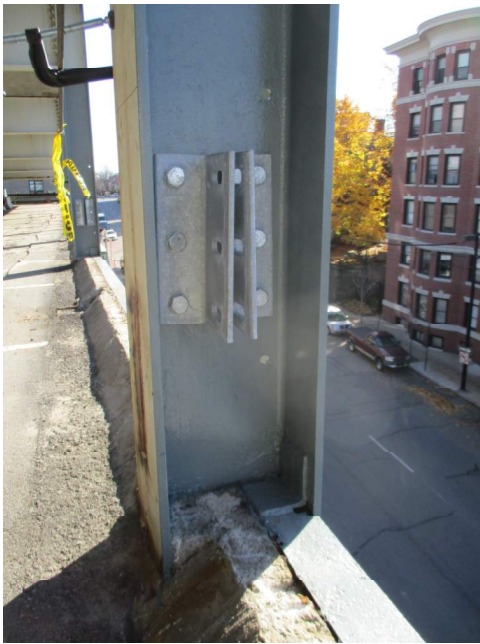
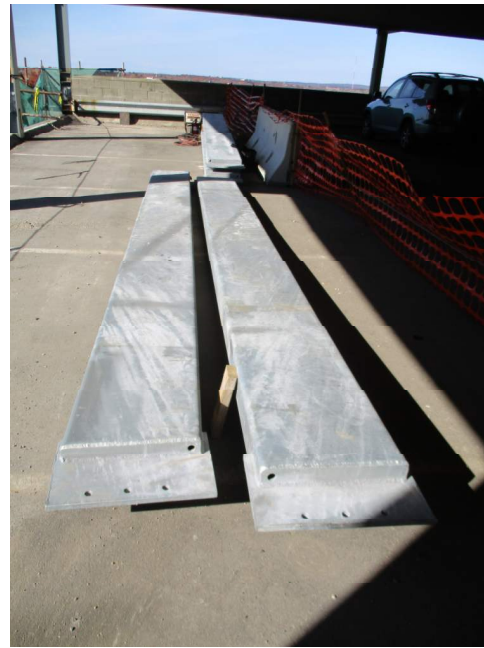
- All HSS bumpers and clip angles for the third level façade are on site. SCF has begun installing clip angles. (See photos below).

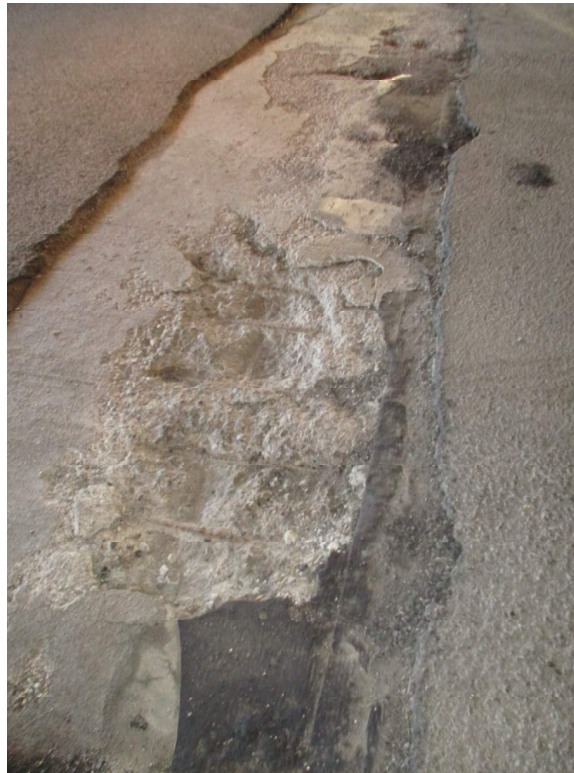
10. It should be noted that delaminated concrete was observed below the pavement and is not in the scope of work to be repaired this phase. (See photo below.)
