## Field Report #5

No. 3521

**Project:** Gateway PG – High St Façade Repairs Phase 1  
**Project #:** WO 3521  
**Date/Time:** November 23, 2015, 2:00 p.m.  
**Observers** Adam Sampson (BSE) (Author), Josh Martin-McNaughton (BSE)

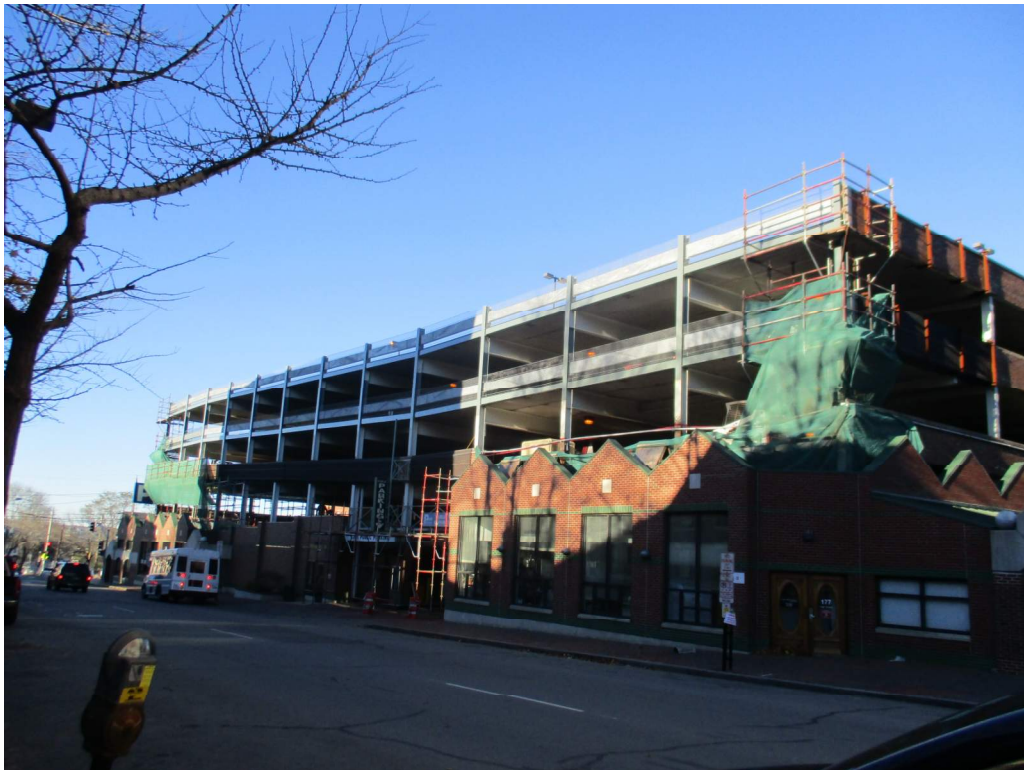
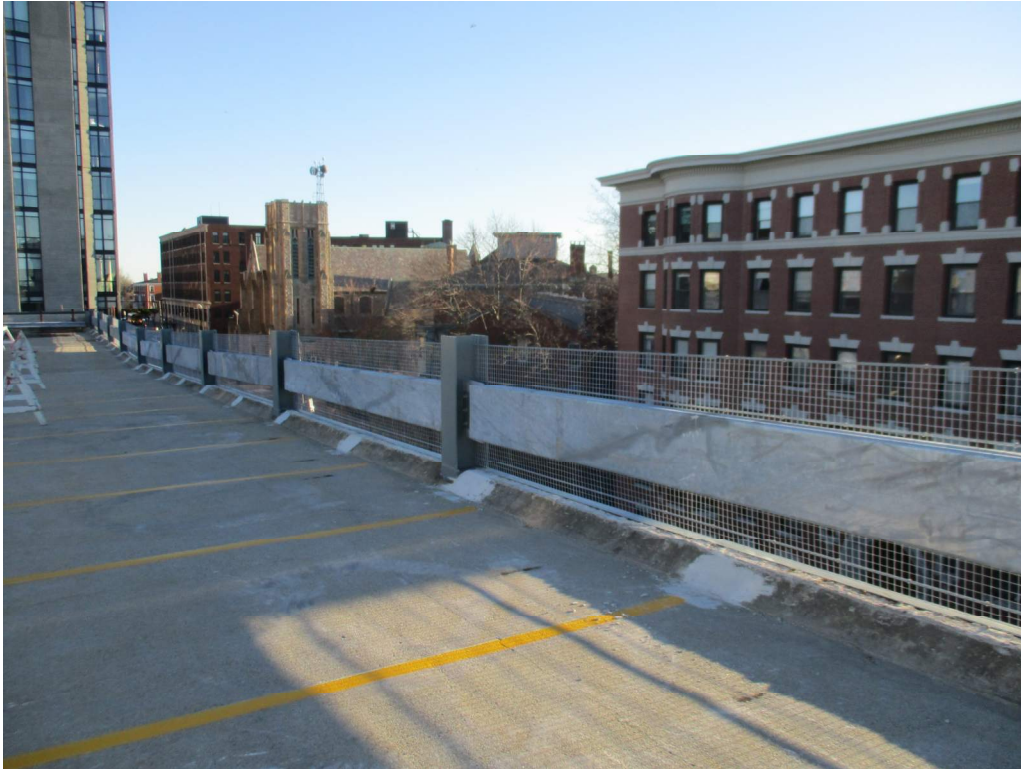
1. Knowles Industrial Services (KISC) has removed the brick and CMU façade from level one between column lines 13 and 10 and begun setting up the staging and removing the façade from level two. Smith Custom Fabrication (SCF) has installed HSS bumpers and Constructive Services has post tensioned all cables, and installed fencing at levels three and four. (See photos below).

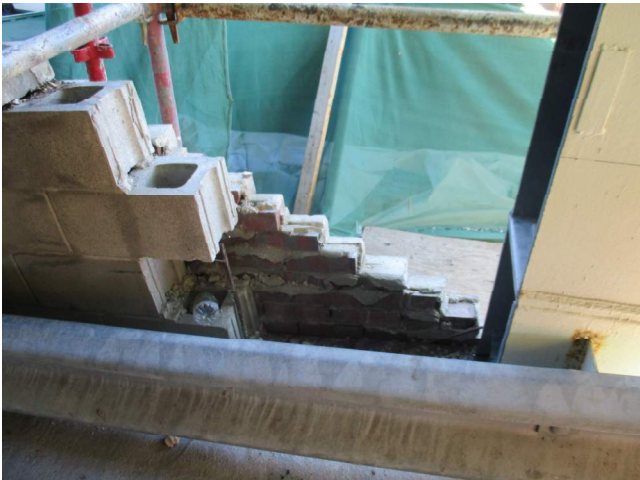
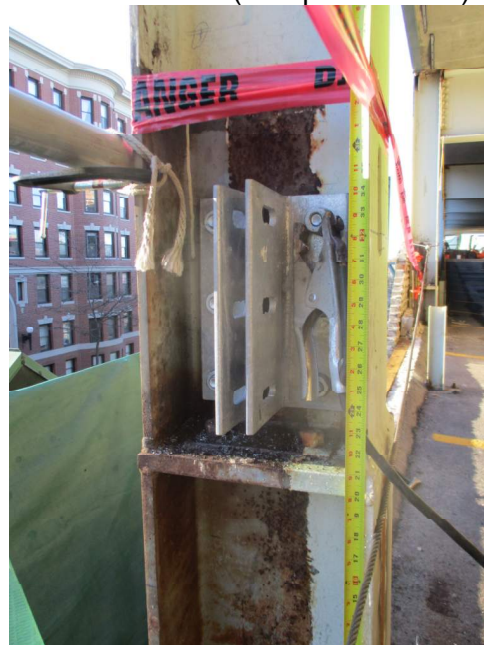
2. At level one KISC has demoed past column line 10 for access to install the HSS bumper and pedestrian cables. A portion of the CMU and brick façade will need to be rebuilt up to the column after the bumpers and cables/fencing has been installed. (See photo below).

3. Due to the asphalt wash and column splice plates at level two, SCF had to raise steel clip angles for the HSS bumpers. SCF was concerned the post tension cable would be hitting the clip angle but after review of the shop drawings it appears the cable will be above the clips. (See photo above).

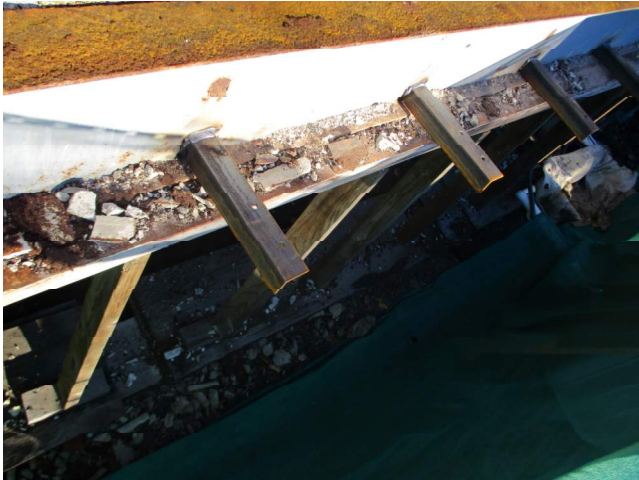
4. SCF has begun welding angles to support the data cable at level two. Due to the poor condition of the steel beam bottom flange, SCF was advised to weld the support angles to the web of the steel beam. (See photo below).

5. At the start of the sloped bays, hard plastic cable sheathing needs to be installed at each post tensioned cable to prevent galvanizing from rubbing off. (See photo above).
6. KISC has repaired the majority of the asphalt potholes. Cold patch asphalt will be required at concrete repairs and other locations not yet repaired. Line stripping has been completed. (See photos below).
