Field Report #6

Project: Gateway PG – High St Façade Repairs Phase 1
Project #: WO 3521
Date/Time: December 9, 2015, 8:00 AM.
Observers Adam Sampson (BSE) (Author), Josh Martin-McNaughton (BSE), Tim Rich (KISC), Dan Tardiff (KISC)

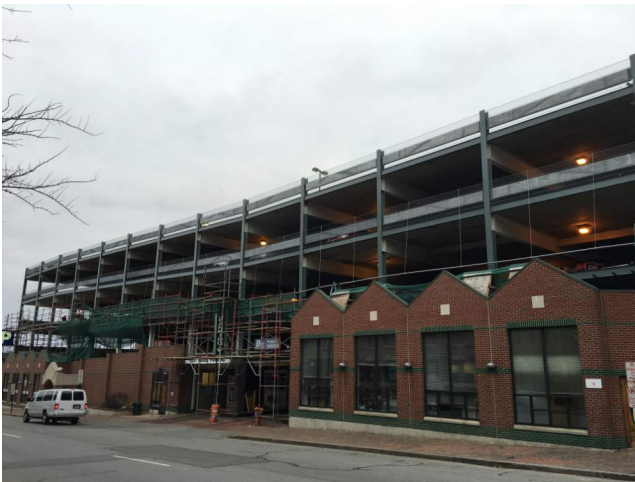
1. Knowles Industrial Services (KISC) has removed all of the brick and CMU façade from level one and two. Smith Custom Fabrication (SCF) has drilled cable and bolt holes at level one and two, and is ready to install HSS bumpers at level two. (See photos below).

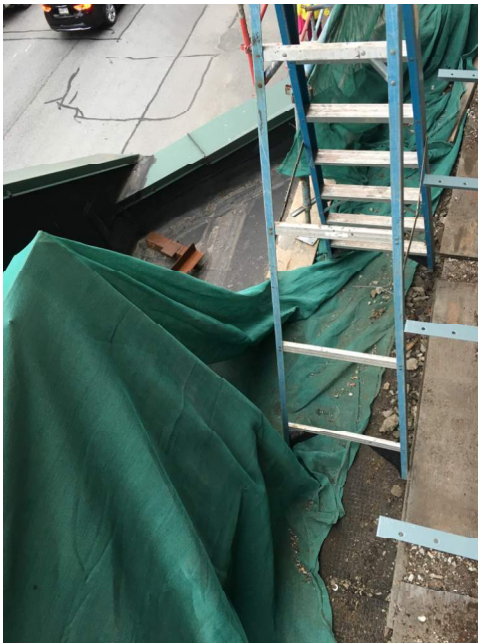
3. BSE advised KISC to clean, prime and paint the green frame of the sign at the entrance. (See photo below).
4. KISC needs to remove all debris and steel braces from the condo roof. If there is any remaining work to be done from this roof plywood protection should be installed. (See photo below).
