## Field Report #8

**Project:** Gateway PG – High St Façade Repairs Phase 1  
**Project #:** WO 3521  
**Date/Time:** December 28, 2015, 9:30 AM.  
**Observers** Adam Sampson (BSE) (Author)

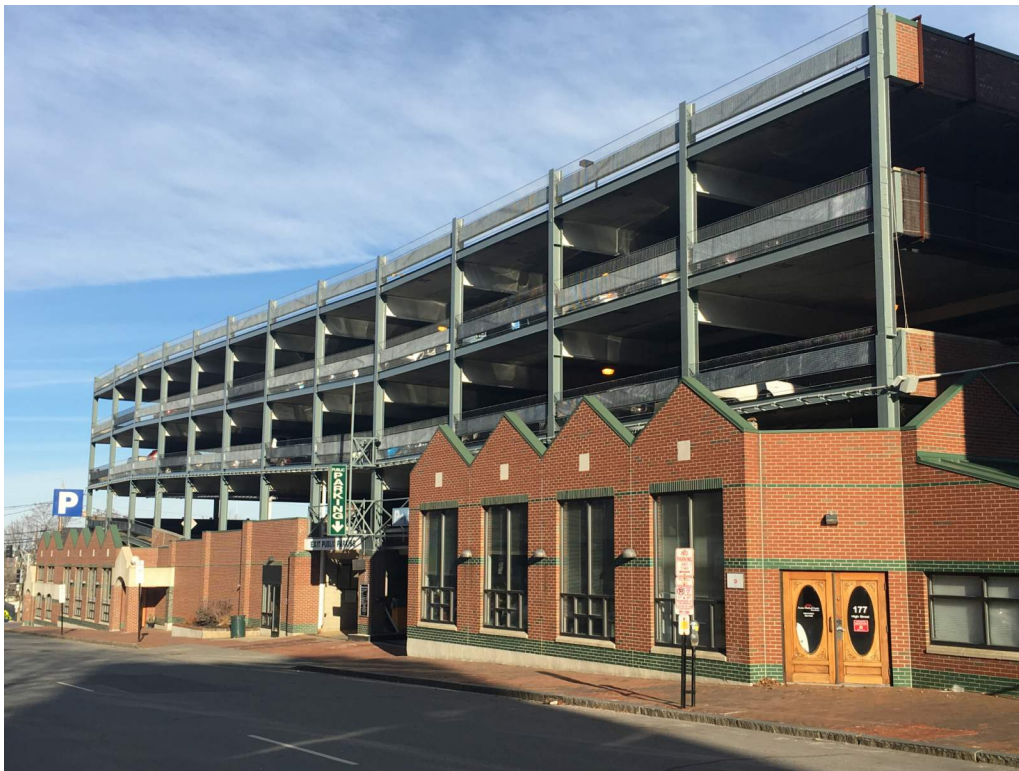
Knowles Industrial Services (KISC) has demobilized from the site. (See photos below).

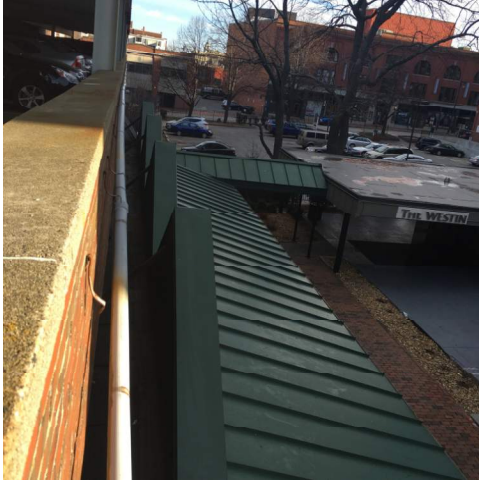
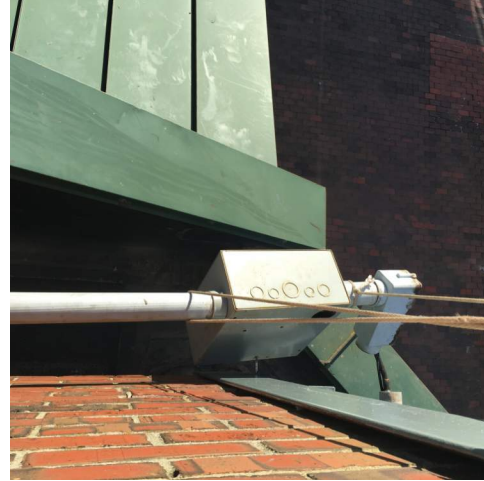
2. Time Warner Cable needs to relocate the data cable and junction box along the Hotel façade. It is recommended to match the elevation of the data cable along the High St. façade since this façade will be removed in the future. (See photo below).

3. The contractor is scheduled to install the two remaining clip angles supporting the data cable today and finish any cold galvanizing to the HSS bumpers.
4. Four hard plastic cable sheathings are missing at the roof level, these need to be installed.
